Stephen & Harriet Myers Residence
Albany, New York

Historic Structure Report

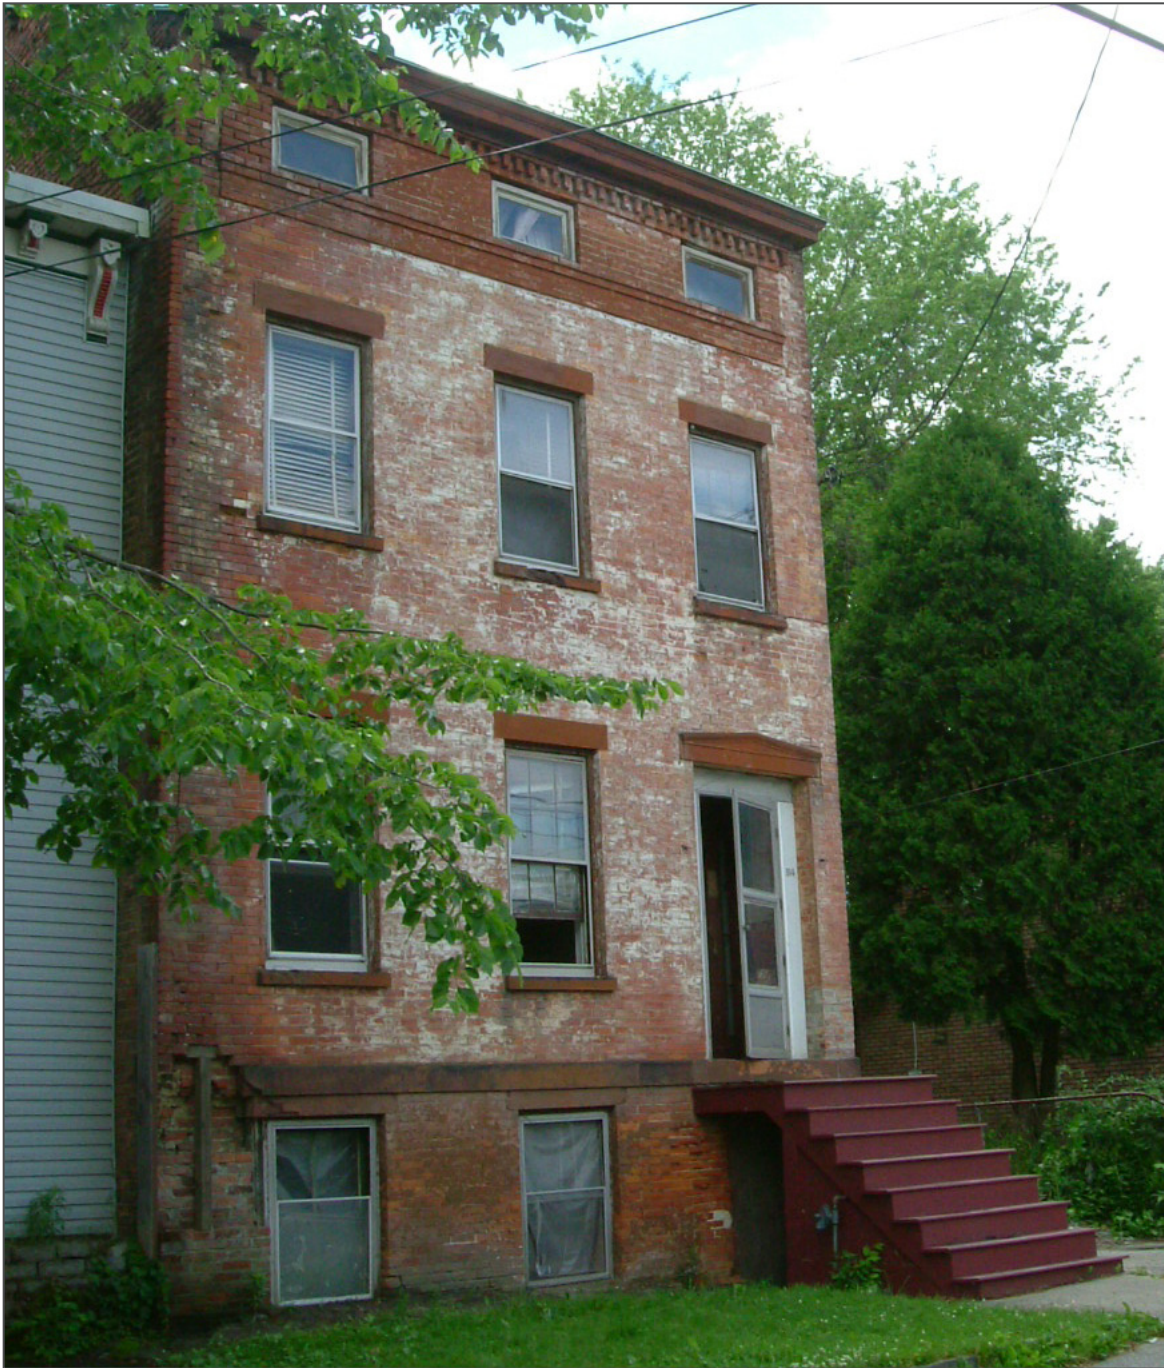
Figure 1: Front (north) facade of the Myers Residence.

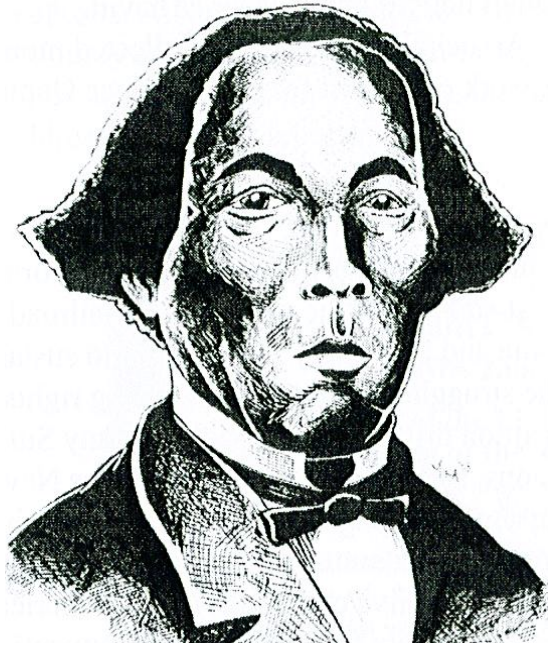
Figure 9: Image of Stephen Myers drawn by Albany artist Marcus Anderson in 2005.

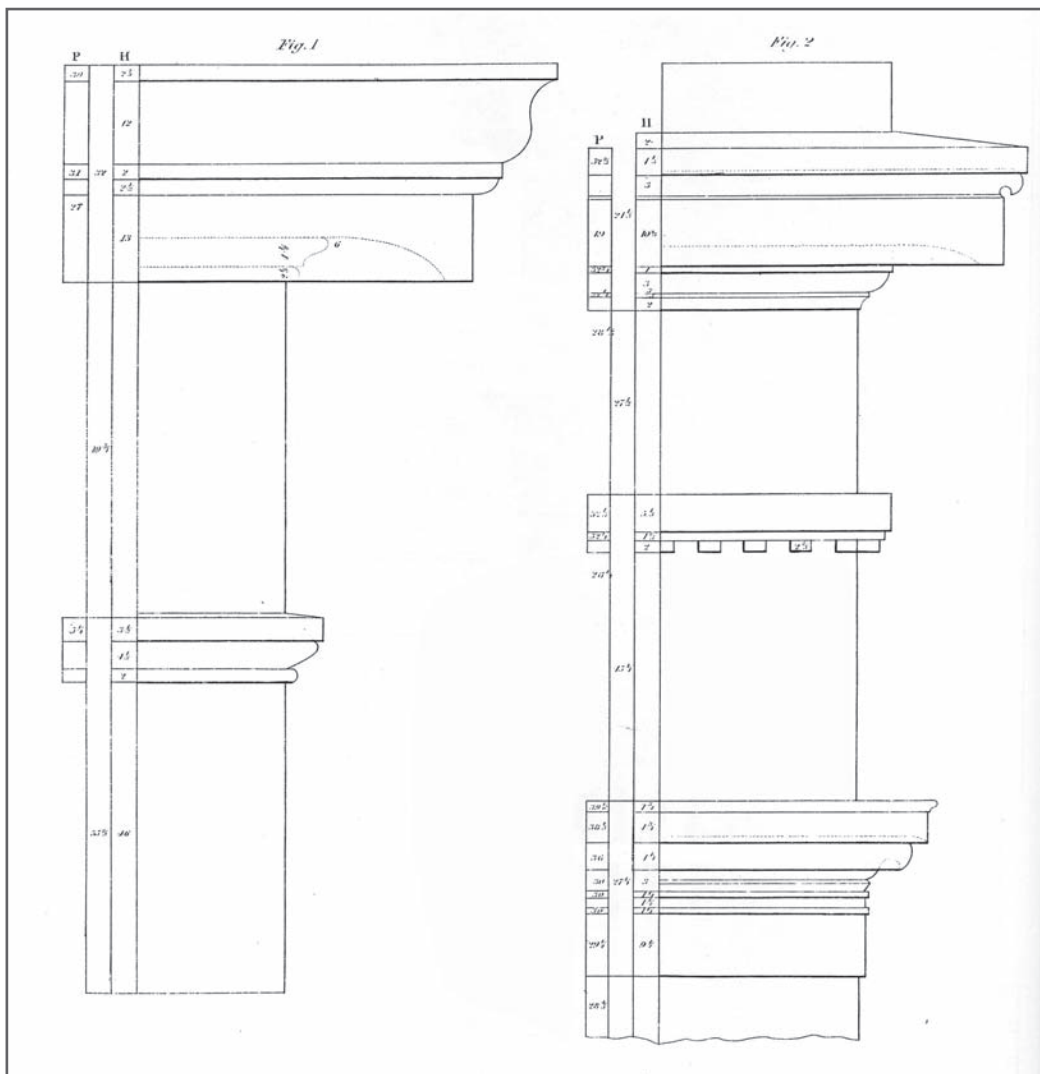
Figure 12: Asher Benjamin, *PLATE XIII*, *Practical House Carpenter*, 1830. Illustrated designs published in architectural handbooks and builder's manuals like Benjamin's influenced details that appeared in Greek Revival buildings.

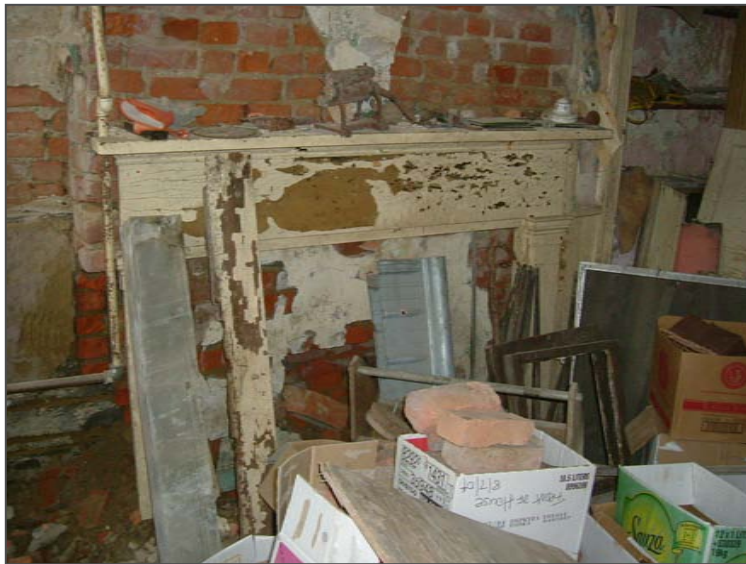
Figure 30: The remaining original fireplace surround is located in the basement dining room. It is wood with a painted finish. The molding work reflects popular examples found in architectural handbooks and builders' manuals.

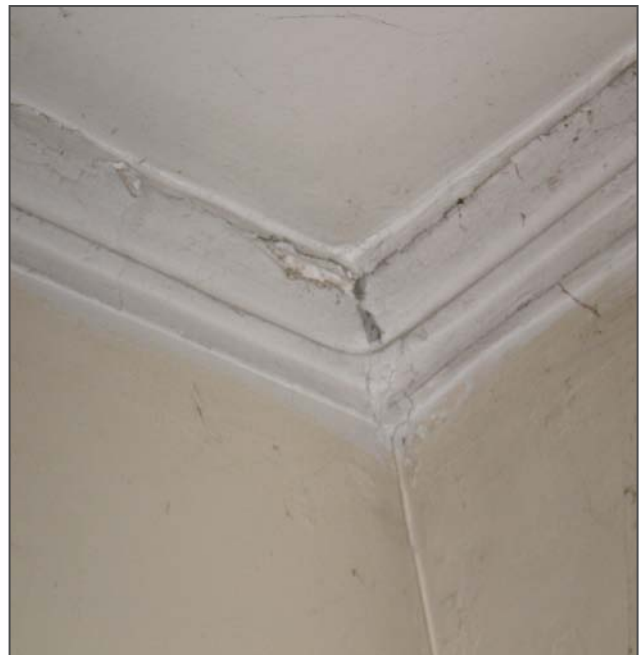
Figure 33: Ceiling decoration in the front parlor on the first floor. The combined moldings stand in contrast to the smooth plaster walls.

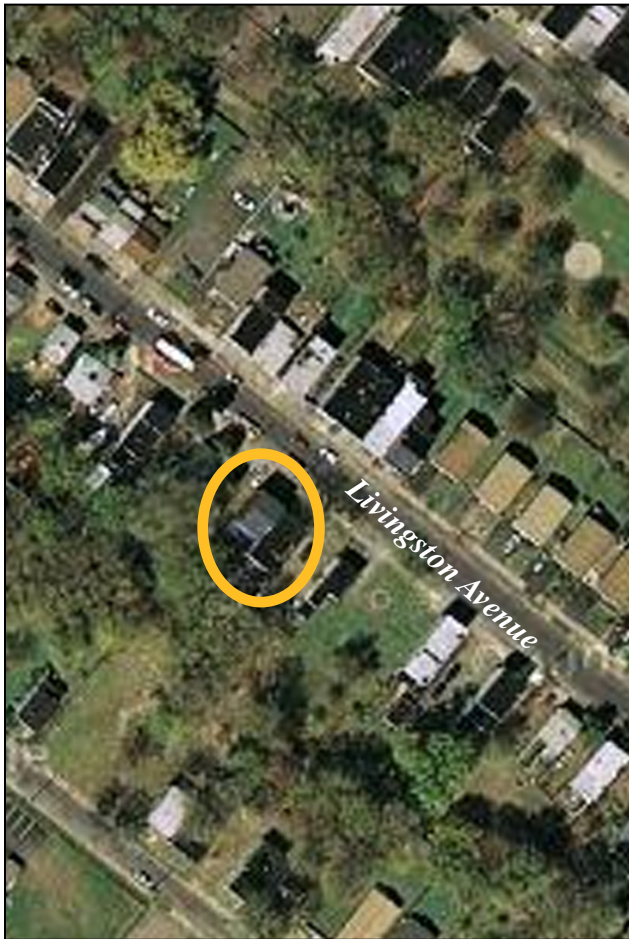
Figure 34: Site Plan of the Myers Residence with Livingston Avenue on the north (front) facade.

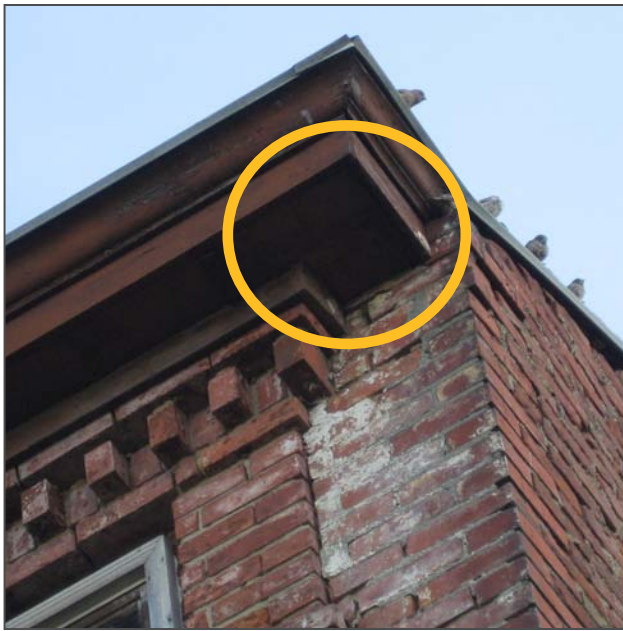
Figure 37: North facade cornice at the corner of the west facade with a detail of the failing built-in gutter system. The location of a since-removed leader is highlighted.

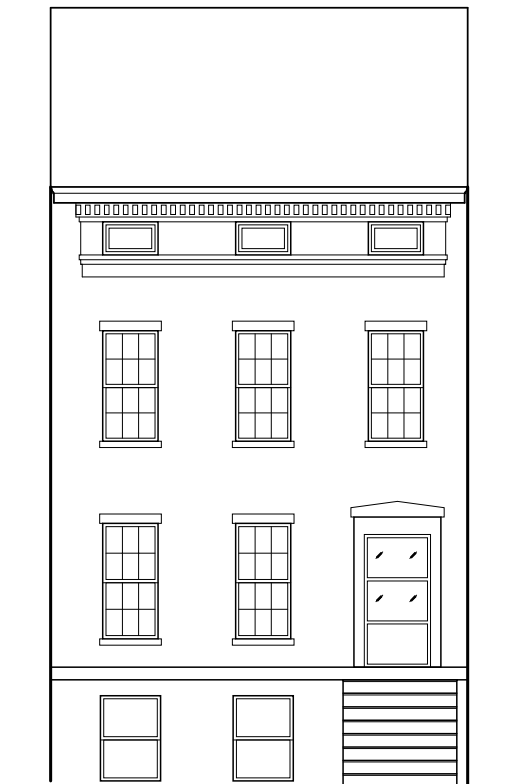
Figure 38: North Facade Elevation

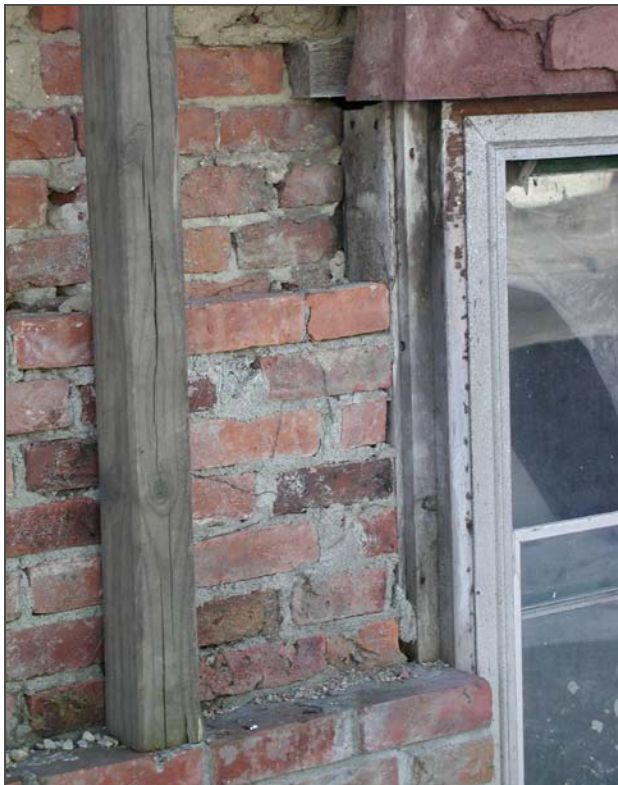
Figure 39: Two of three wythes of the brickwork at the east corner of the north façade have partially collapsed and require immediate attention (note temporary support).

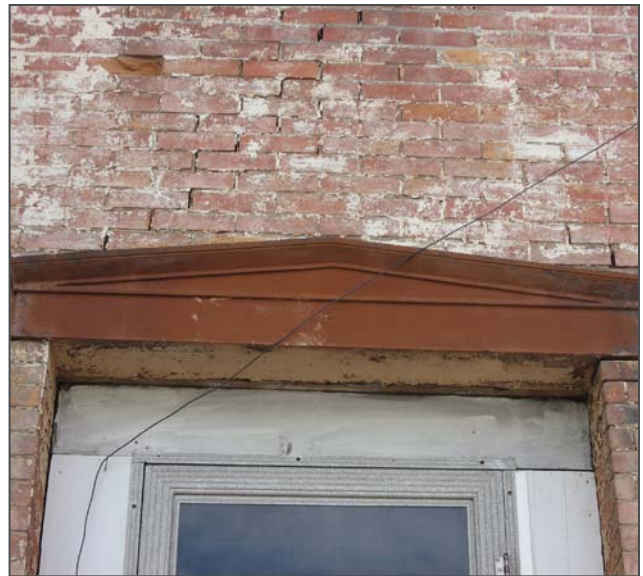
Figure 40: Pediment detail above the front door

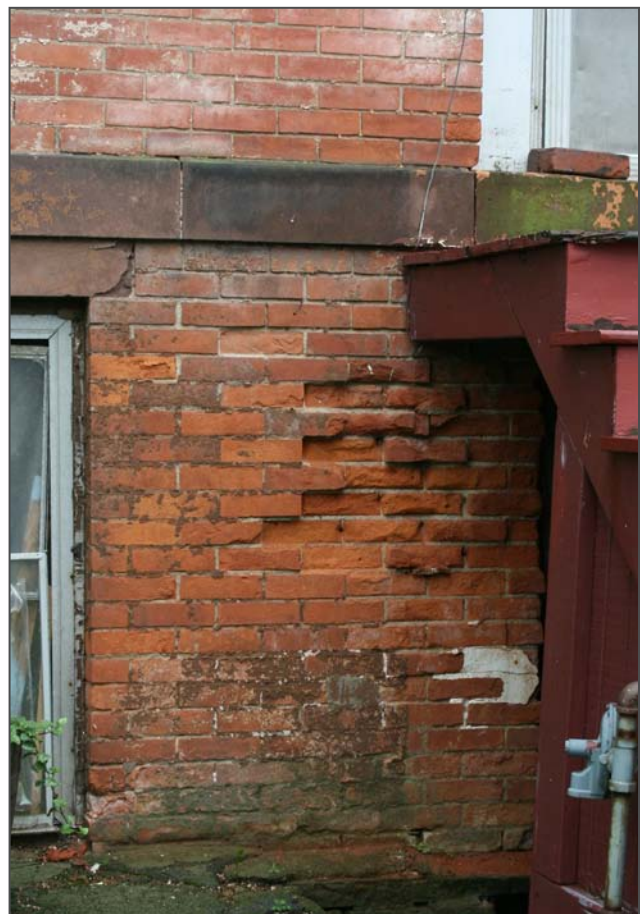
Figure 41: Area of spalling brick to the east of the contemporary stoop.

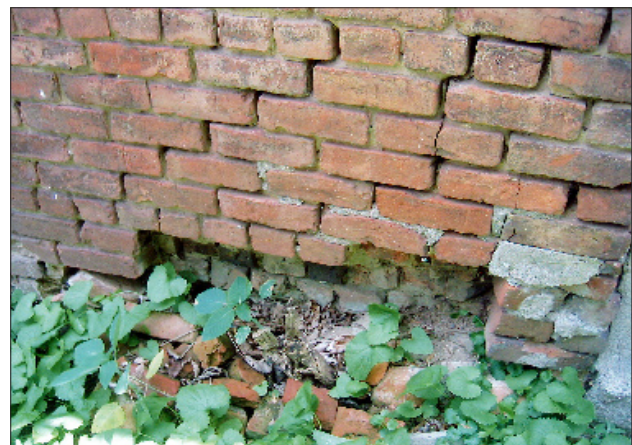
Figure 42: Weakened masonry at the south end of the west façade (note severely eroded mortar joints) has partially collapsed.

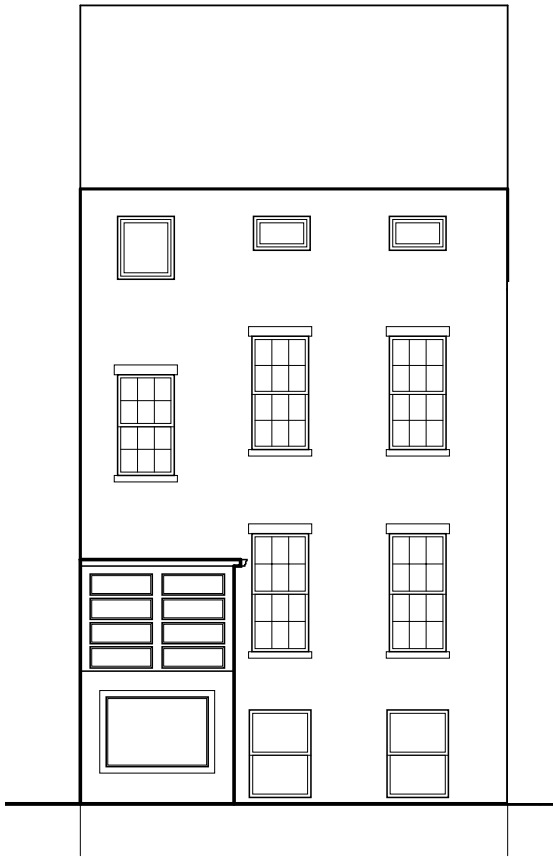
Figure 44: South Facade Elevation

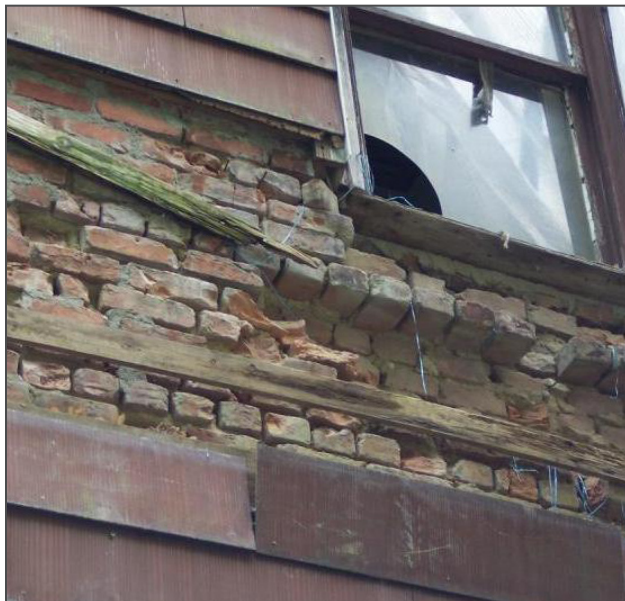
Figure 45: When a new tarp was added to the south facade in June of 2008, fallen asbestos siding revealed the deteriorated masonry wall underneath.

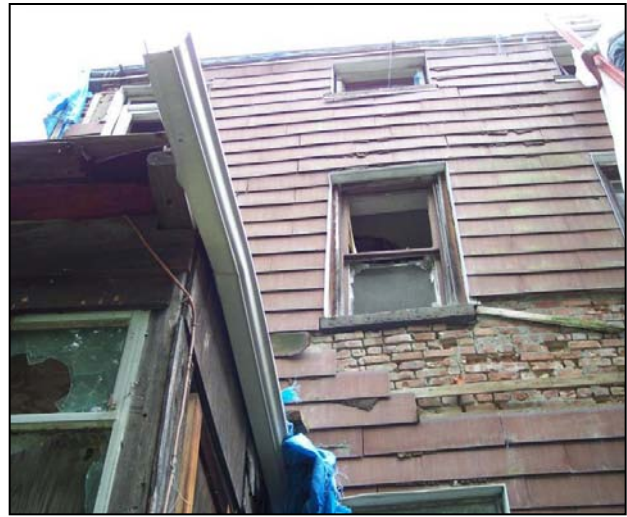
Figure 46: Exposed siding and brick on the south facade on June 20, 2008 when the tarp was being replaced.

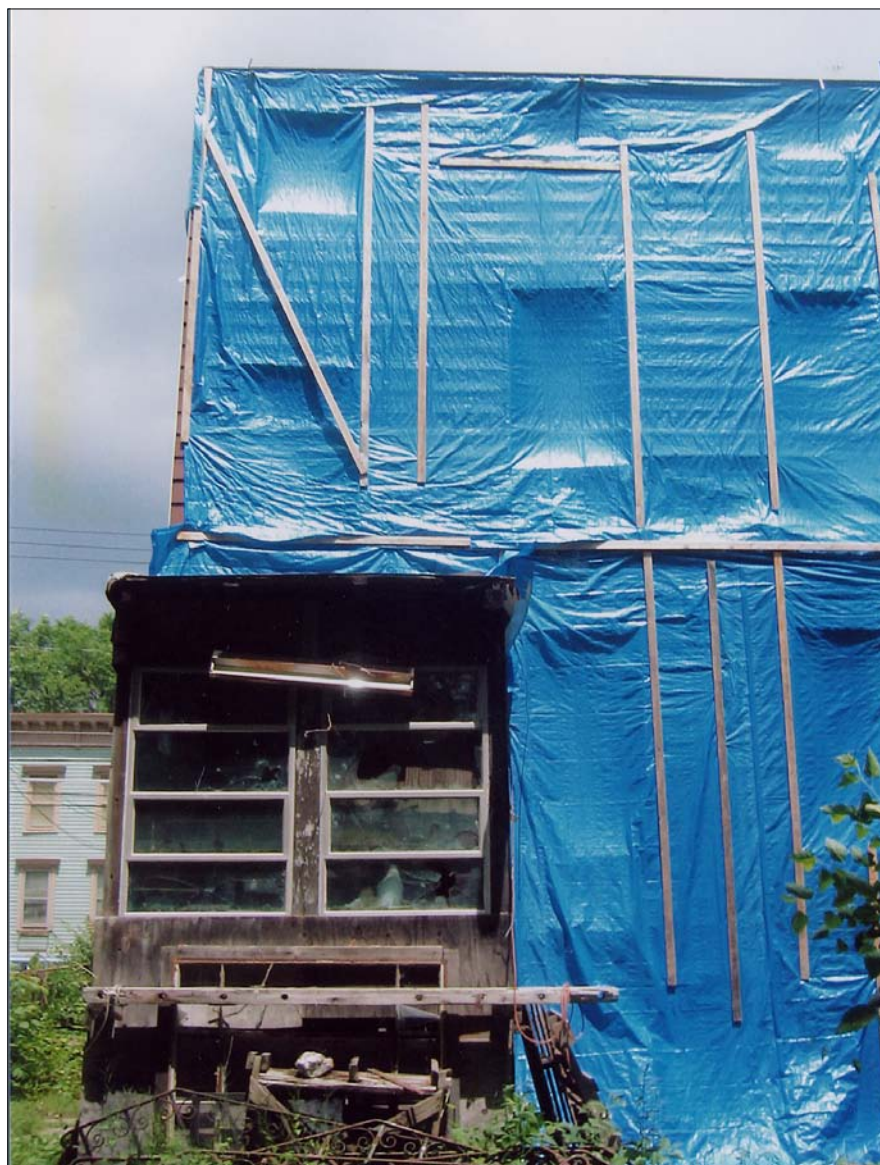
Figure 47: The south façade was covered in tarps to stop ongoing water infiltration during an initial attempt at stabilization in fall of 2004. The rear porch, a later addition, is probably not salvageable.

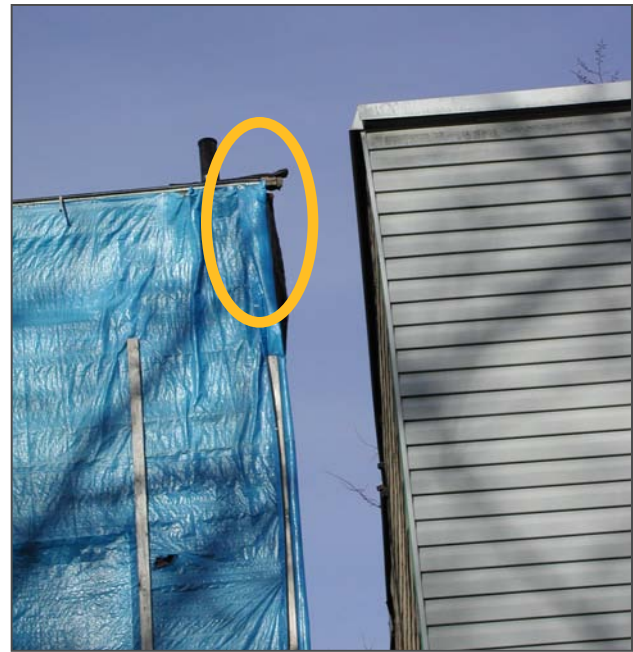
Figure 49: View from rear (south). The masonry at the upper portion of the gable on the east façade is visibly bulging.

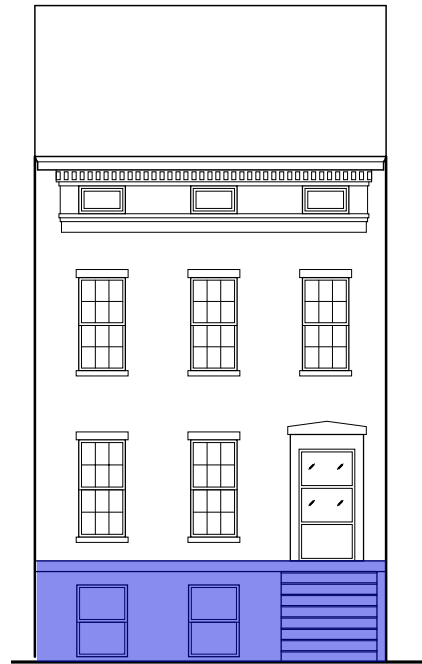
Figure 50: North Facade Elevation with the basement highlighted.

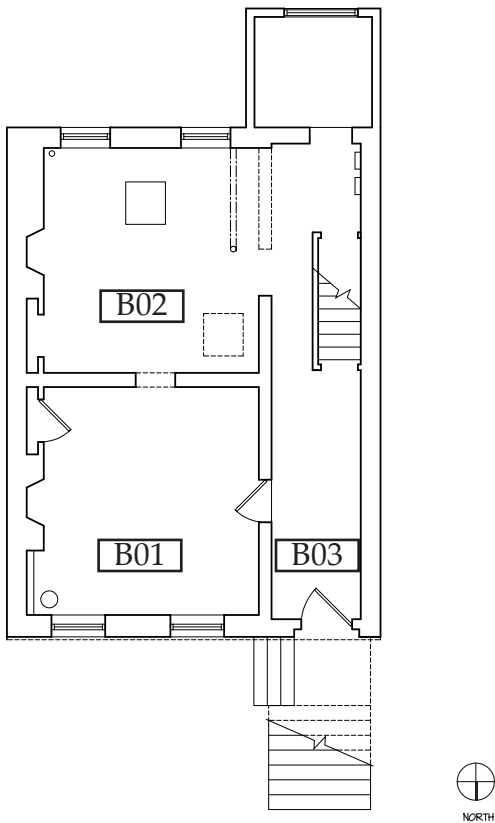
Figure 51: Existing Condition Basement Floor Plan

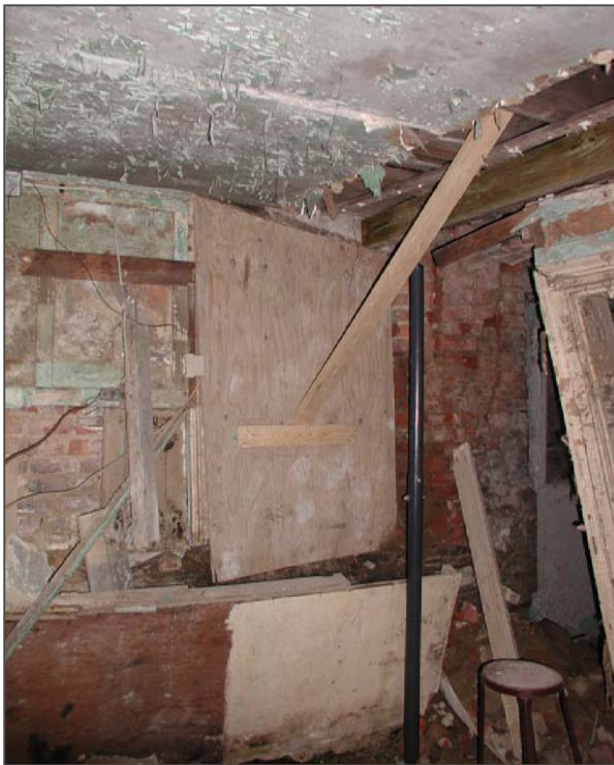
Figure 52: All of the brickwork at the south end of the stiffening partition between B02 and B03 has collapsed. Temporary posts and beam support the first floor.

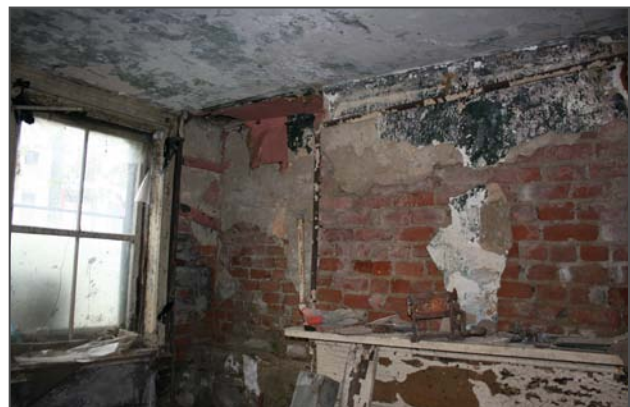
Figure 55: Most of the finishes in the basement are deteriorated from water infiltration. Plaster from the walls and chimney breast in the northeast corner of Room B01 have delaminated from the brick walls.

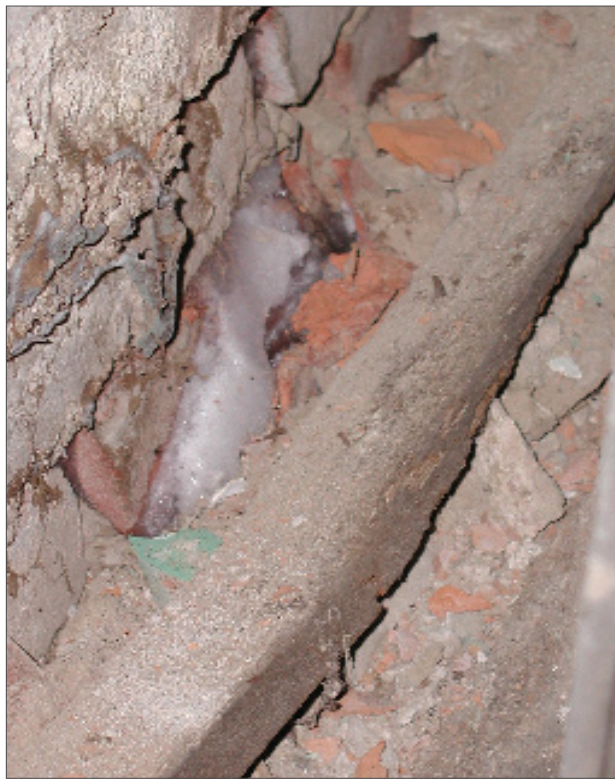
Figure 56: During a winter visit, ice was visible in the bricks in the east-west basement partition.

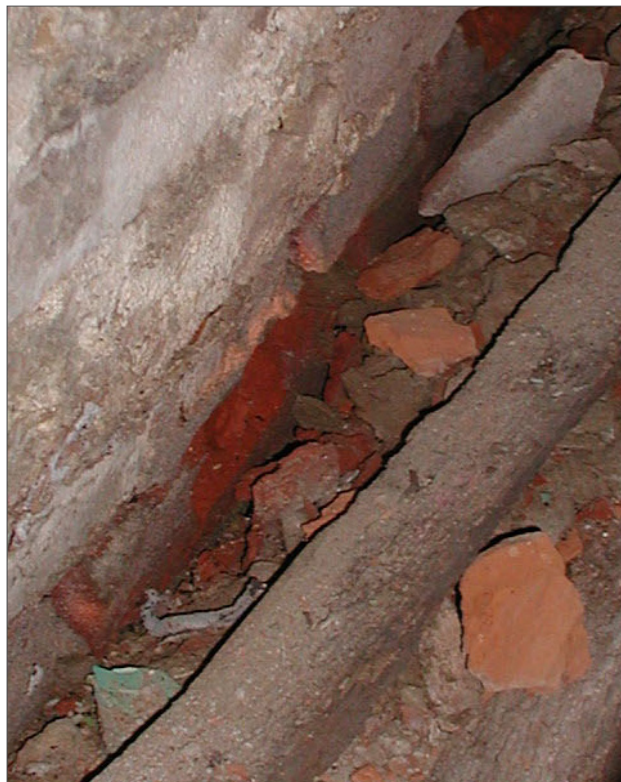
Figure 57: During a spring visit, damage was visible in the bricks in the east-west basement partition, where the ice has melted.

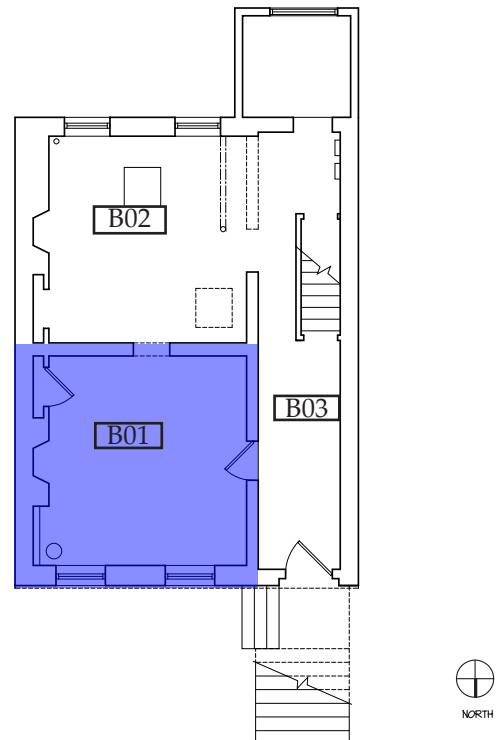
Figure 58: Existing Condition Basement Floor Plan with Room B01 highlighted.

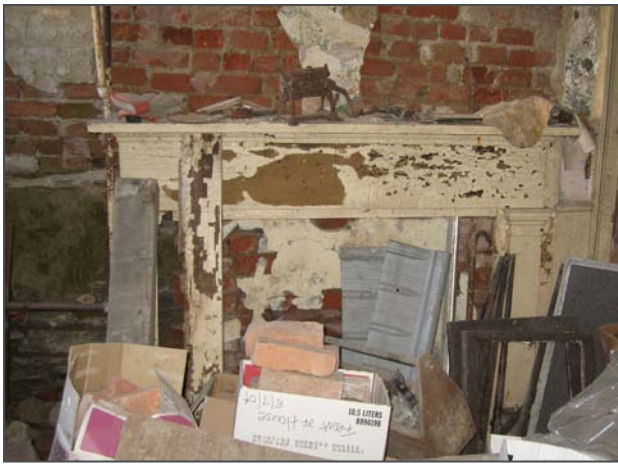
Figure 59: Only remaining original mantelpiece on the east wall in Room B01.

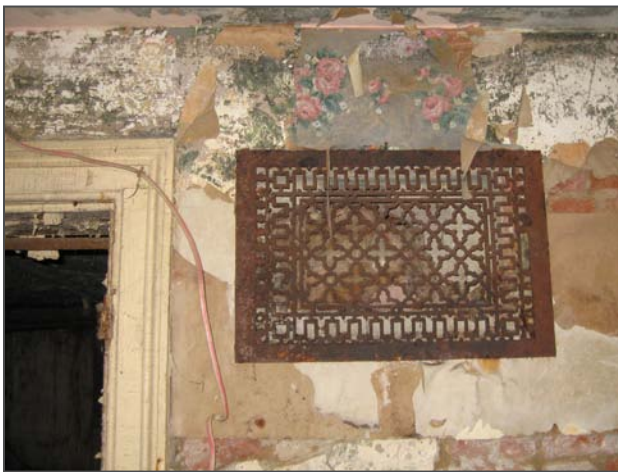
Figure 60: Cast iron grill on the south wall likely part of first central heating system.

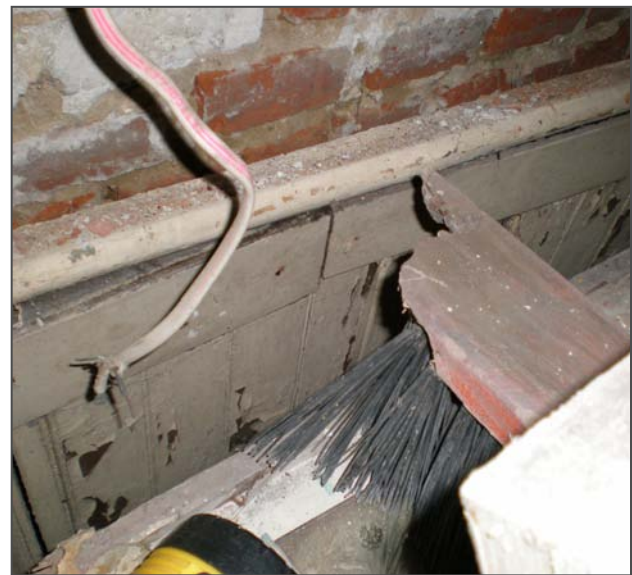
Figure 61: Intact wainscoting and chair rail on the south wall in Room B01.

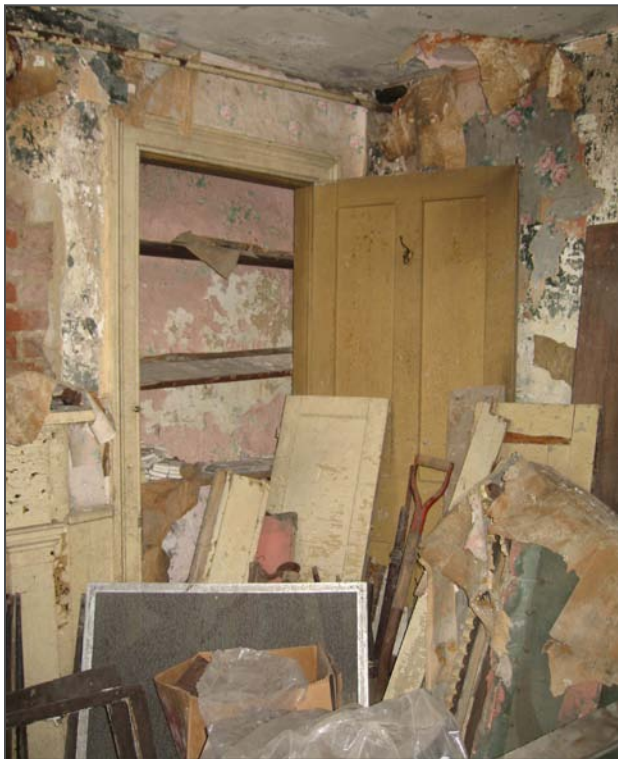
Figure 62: Closet and likely original door on the east wall in Room B01.

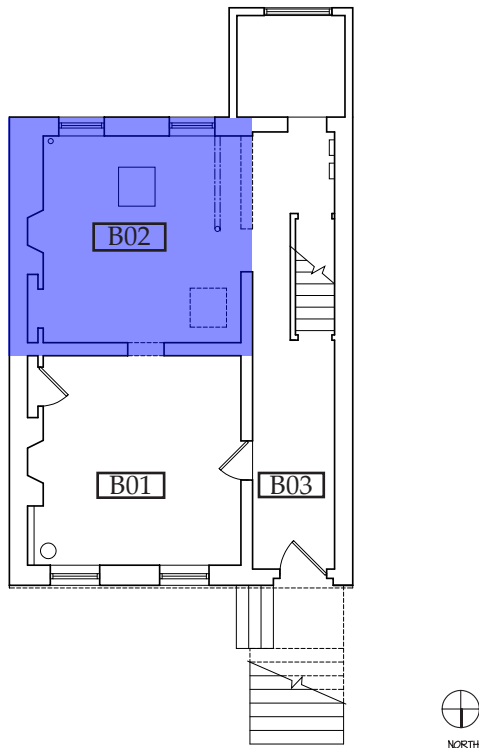
Figure 63: Existing Condition Basement Floor Plan with Room B02 highlighted.

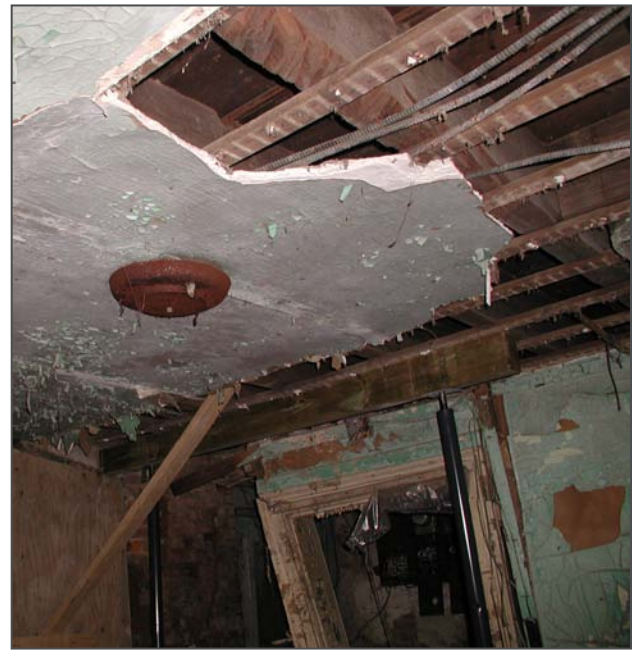
Figure 64: Both plaster and lath are missing from the ceiling in B02.

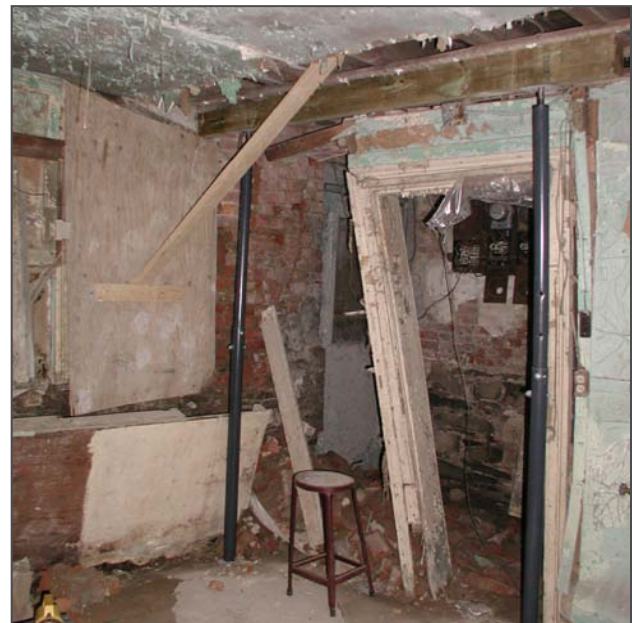
Figure 65: Ongoing water infiltration has destroyed many of the finishes in Room B02.

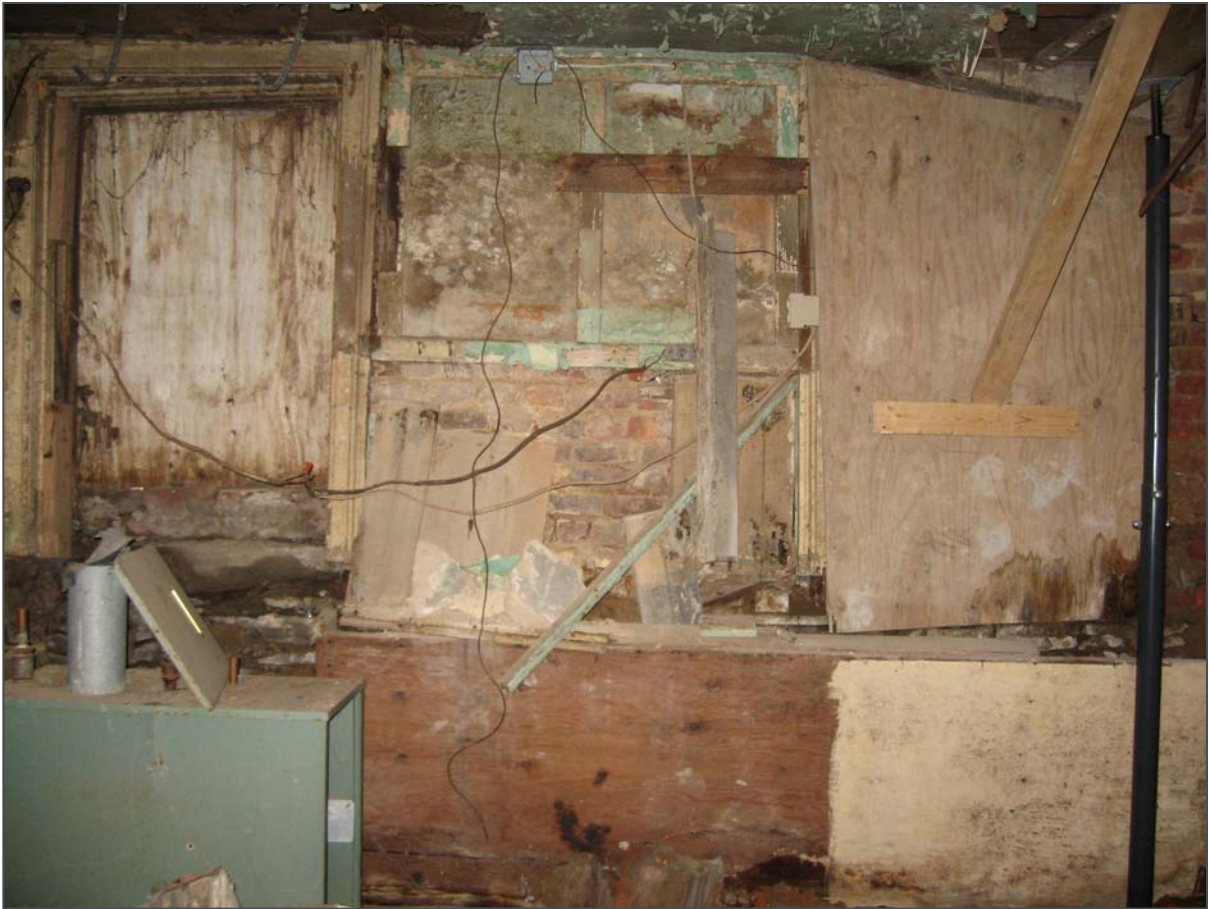
Figure 66: Boarded up windows on the south wall.

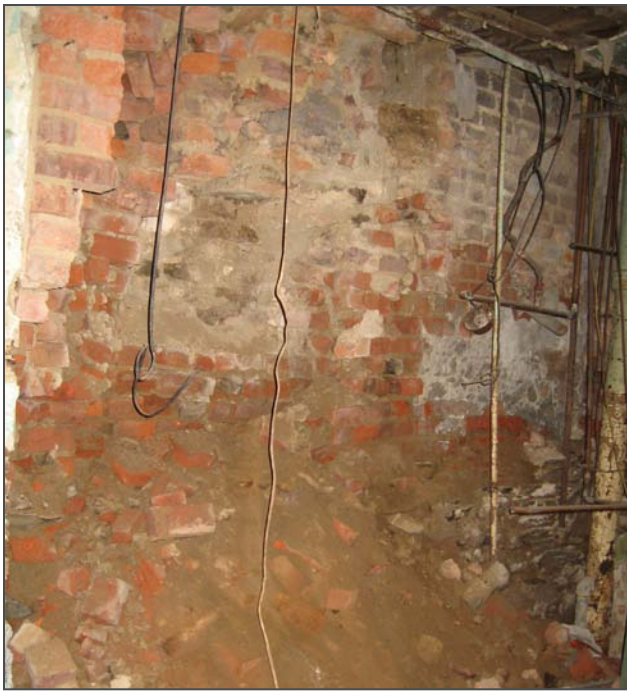
Figure 67: Collapsed chimney breast on the east wall.

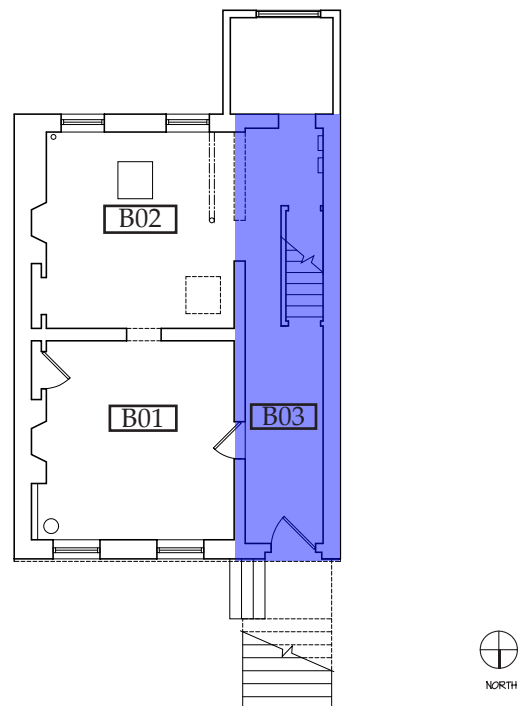
Figure 68: Existing Condition Basement Floor Plan with Room B03 highlighted.

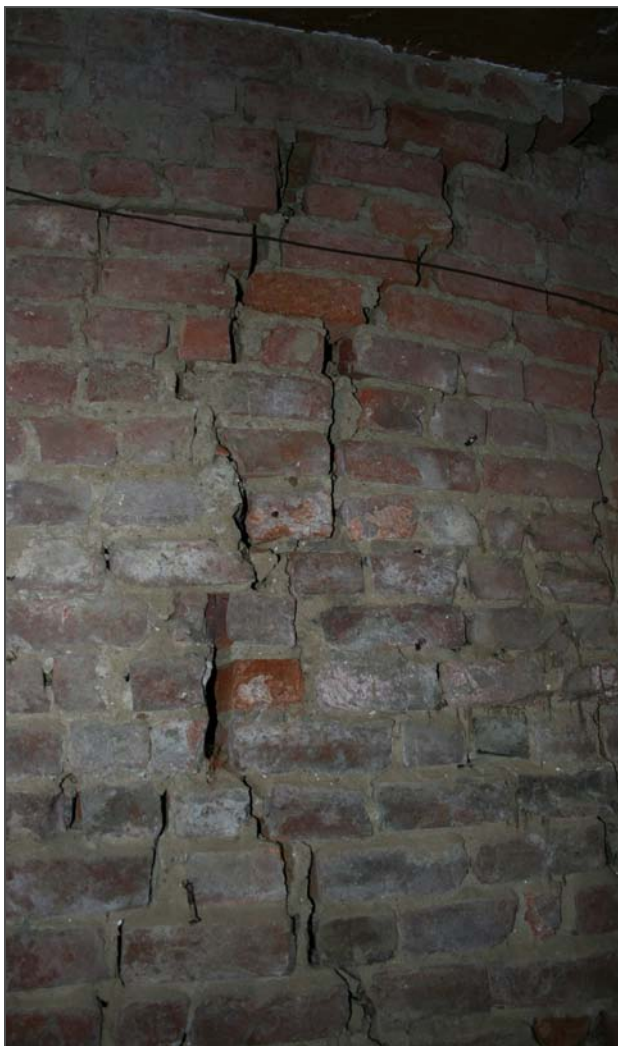
Figure 69: Large vertical crack in the stiffening wall.

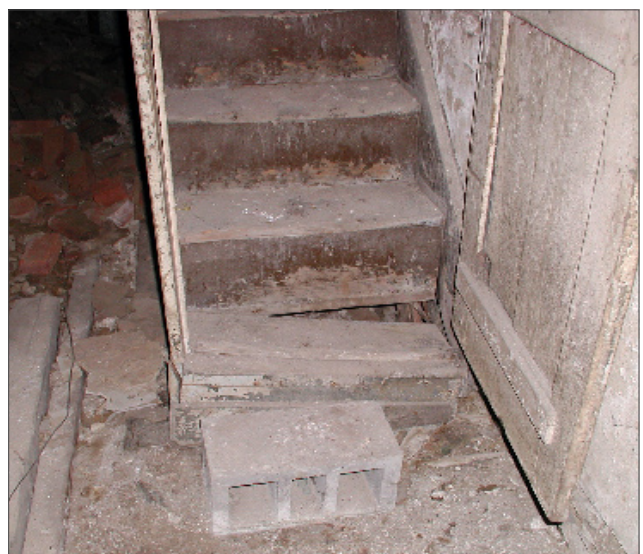
Figure 70: Removal of the historic floor and deterioration of the stringers have left the bottom of the stair to the basement unsupported and precarious.

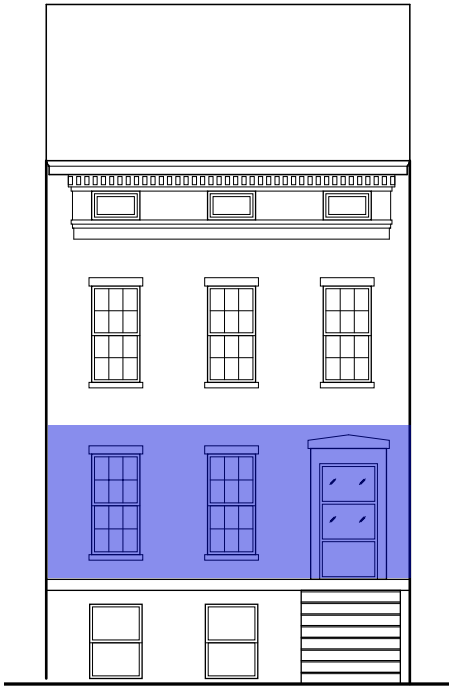
Figure 71: North Facade Elevation with the first floor highlighted.

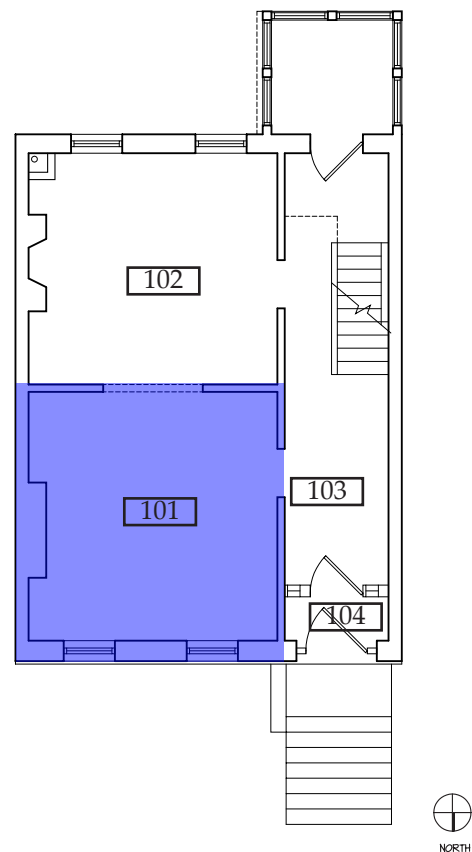
Figure 72: Existing Conditions First Floor Plan with Room 101 highlighted.

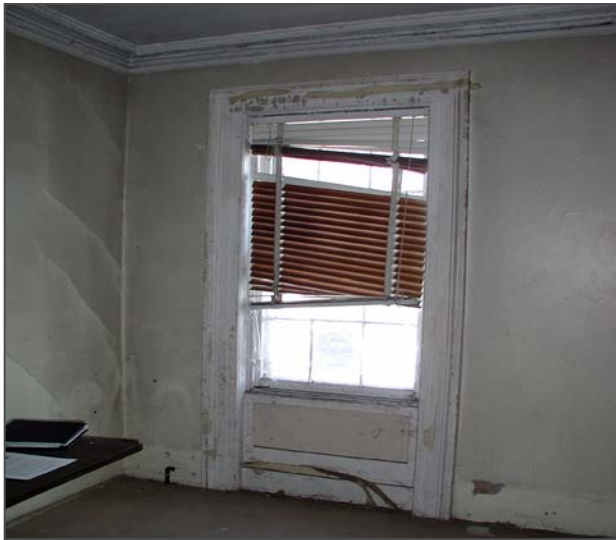
Figure 73: In Room 101, the front parlor has the most elaborate finishes in the house: a run plaster cornice and recessed wood panels below the windows. Diagonal cracks (at left in this photo) indicate settling.

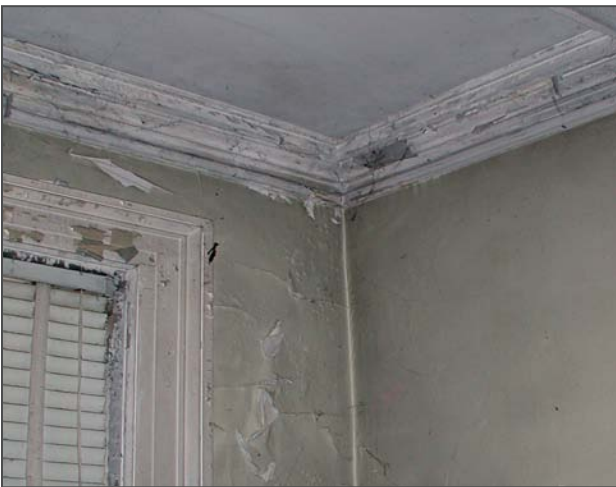
Figure 74: In the northeast corner of Room 101, peeling paint and soft plaster indicate moisture infiltration.

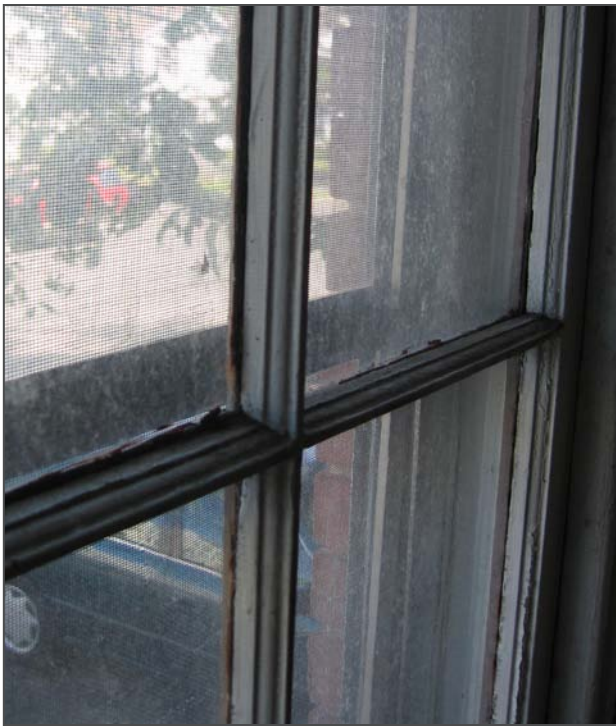
Figure 75: Detail of muntin profile on East window in Room 101, likely original.

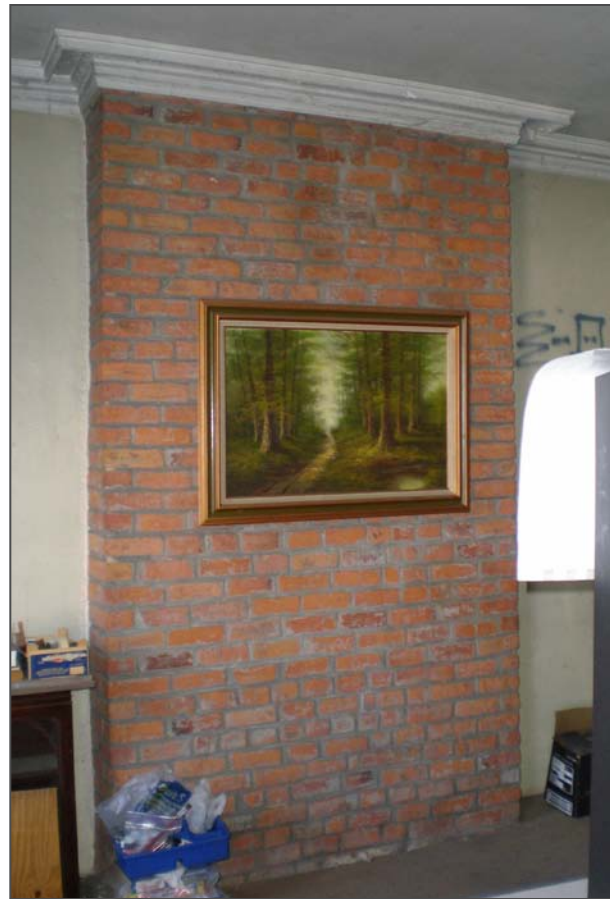
Figure 76: Chimney breast in Room 101 with repointed mortar and run-in-place plaster cornice.

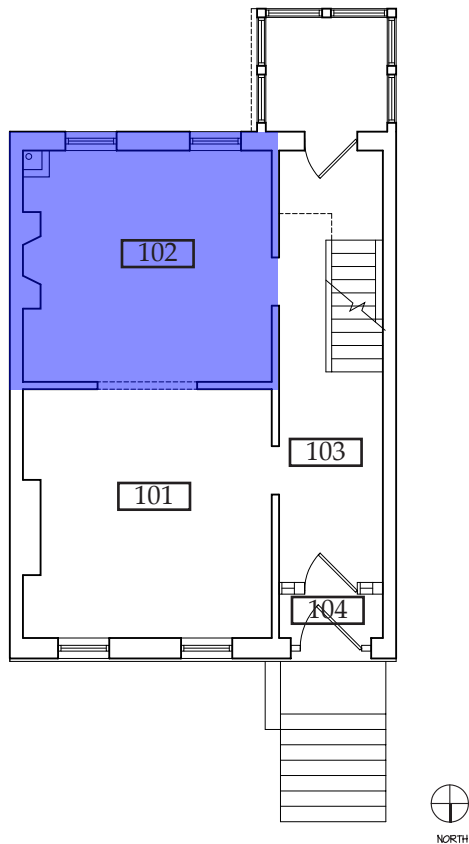
Figure 77: Existing Conditions First Floor Plan with Room 102 highlighted.

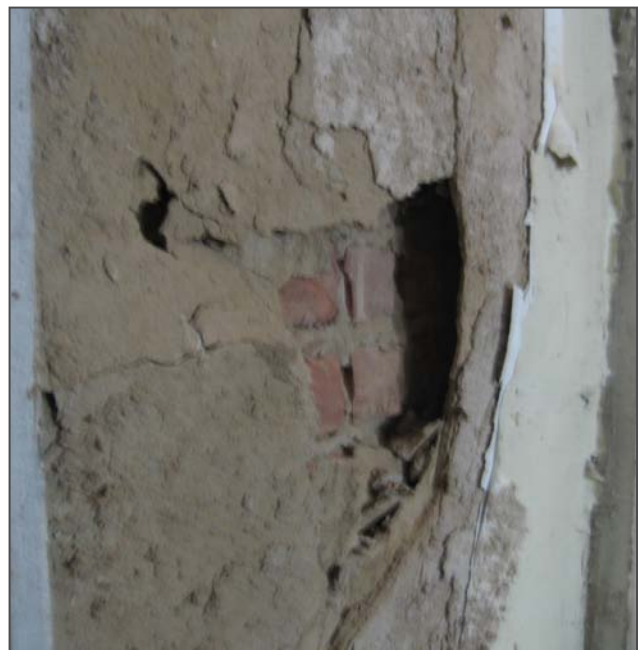
Figure 78: Southern wall in Room 102 in between the windows. Severe water infiltration has resulted in the plaster detaching from the brick, buckling and falling off.

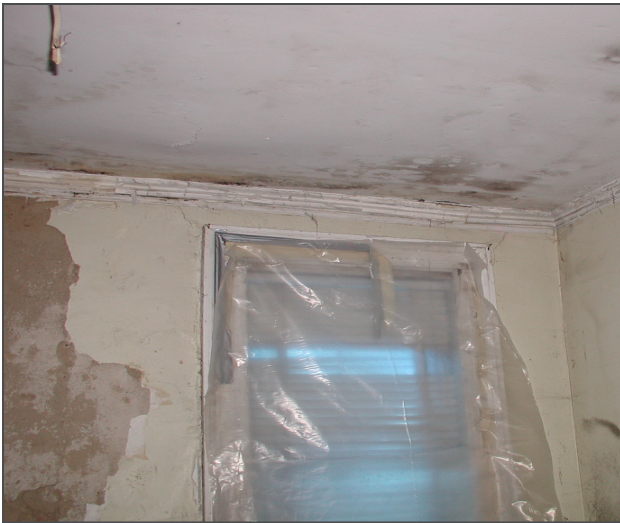
Figure 79: Water infiltration through the south wall damaged the plaster walls and cornice and left mildew stains on the ceiling of Room 102.

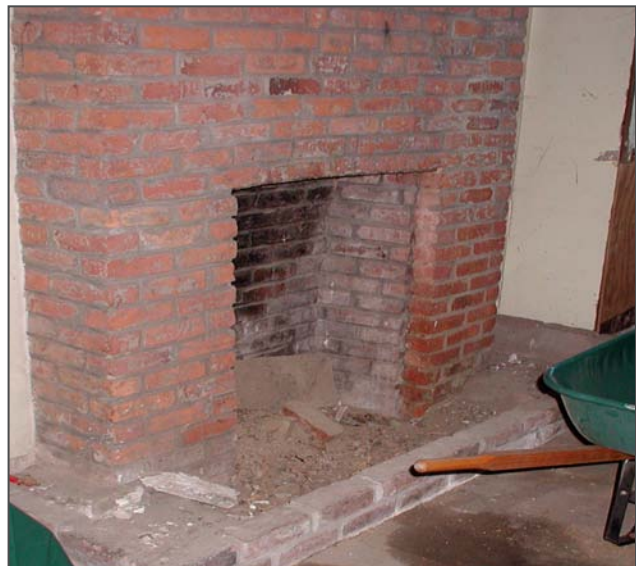
Figure 80: The curb of bricks in front of the fireplace in Room 102 is a contemporary alteration.
