Stephen & Harriet Myers Residence
Albany, New York

Historic Structure Report

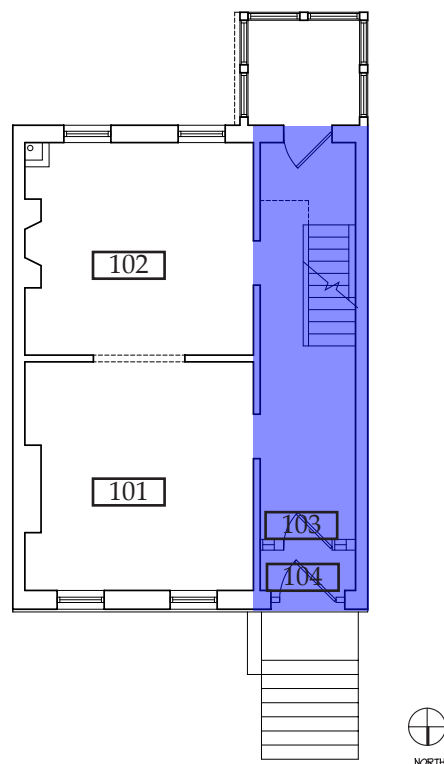
Figure 81: Existing Condition First Floor Plan with Room 103 and Room 104 highlighted.

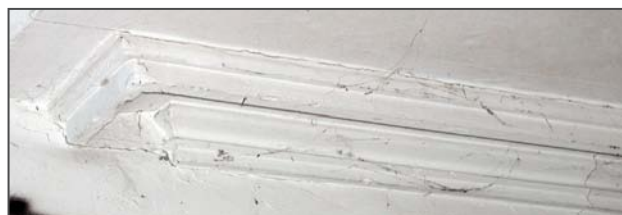
Figure 82: Room 103 retains an original plaster cornice.

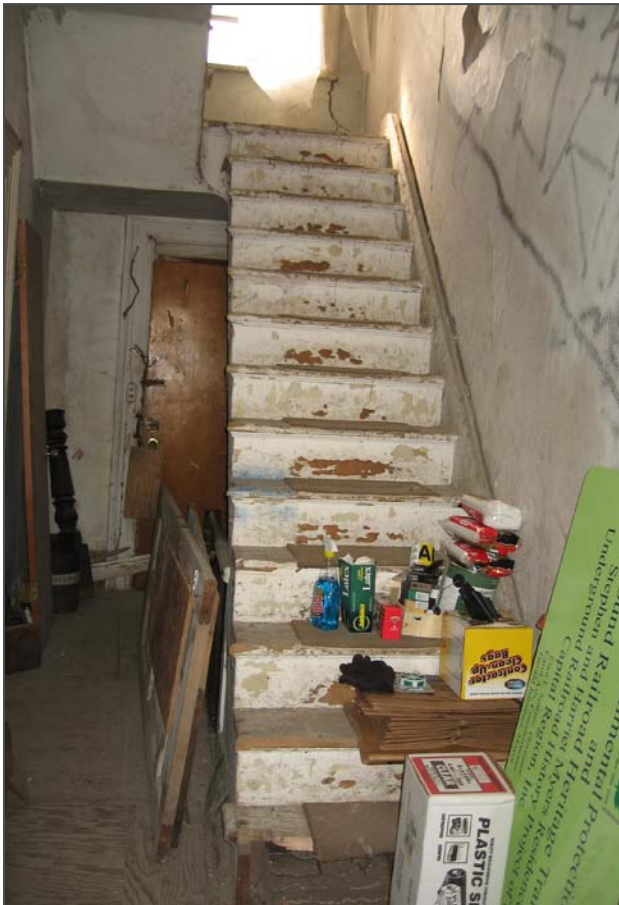
Figure 83: Staircase to the second floor with missing railing and balluster.

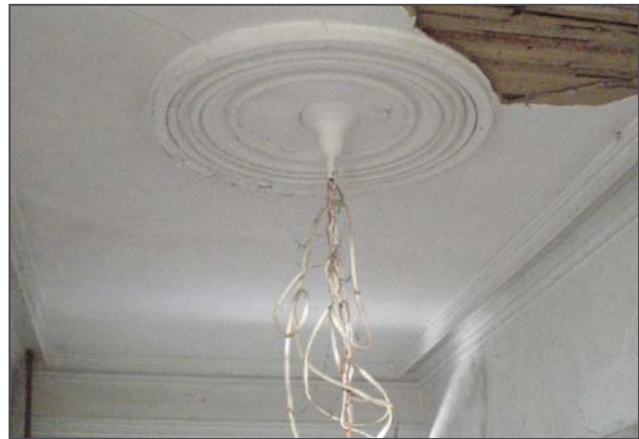
Figure 84: Central ceiling medallion with wiring and chain remaining from previous fixture.

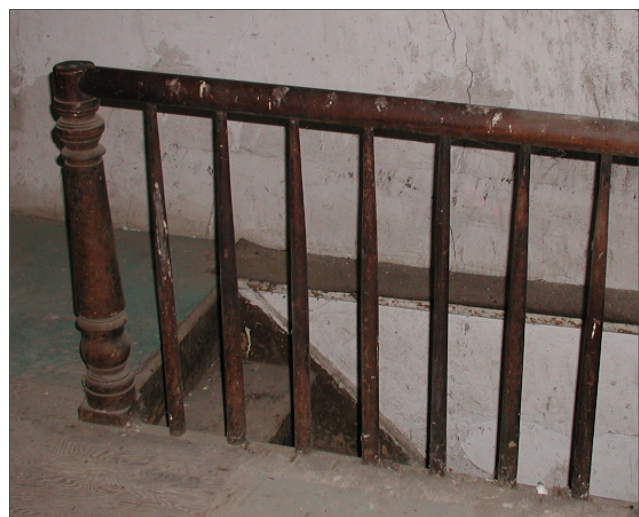
Figure 85: The stair to the cellar retains most of its original ballustrade. The cap on the newel post is missing.

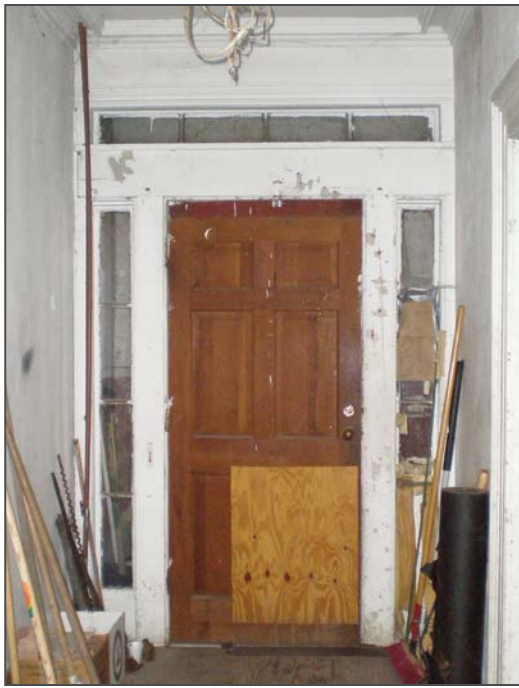
Figure 86: Interior view of the main entrance with original trim and transom and contemporary door.

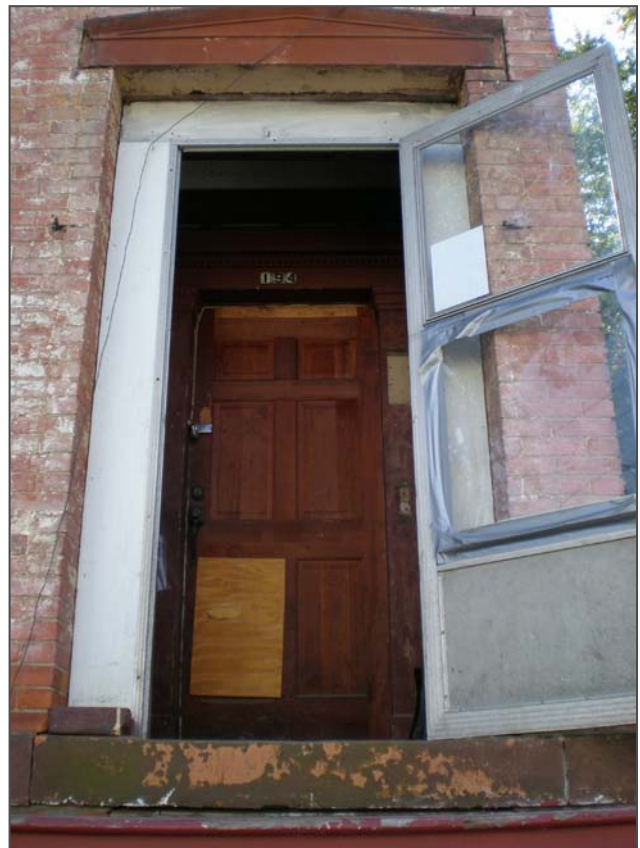
Figure 87: North entrance with screen door and sandstone sill, looking at frontispiece.

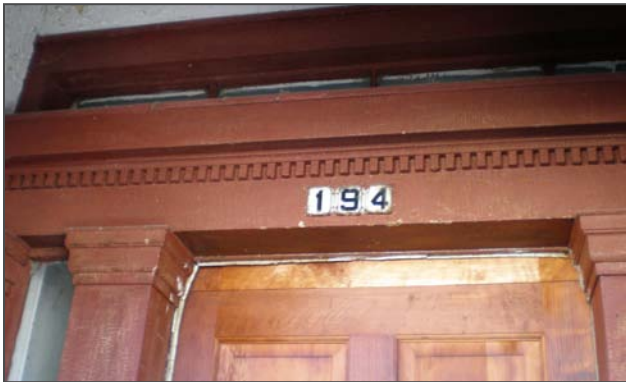
Figure 88: Detail of wooden frontispiece with dentil cornice.

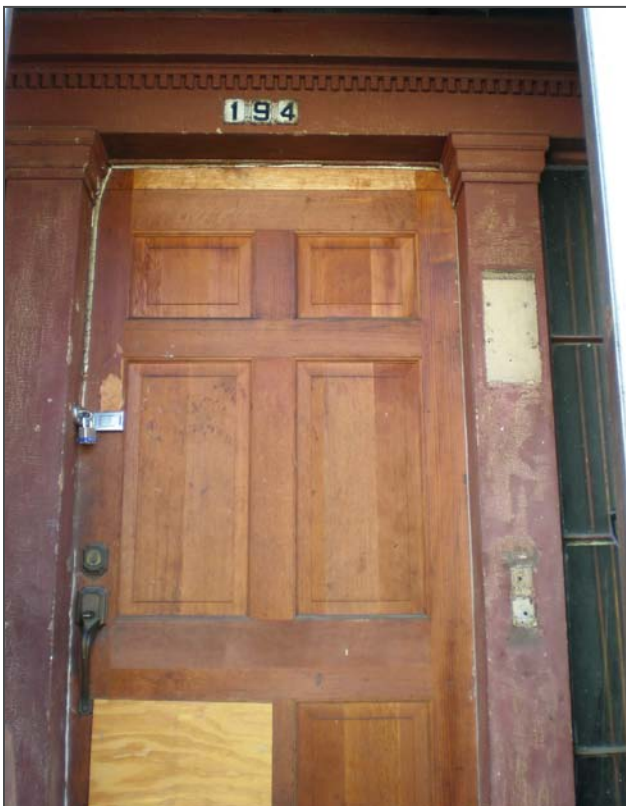
Figure 89: Contemporary door replacement on frontispiece on the south wall of Room 104.

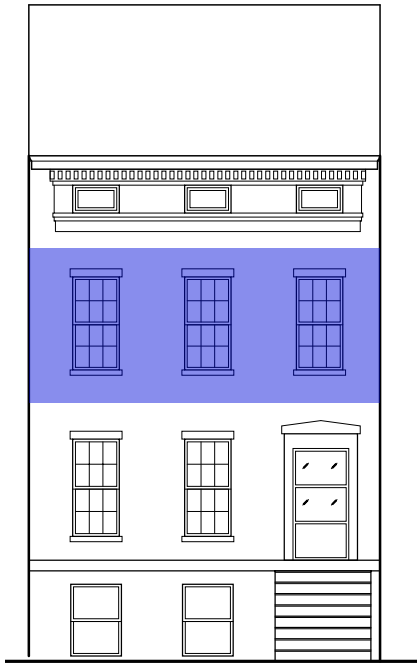
Figure 90: North facade elevation with the second floor highlighted.

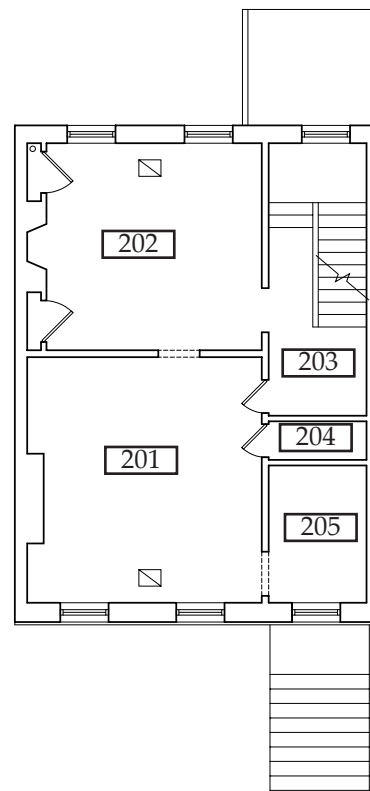
Figure 91: Existing Condition Second Floor Plan

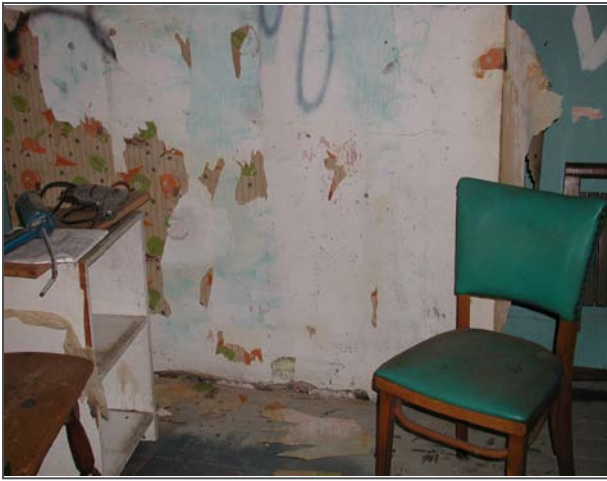
Figure 92: The chimney breast in Room 201 is currently covered in *GWB*.

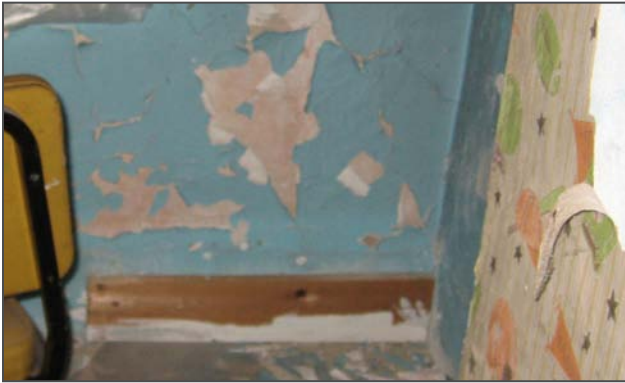
Figure 93: A small area of “modern” baseboard in the northwest corner.

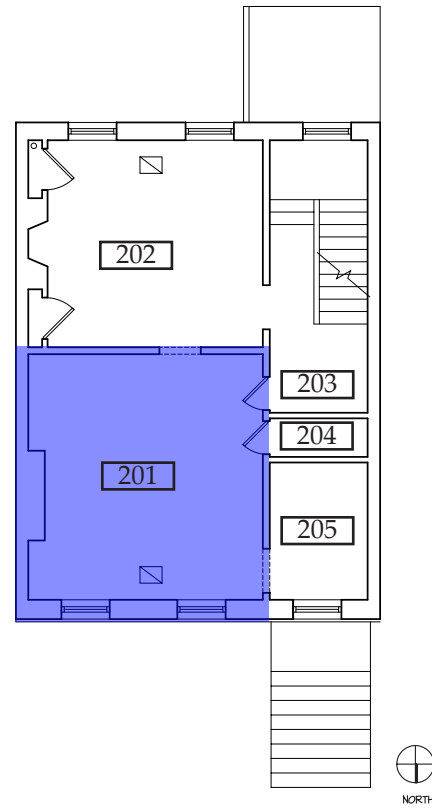
Figure 94: Existing Conditions Second Floor Plan with Room 201 highlighted.

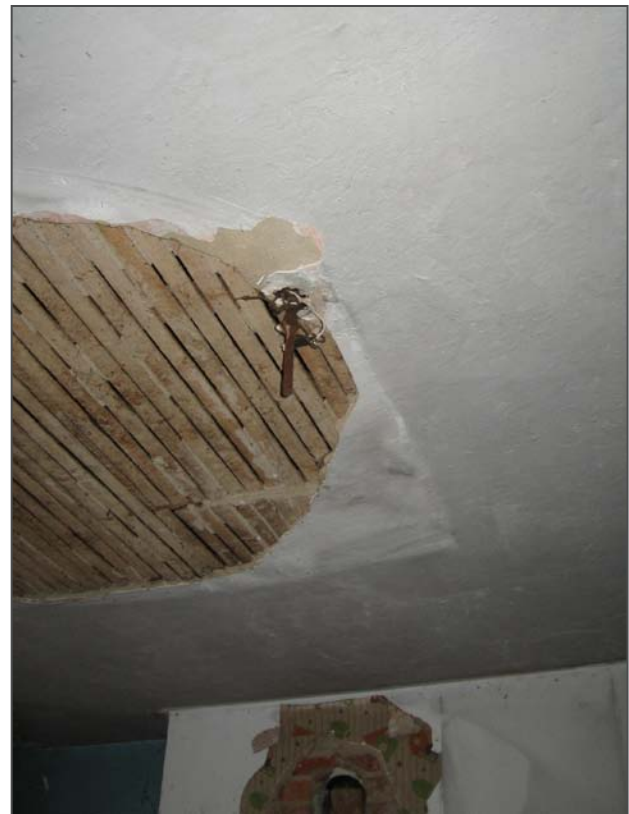
Figure 95: Remnants of an electrical fixture on the ceiling next to a large section of broken plaster.

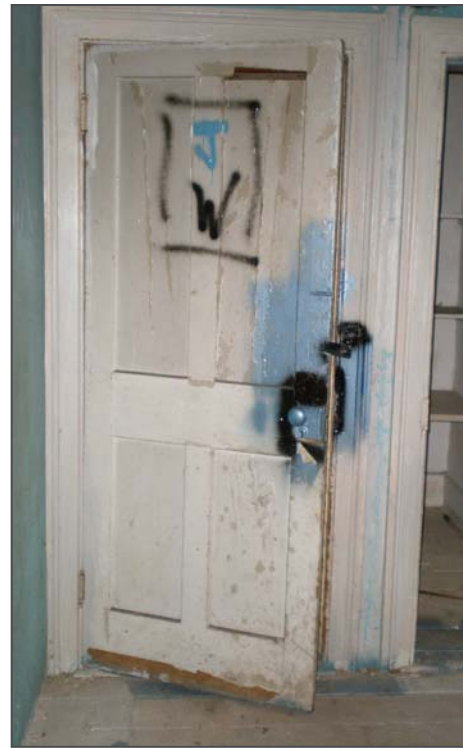
Figure 96: A four-paneled door hanging in 201 with possible original hardware, one of the few that remain.

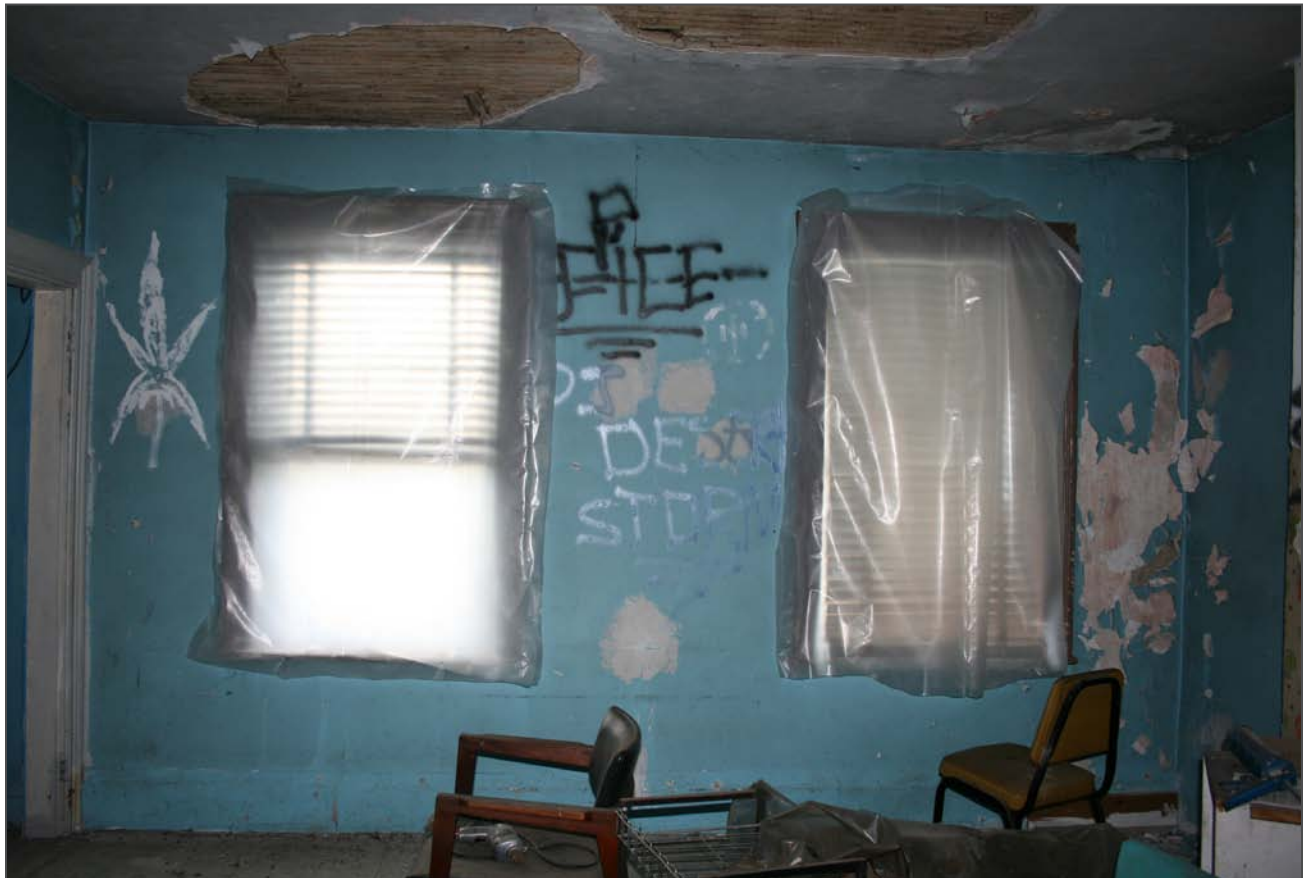
Figure 97: Two windows on the north facade illuminate this room.

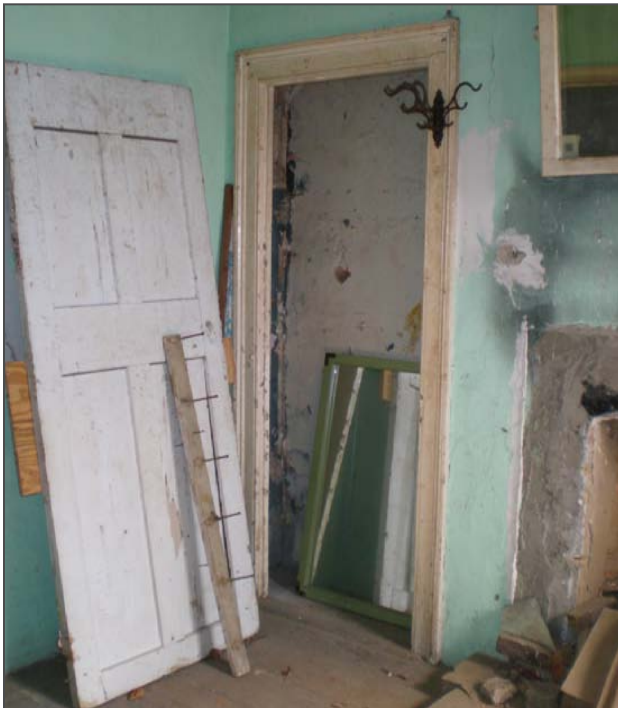
Figure 98: An original door with original hinges was found in Room 202.

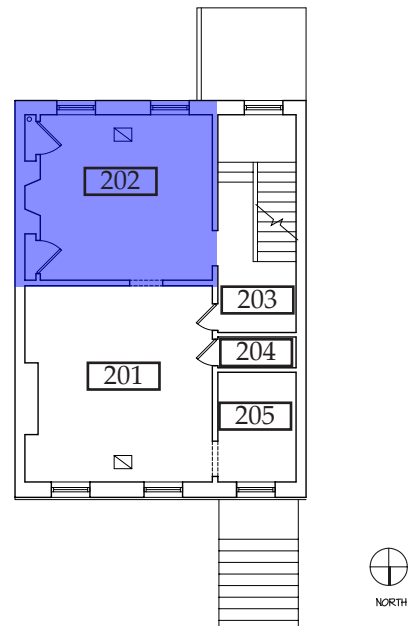
Figure 99: Existing Conditions Second Floor Plan with Room 202 highlighted.

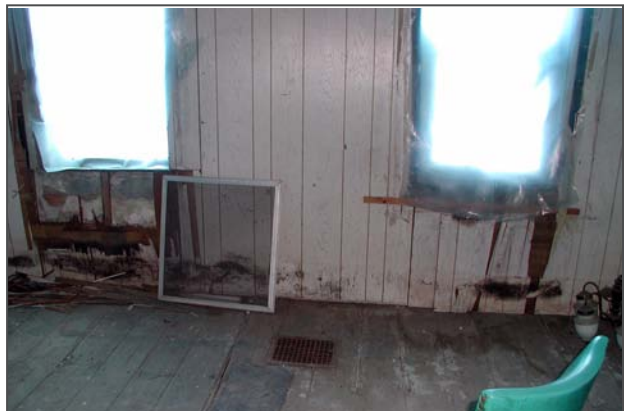
Figure 100: Ongoing water infiltration through the exterior south wall of Room 202 has damaged both the original plaster wall finish and the wood paneling likely installed to hide the ruined plaster.

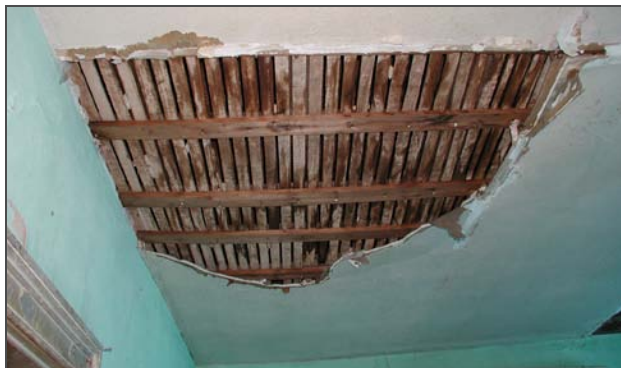
Figure 101: In Room 202 all of the original ceiling plaster was removed and a gypsum wallboard ceiling was installed on furring strips attached to original lath.

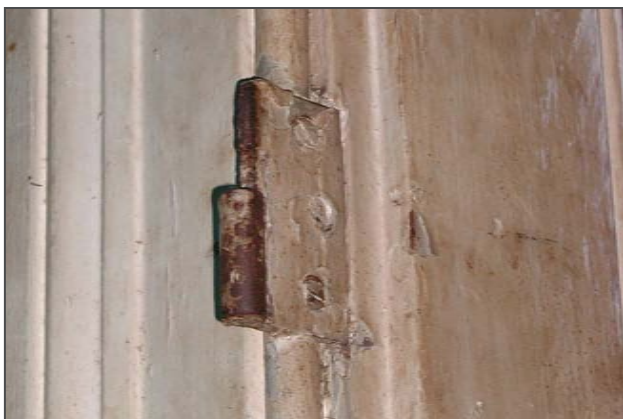
Figure 102: This lift-off hinge was found in Room 202. It was the only example of this type of hinge found in the building.

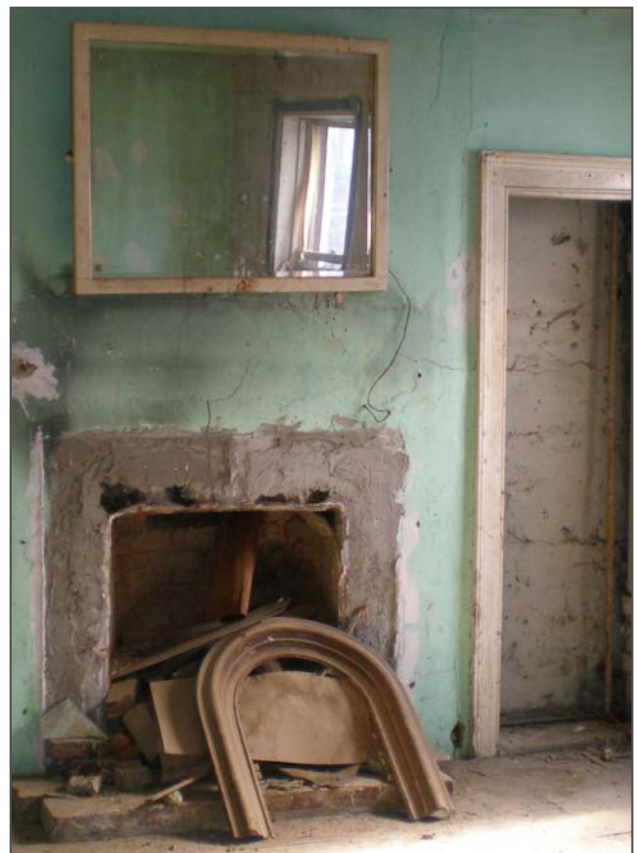
Figure 103: Room 202 has a shallow closet on either side of the fireplace opening. The mantelpiece was removed at an unknown date and the wall repaired with portland cement.

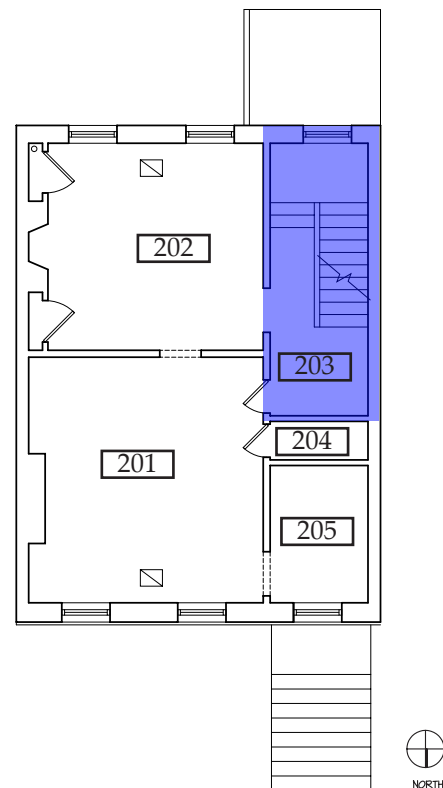
Figure 104: Existing Conditions Second Floor Plan with Room 203 highlighted.

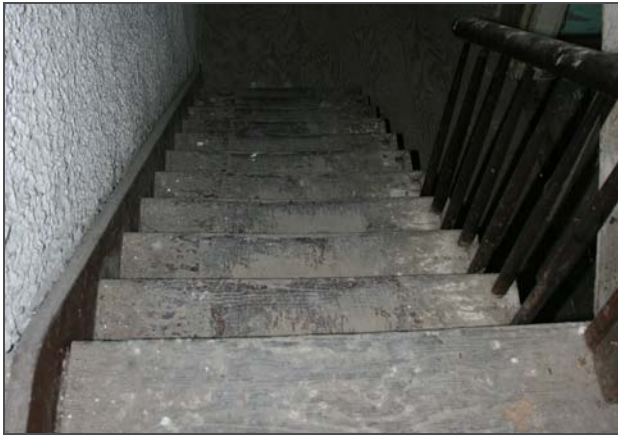
Figure 105: Stairs to the third floor with remaining railing and balusters.

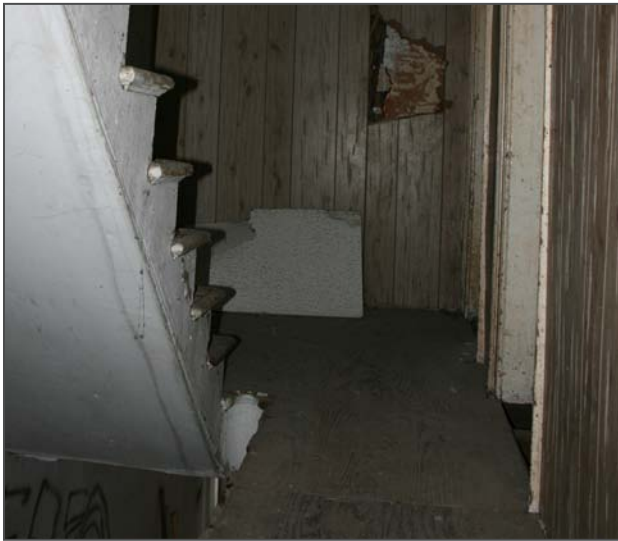
Figure 106: View of hallway and staircase on the second floor (Room 203)

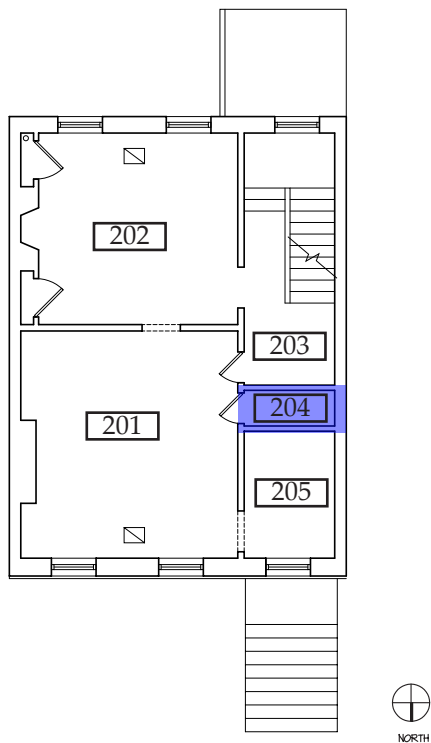
Figure 107: Existing Conditions Second Floor Plan with Room 204 highlighted.

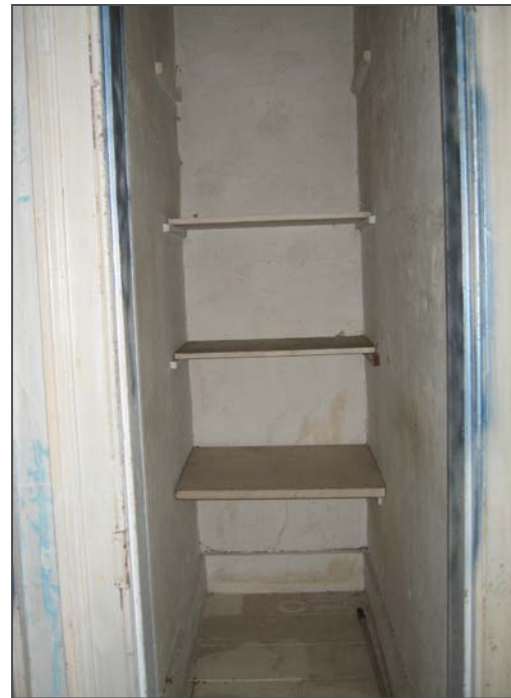
Figure 108: View of the room looking west.

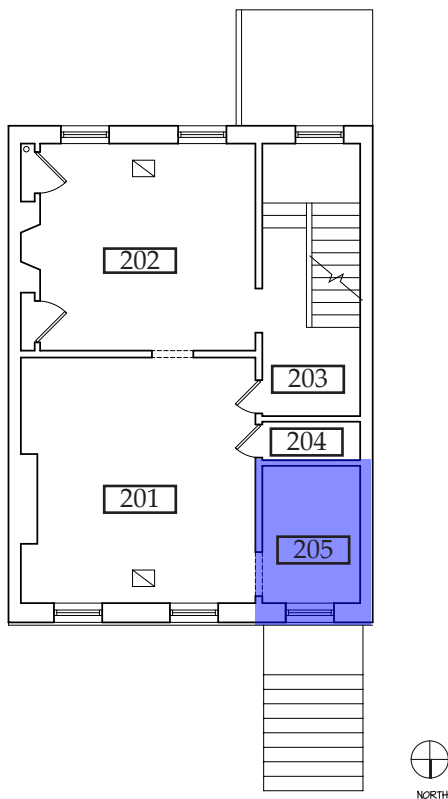
Figure 111: Existing Conditions Second Floor Plan with Room 205 highlighted.

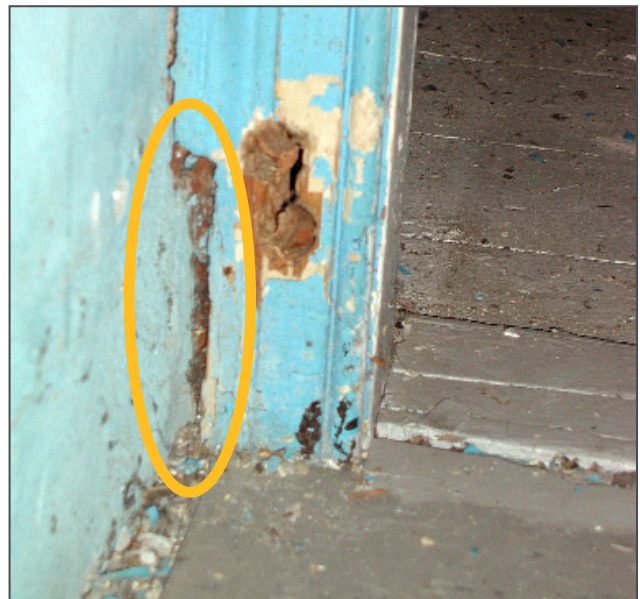
Figure 112: This cut in the door casing indicates that Room 205 once had baseboards similar to those found in Room 204.

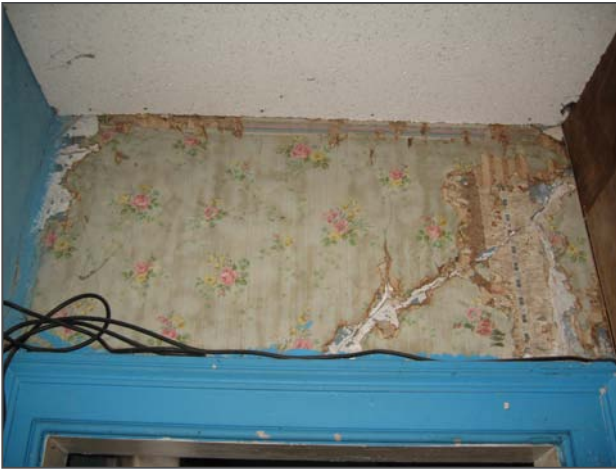
Figure 113: Layers of wallpaper visible over the door trim on the eastern wall.

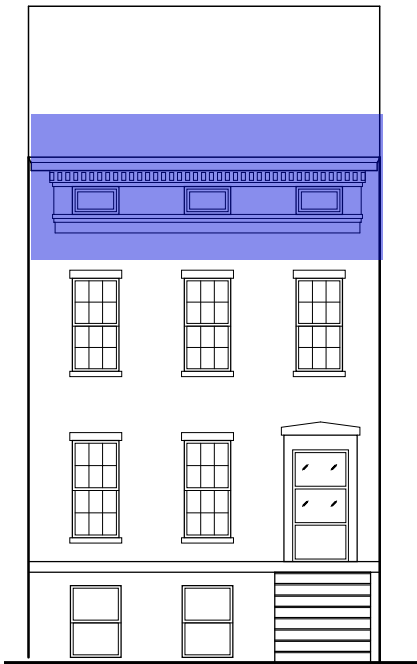
Figure 114: North facade elevation with the third floor highlighted in blue.

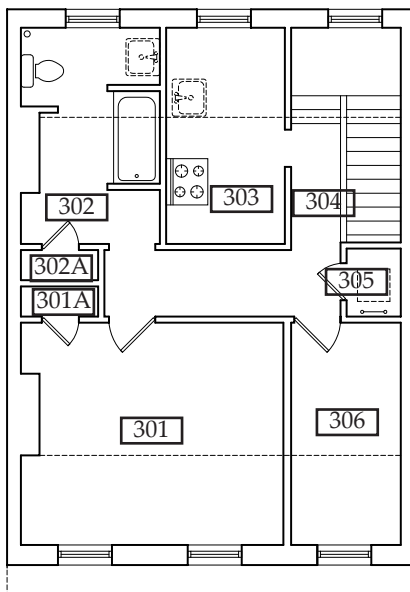
Figure 115: Existing Conditions Third Floor Plan.

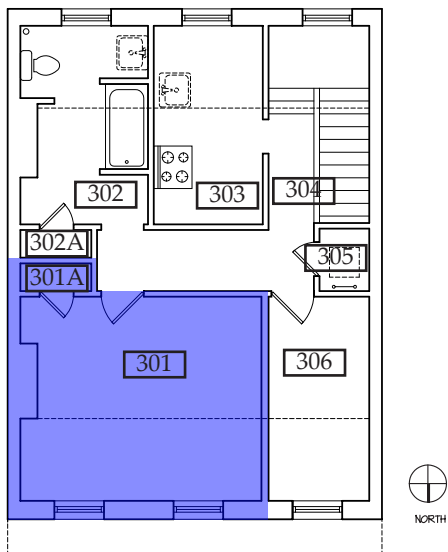
Figure 116: Existing Conditions Third Floor Plan with Room 301 and Room 301A highlighted.

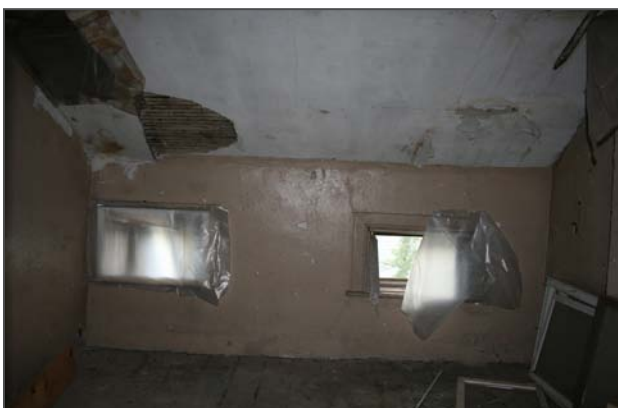
Figure 117: Two north-facing windows and sloping ceiling.

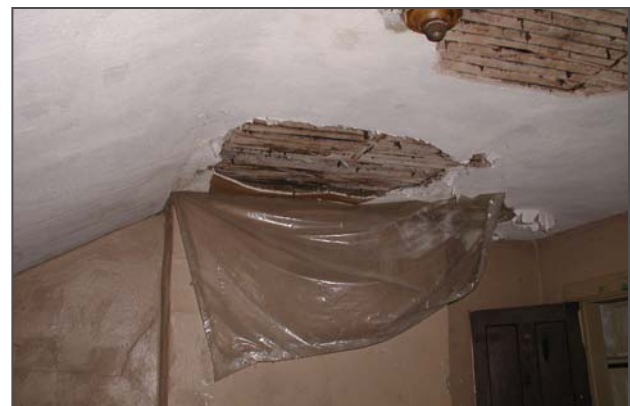
Figure 118: Damage to the plaster ceiling along the east wall in Room 301 was likely caused by water entering through failed chimney flashings.

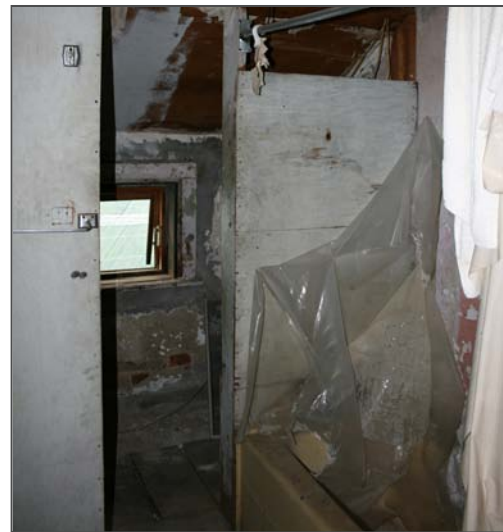
Figure 119: View looking south with tub and window in Room 302.

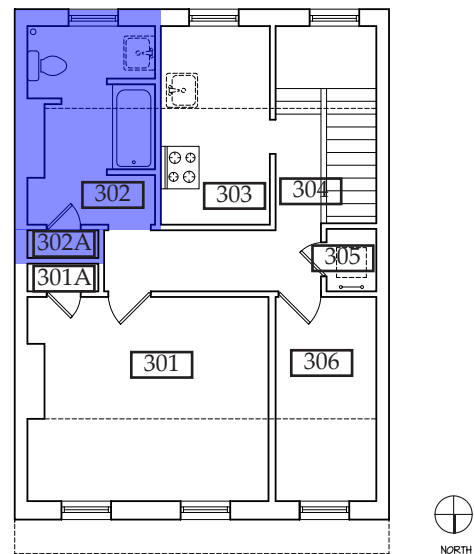
Figure 120: Existing Conditions Third Floor Plan with Room 302 and Room 302A highlighted.

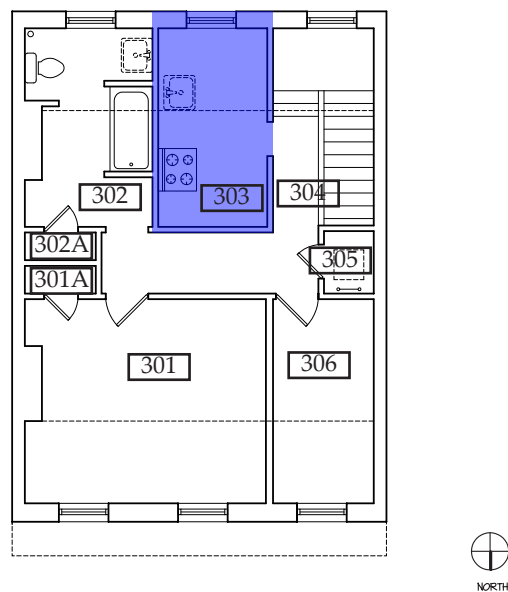
Figure 121: Existing Conditions Third Floor Plan with Room 303 highlighted.

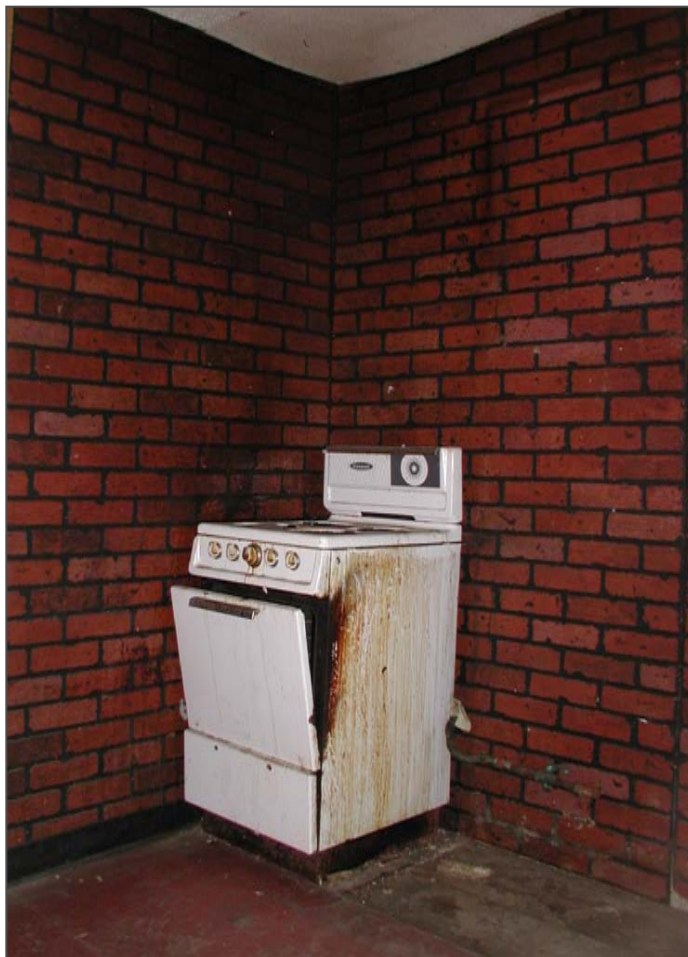
Figure 122: A modern stove in Room 303 indicates that this room was used as a kitchen in the late twentieth century.

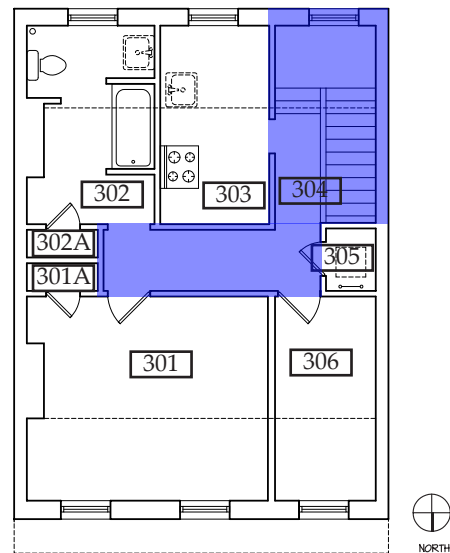
Figure 123: Existing Conditions Third Floor Plan with Room 304 highlighted.

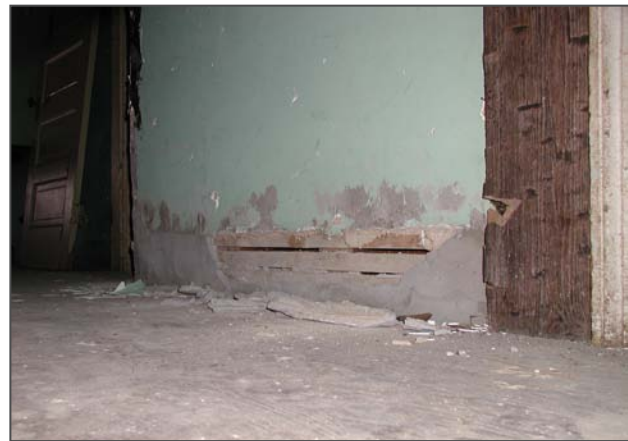
Figure 124: In Room 304, the baseboards were removed and the exposed space parged with cement.

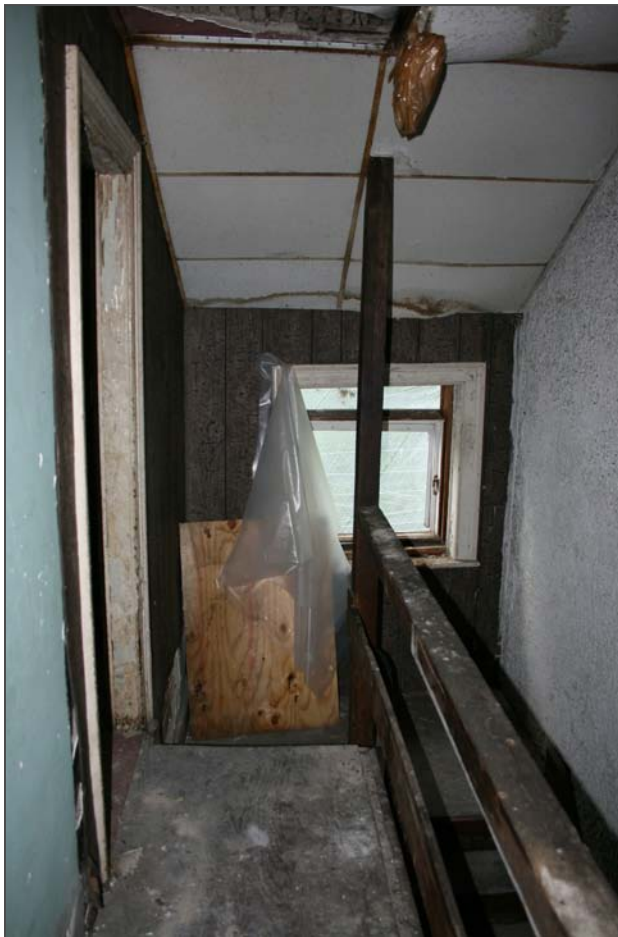
Figure 125: View looking south into the north-south corridor of Room 304.

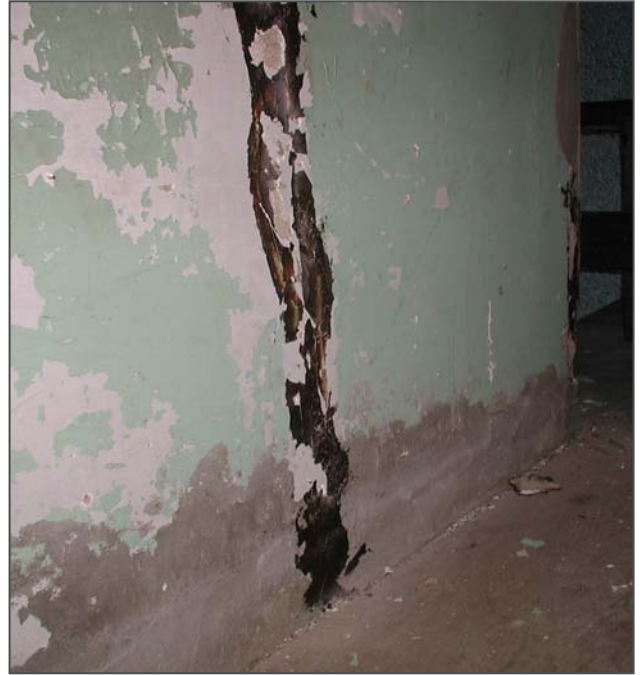
Figure 126: Ghost wall from a partition that separated the hall into two portions, likely to serve two apartments.

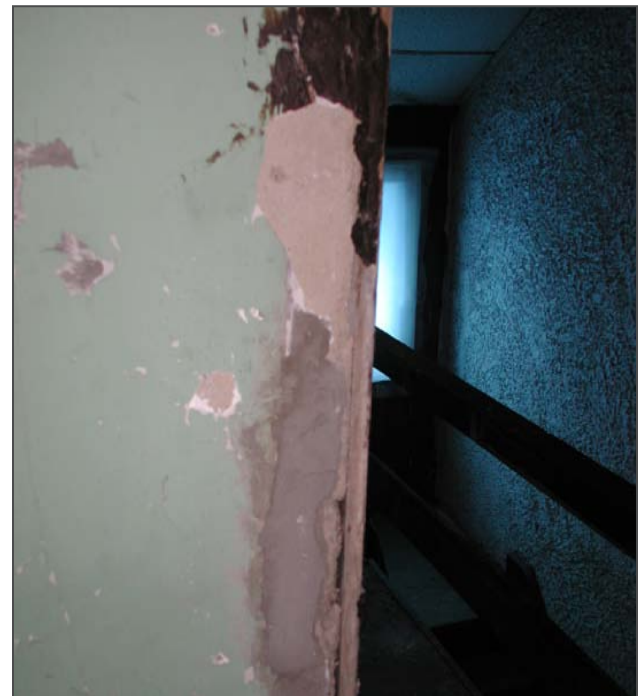
Figure 127: Damage to the outside corner in Room 304 exposed a wood corner bead.

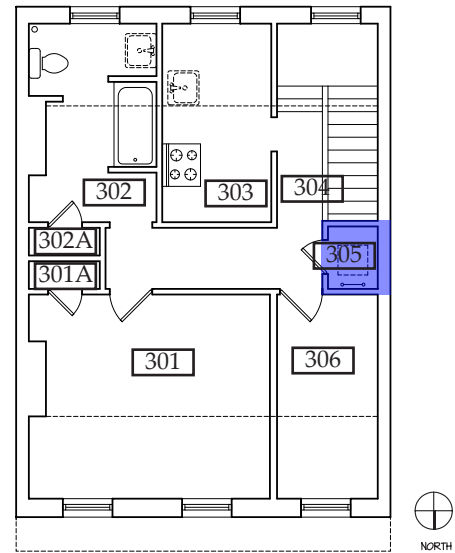
Figure 128: Existing Conditions Third Floor Plan with Room 305 highlighted.

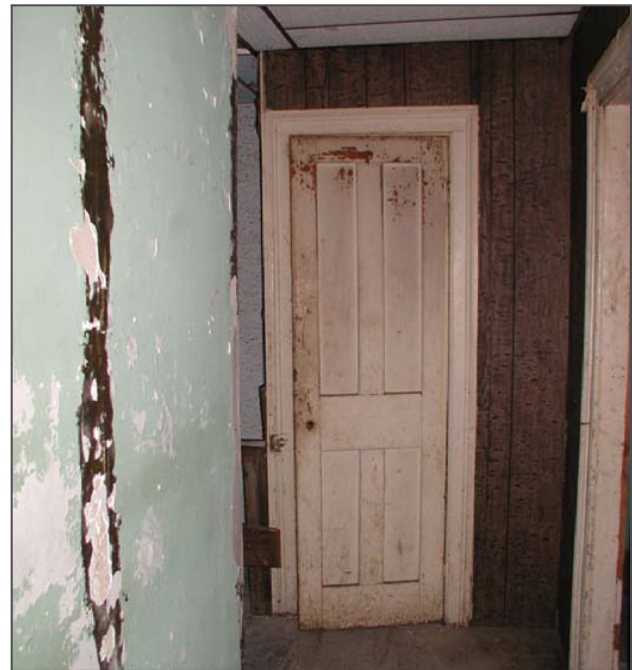
Figure 129: An original door frame with a four-panel, rail and stile door remains in place in the west wall of Room 304.

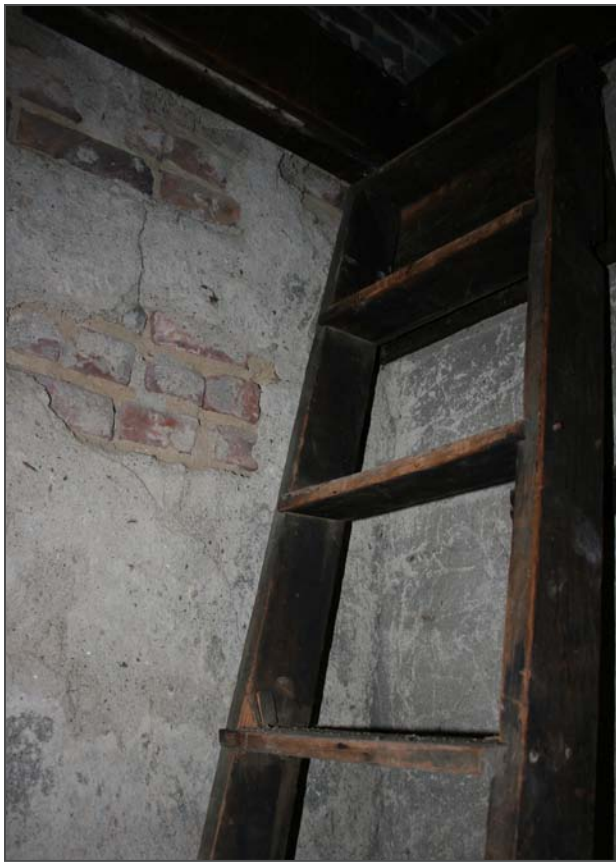
Figure 130: The ladder in Room 305 that accesses the attic.

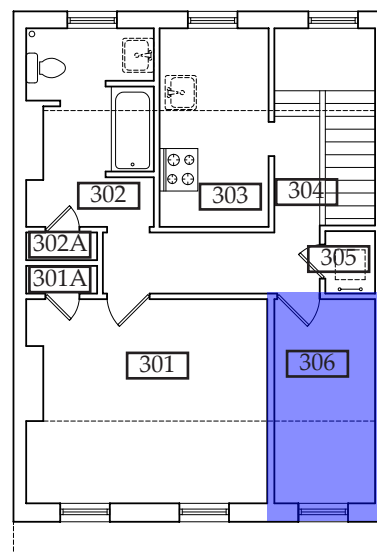
Figure 131: Existing Conditions Third Floor Plan with Room 306 highlighted.

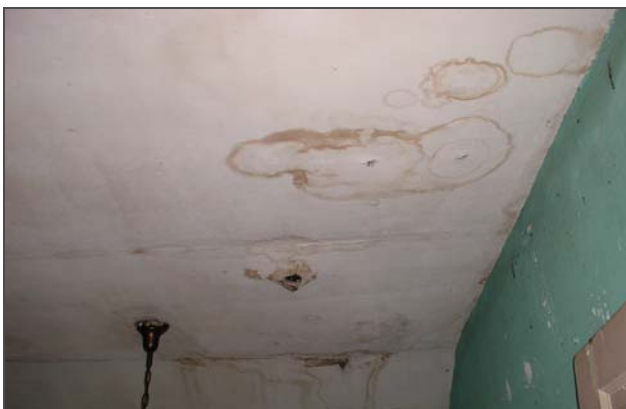
Figure 132: Water damage is clearly visible on the ceiling of Room 306.

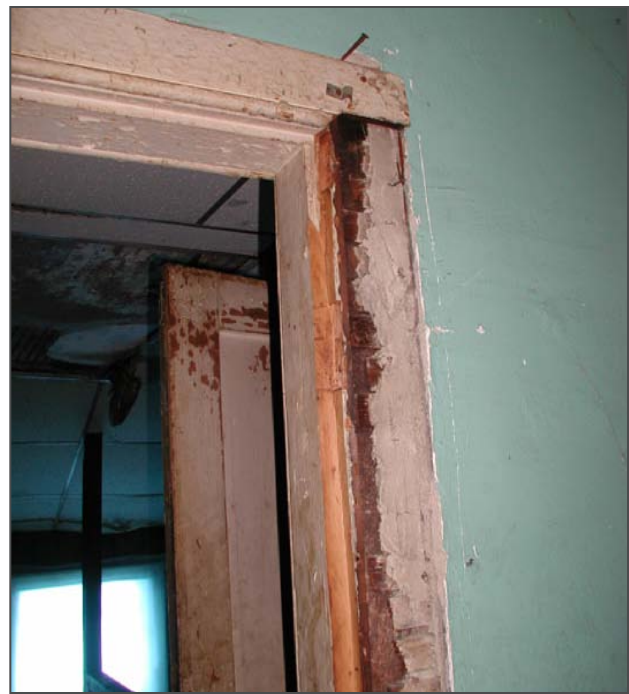
Figure 133: A missing door casing in Room 306 reveals that the lath and plaster base coat continued behind the trim. The final coat of plaster was installed after the casing was in place.

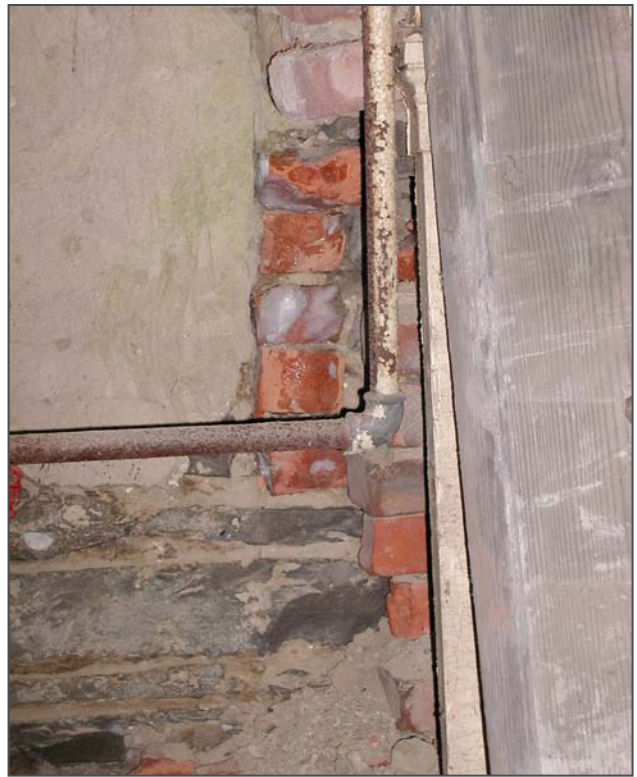
Figure 134: This iron pipe in Room B01 was likely a gas pipe.

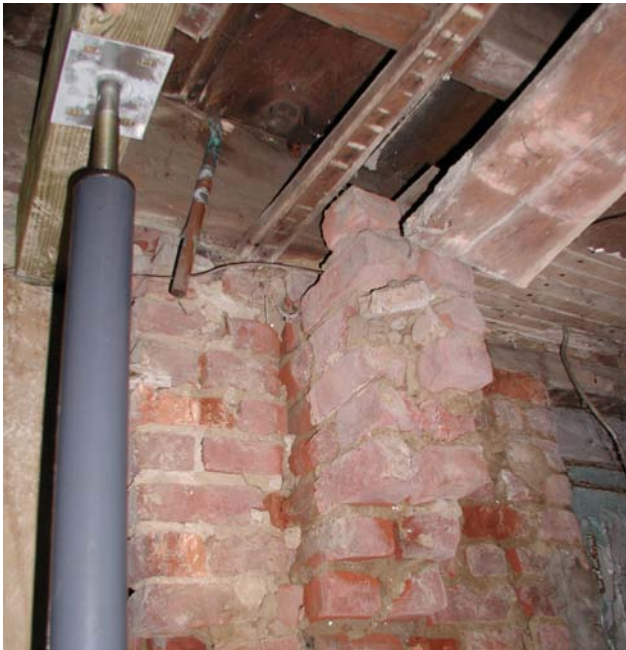
Figure 136: Lally columns in the basement are temporarily supporting the collapsing stiffening wall, but shoring, bracing and reconstruction of this wall are needed to sustain the building's structural integrity.

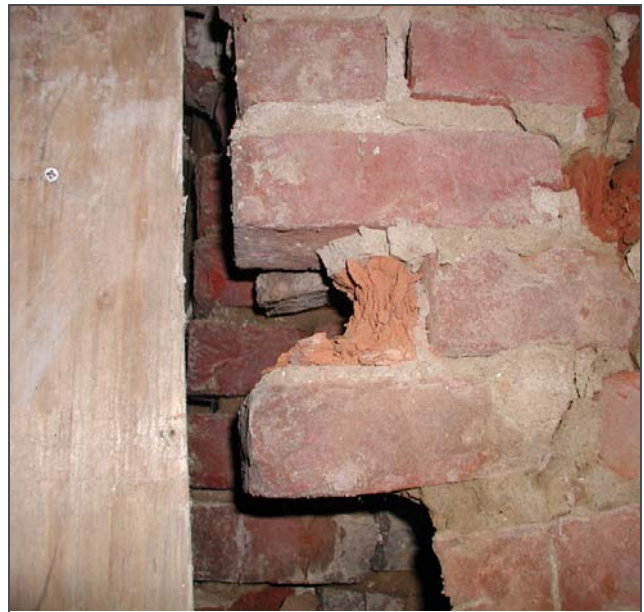
Figure 137: Water infiltration in the basement has severely damaged numerous bricks beyond the point of repair.

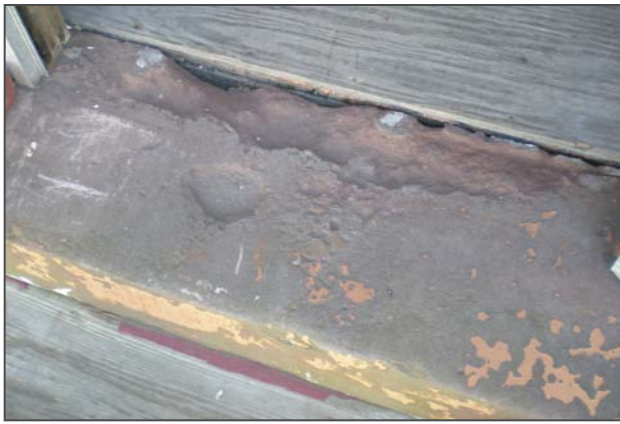
Figure 138: Deteriorated sandstone sill on the main entrance door will need restoration through limited patching.

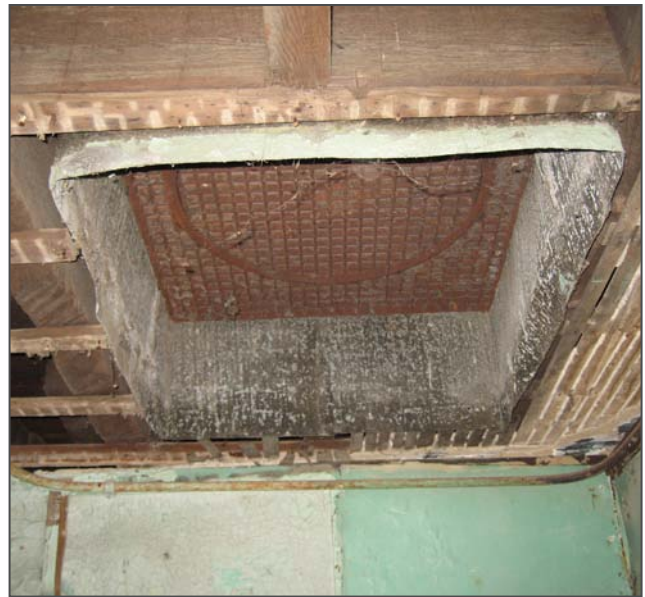
Figure 139: When a temporary heating system is installed, the vent between the ceiling in Room B01 and the floor in Room 102 should be opened, allowing warm air to rise through the house.

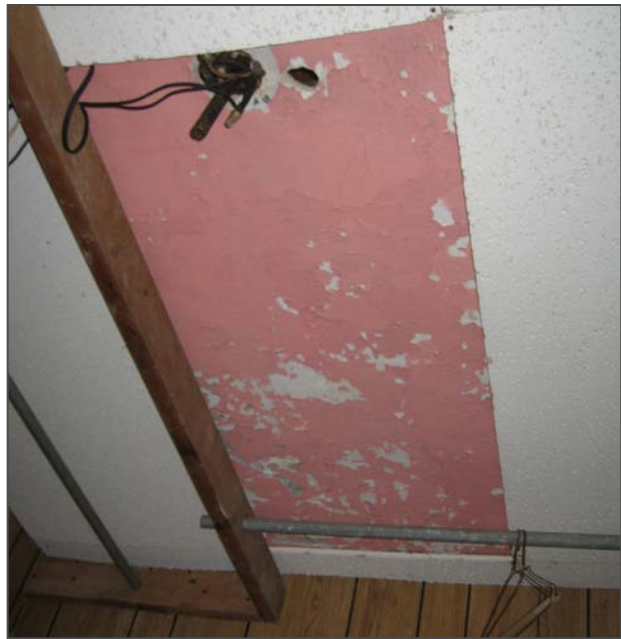
Figure 140: Removing modern materials, such as the acoustical tiles in Room 205, will reveal the condition of historic plaster and determine the level of restoration needed.
