Stephen & Harriet Myers Residence
Albany, New York

Historic Structure Report

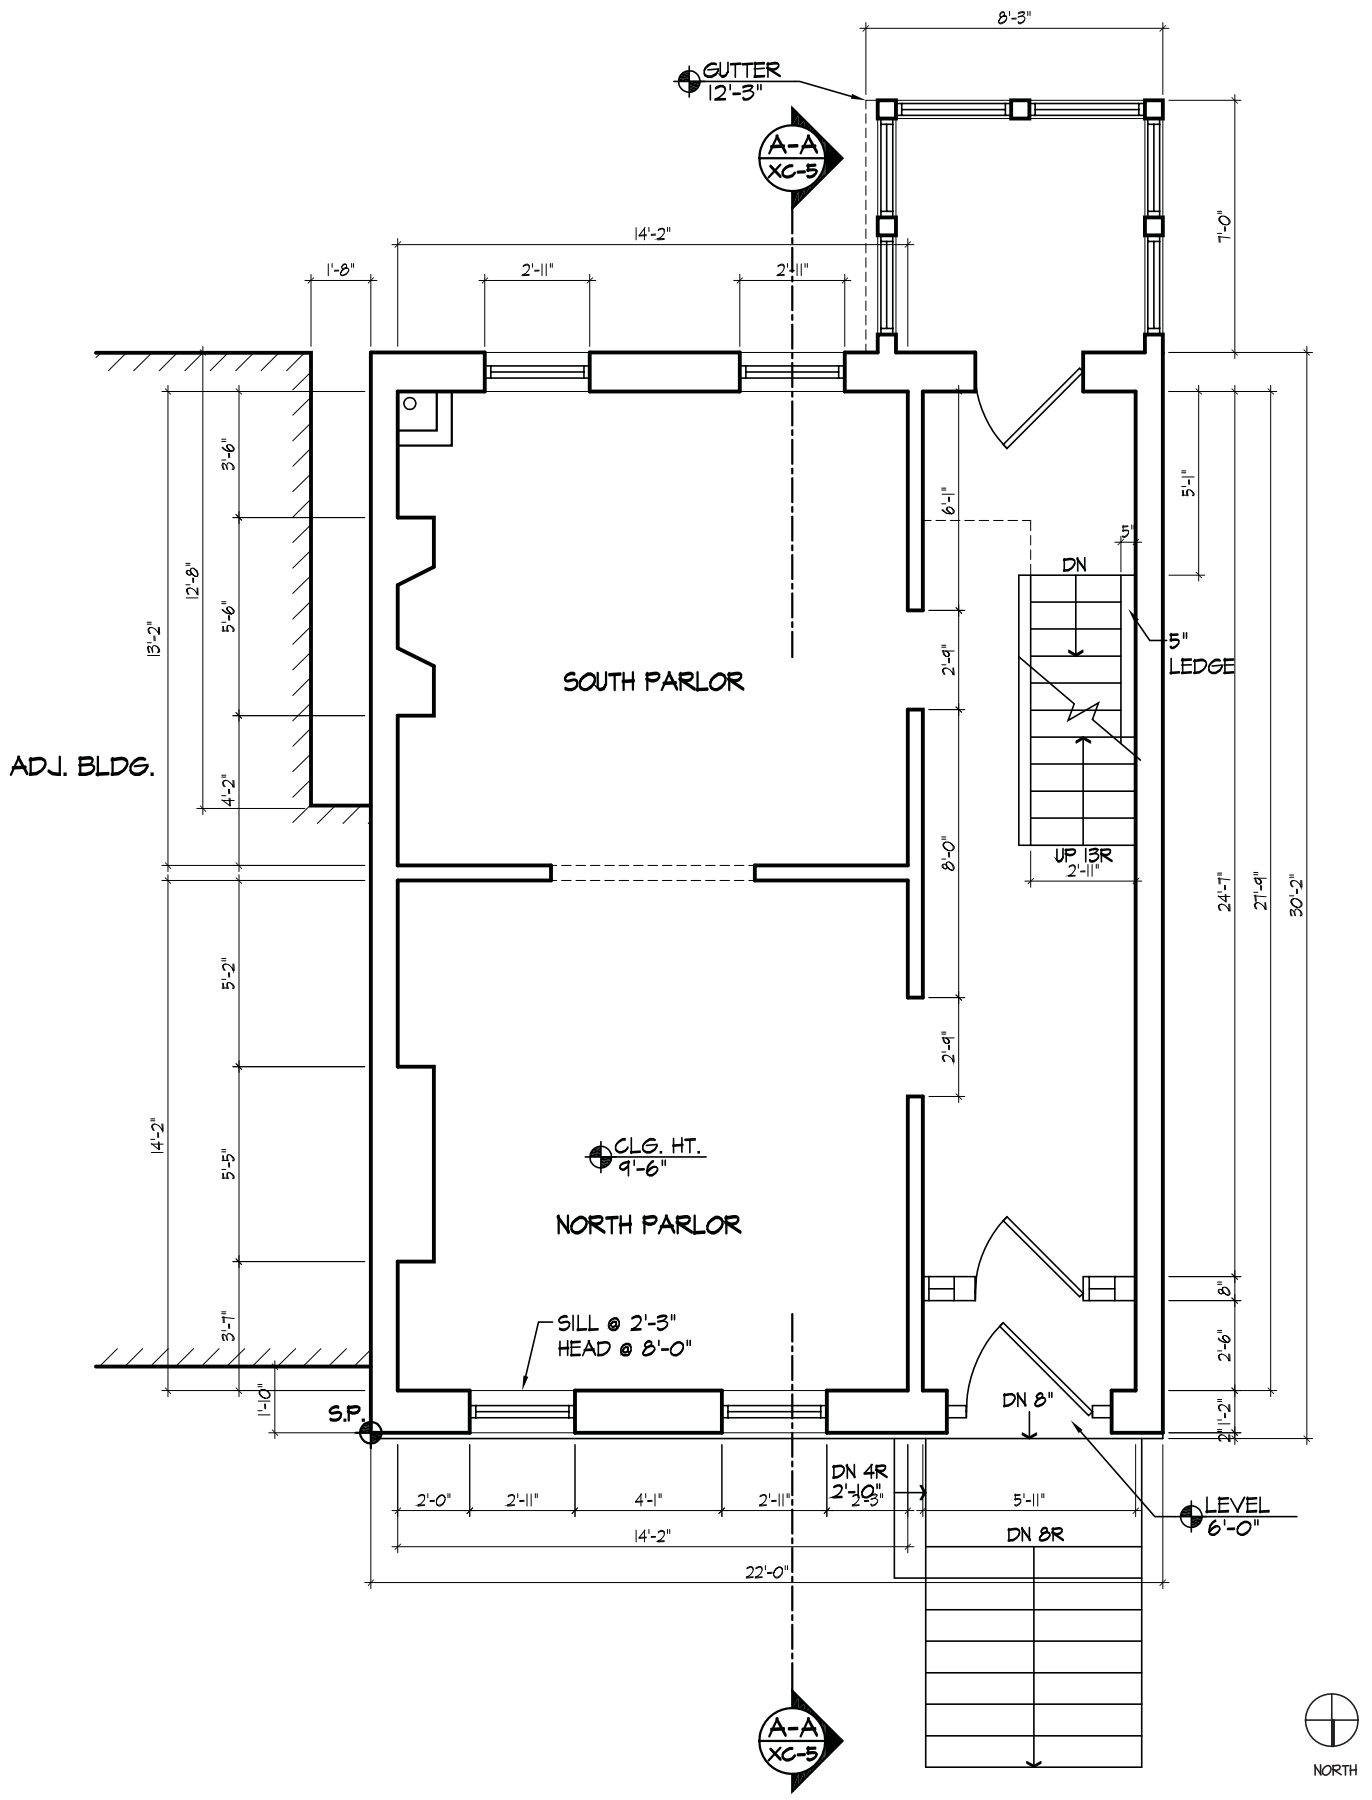
<p>STEPHEN TILLY, Architect 22 Elm Street Dobbs Ferry, NY 10522 914-693-8898</p>	<p>Project: Myers Residence HSR 194 Livingston Avenue Albany, New York 12210</p>	<p>Title: Existing Conditions First Floor Plan Date: 2008</p>	<p>Scale: <i>These drawings are for general reference only and are not to scale.</i></p>
---	---	---	---

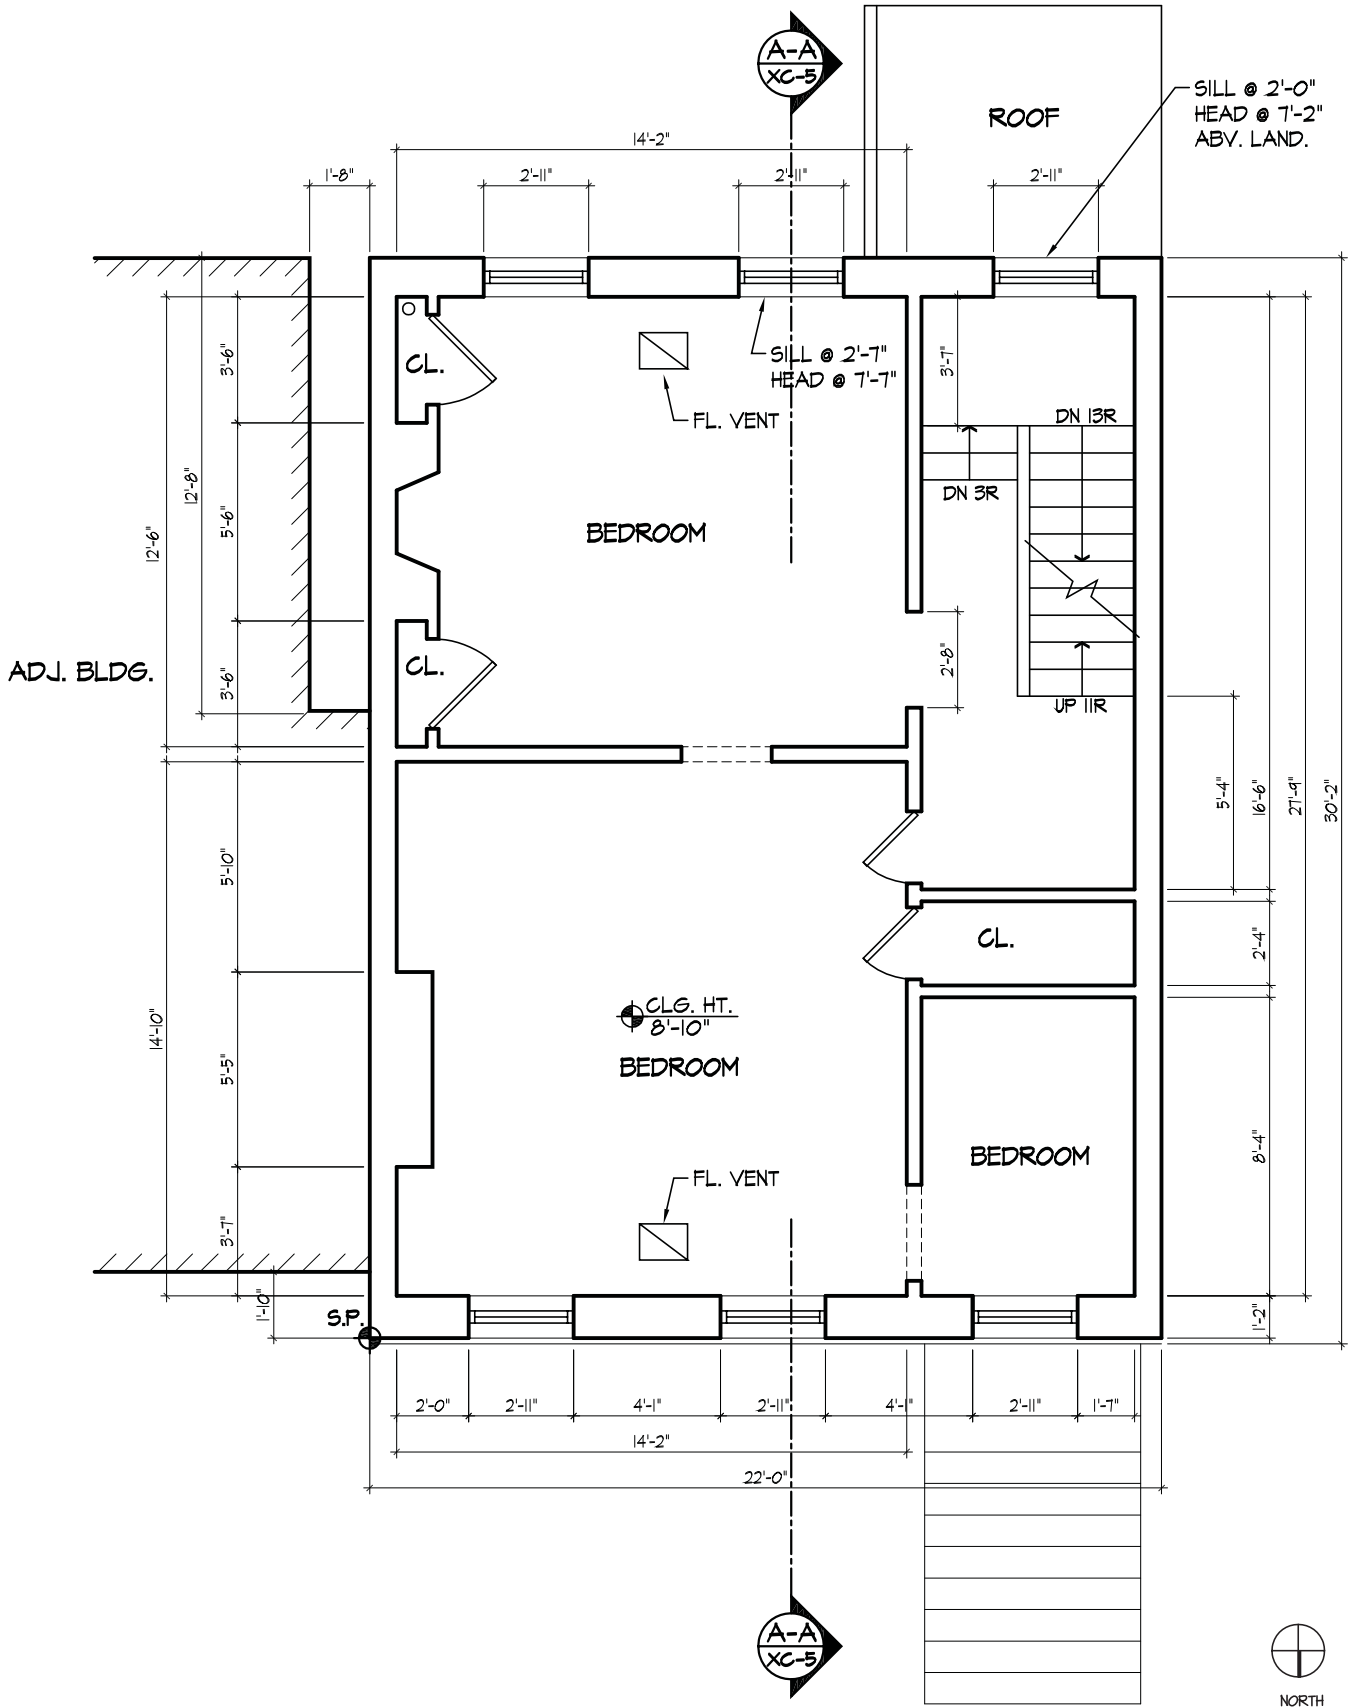
STEPHEN TILLY, Architect
22 Elm Street
Dobbs Ferry, NY 10522
914-693-8898

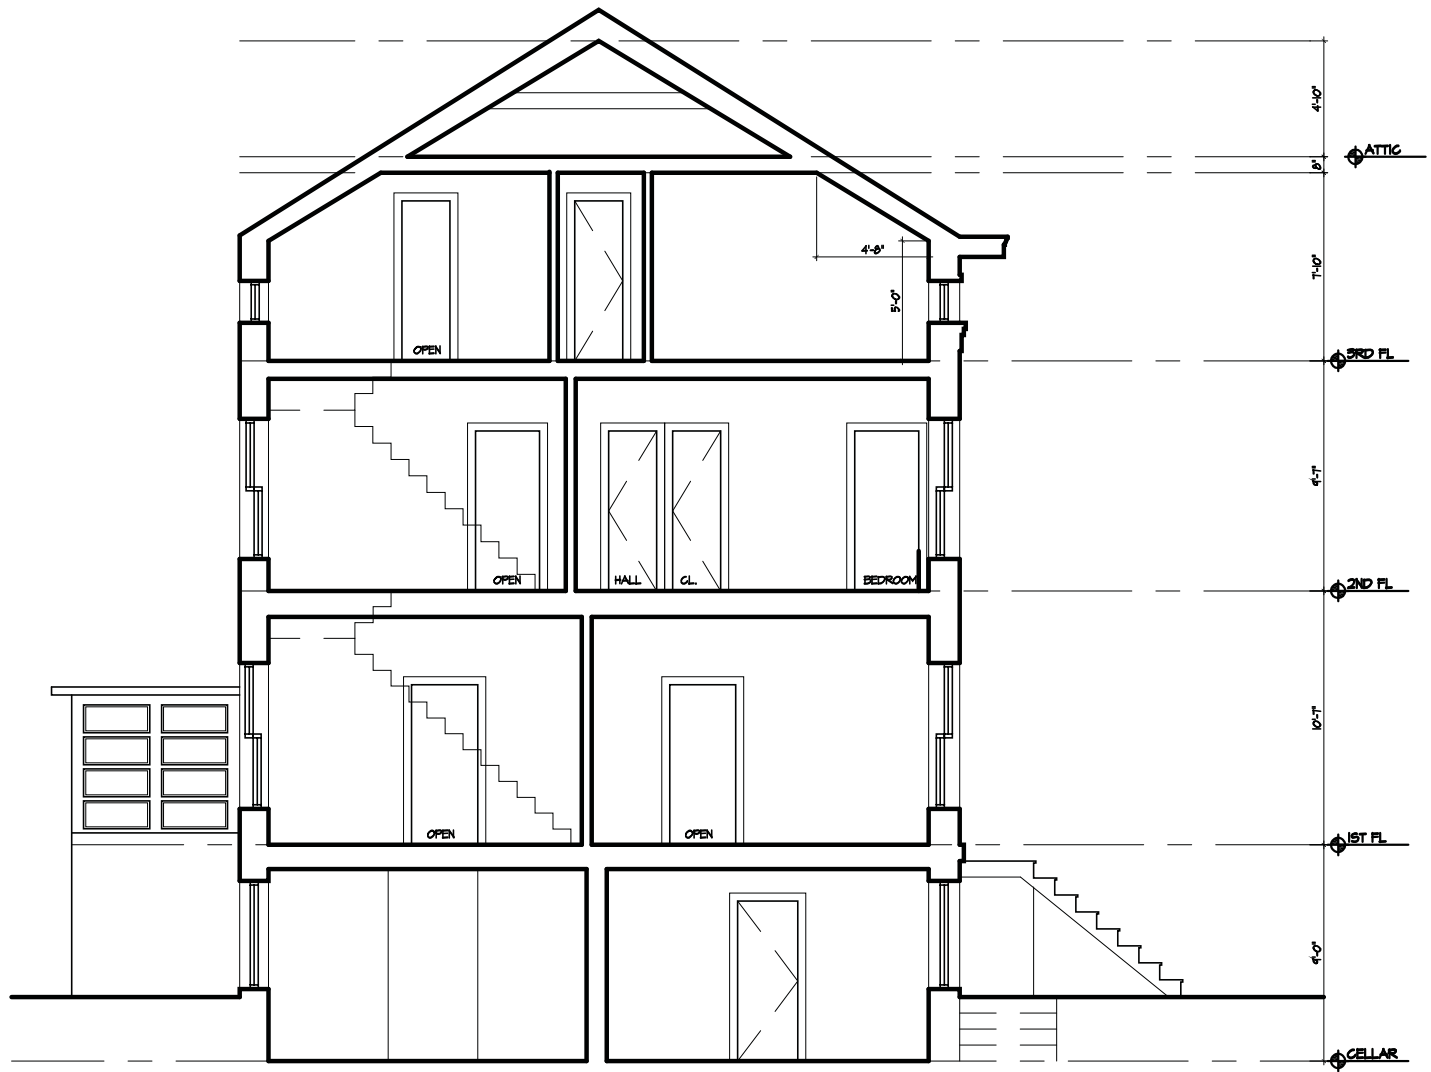
STEPHEN TILLY, Architect
 22 Elm Street
 Dobbs Ferry, NY 10522
 914-693-8898

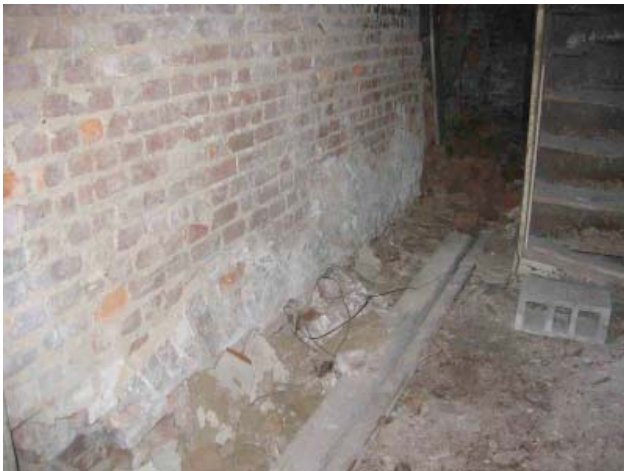
Photograph No. 3. View of west elevation of the north/south bearing wall in the basement. Note the severe deterioration/loss of masonry at the bottom of this wall.

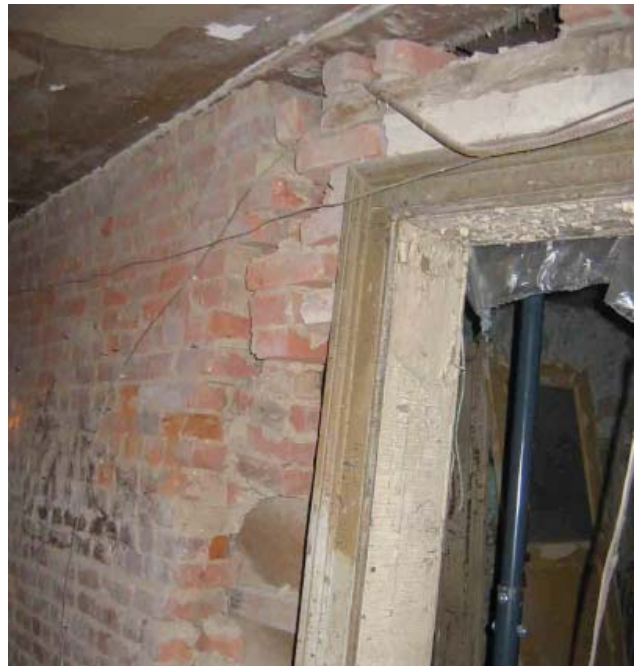
Photograph No. 4. View of the south end of the north/south bearing wall in the basement. Note the significant loss of bricks and disintegration of the wall.

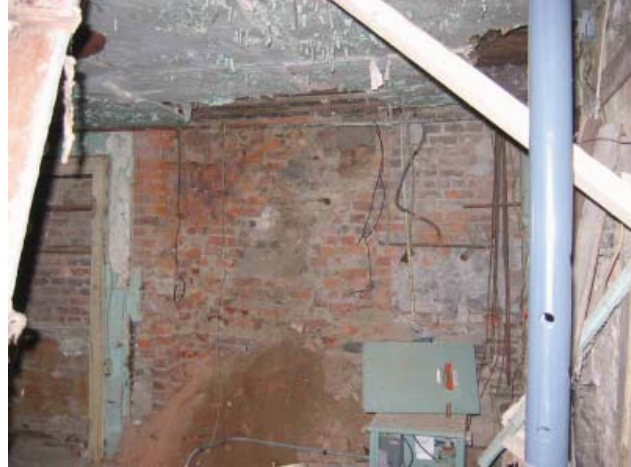
Photograph No. 6. View of brick wall failure at the SE corner of the basement; note pile of brick, mortar, and other debris from the collapsed portions of this brick wall.

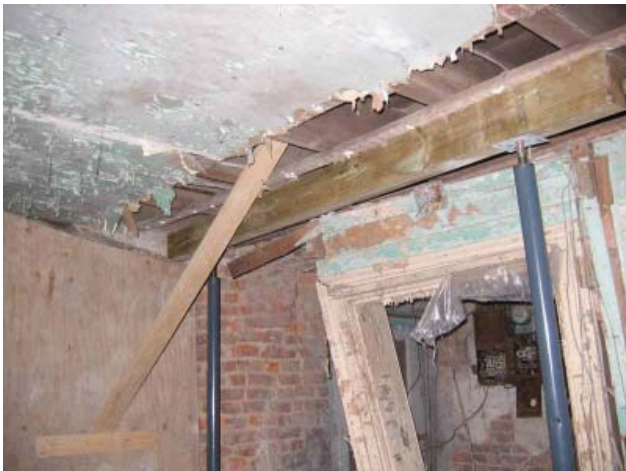
Photograph No. 7. View of eastern side of the north end of the north/south bearing wall in the basement. Note that even the temporary screw jacks appear to have displaced horizontally.

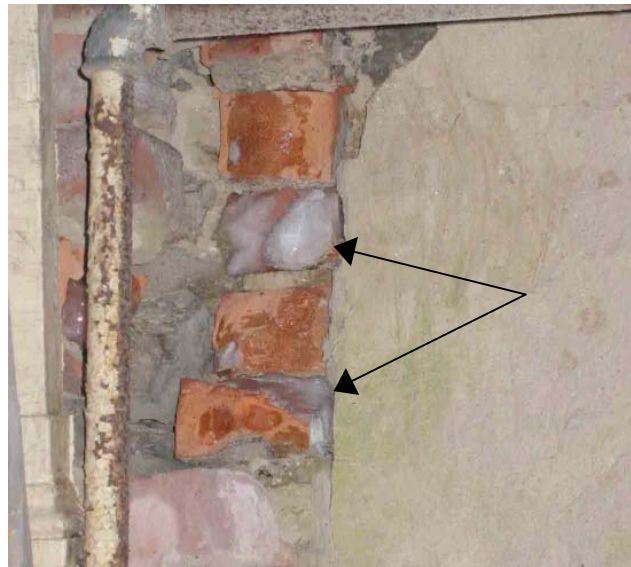
Photograph No. 8. View of severe moisture in the brick walls of the basement. This photograph was taken at the east wall of the building (i.e., the party or common wall with the adjacent row house). Arrows point to ice deposition on the brick surfaces.

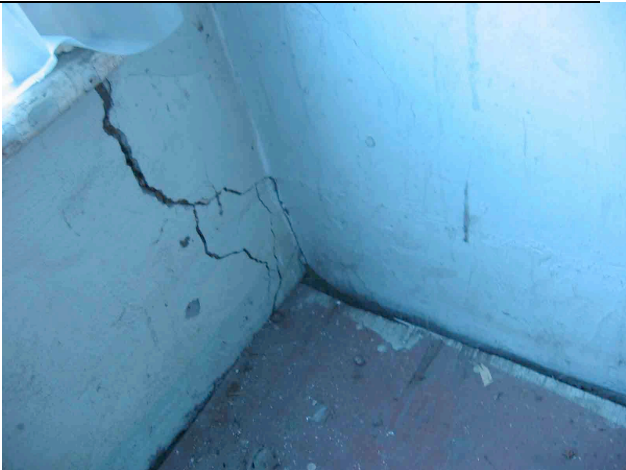
Photograph No. 14. View of crack in the interior plaster near the SW corner of the building.

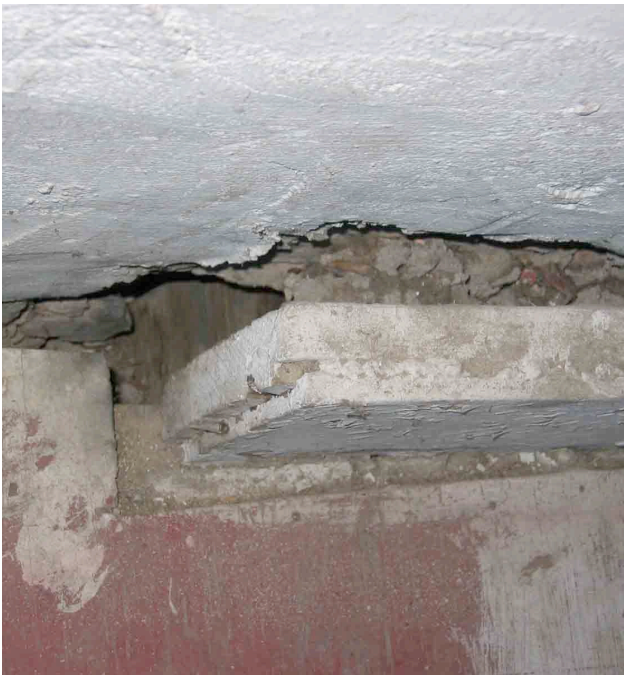
Photograph No. 15. View of another landing of the main staircase where the header and the stair have moved away from the interior face of the exterior wall.

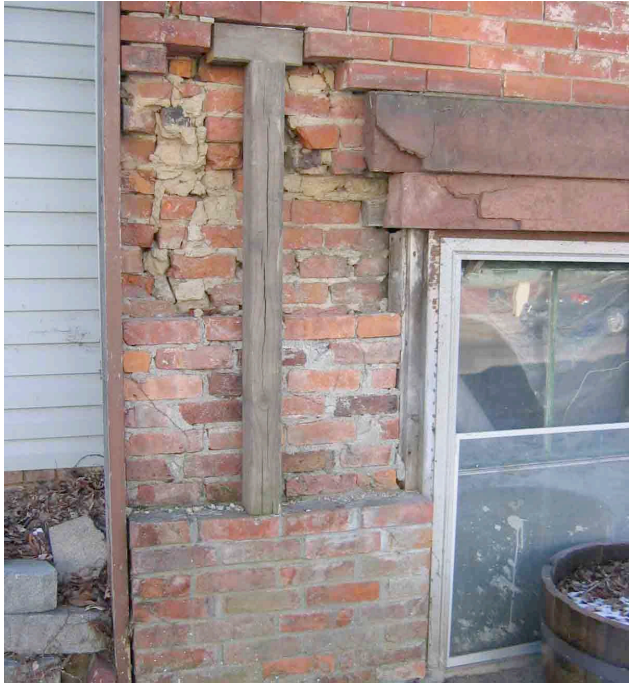
Photograph No. 17. View of localized failure of exterior wythes of brick masonry at the NE corner of the building.

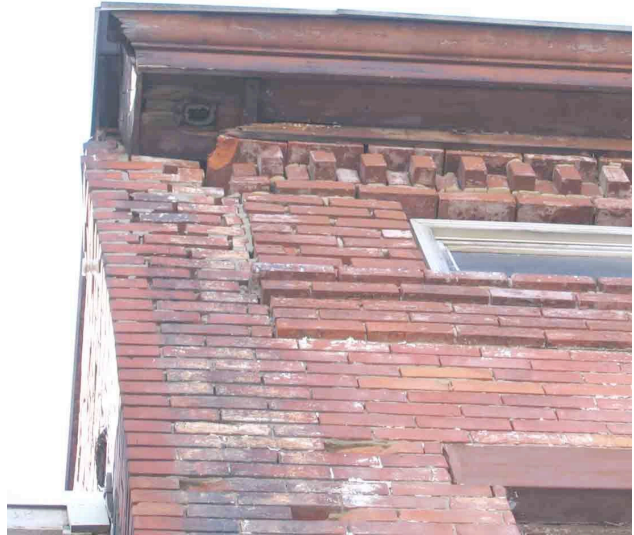
Photograph No. 18. View of missing mortar, missing bricks, and loose masonry at the cornice level (at the NE corner of the building).

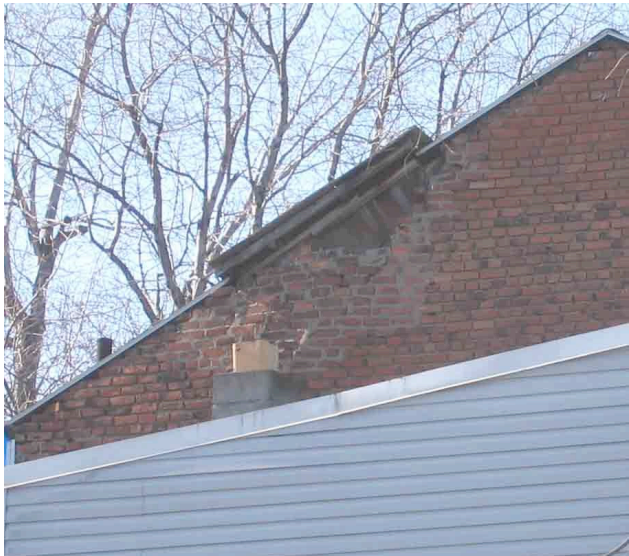
Photograph No. 19. View of missing masonry and poorly reconstructed masonry on the exterior of the East elevation.

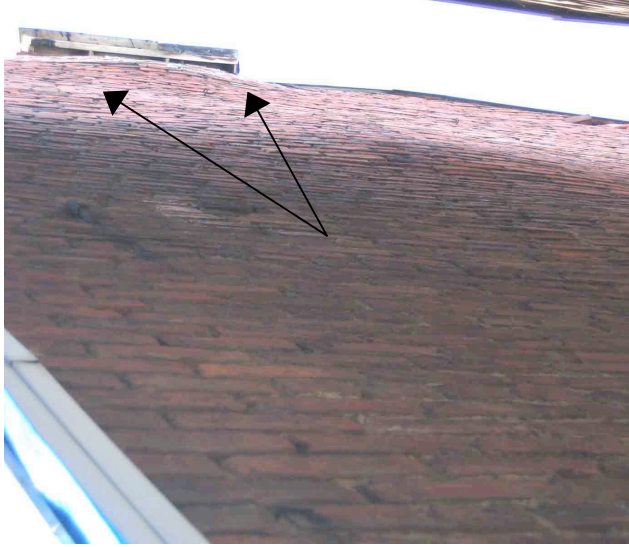
Photograph No. 21. View of one of the bulges in the exterior brick masonry. This view is at the SE corner looking up. The arrows point to the most severe bulging.

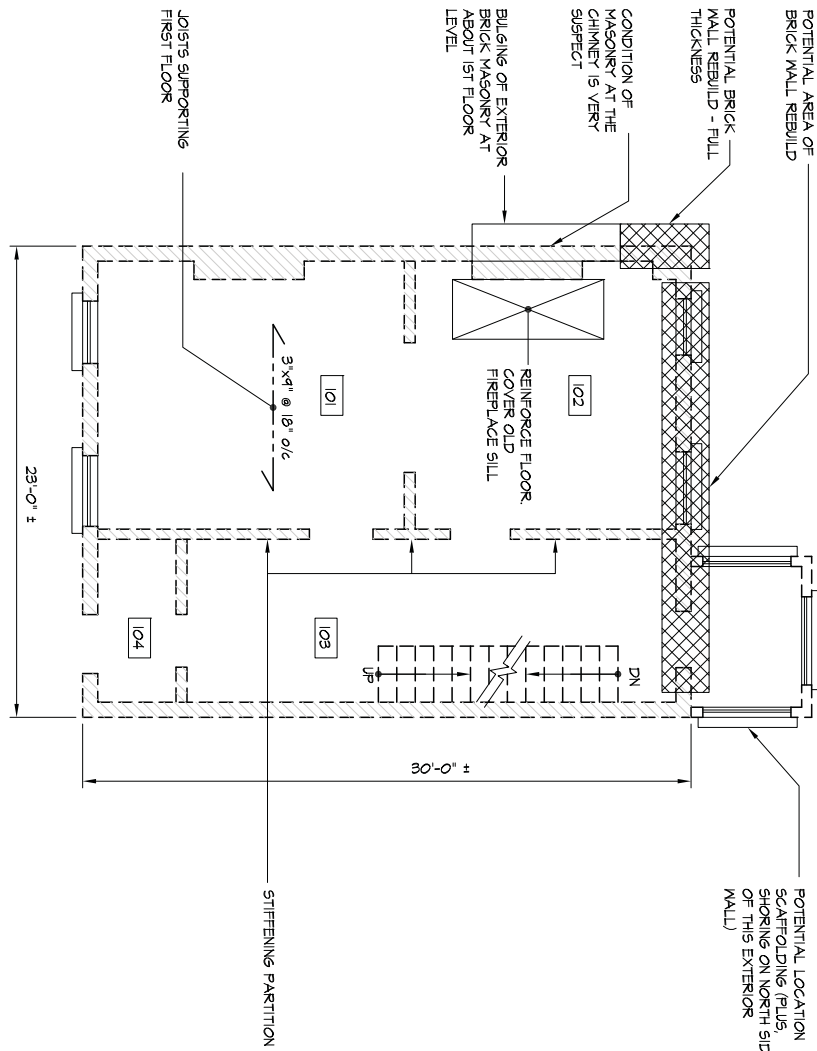
ROBERT SILMAN ASSOCIATES, P.C.
 CONSULTING ENGINEERS
 88 UNIVERSITY PLACE, NEW YORK, N.Y. 10003
 TELEPHONE (212) 620-7970 FAX (212) 620-8157

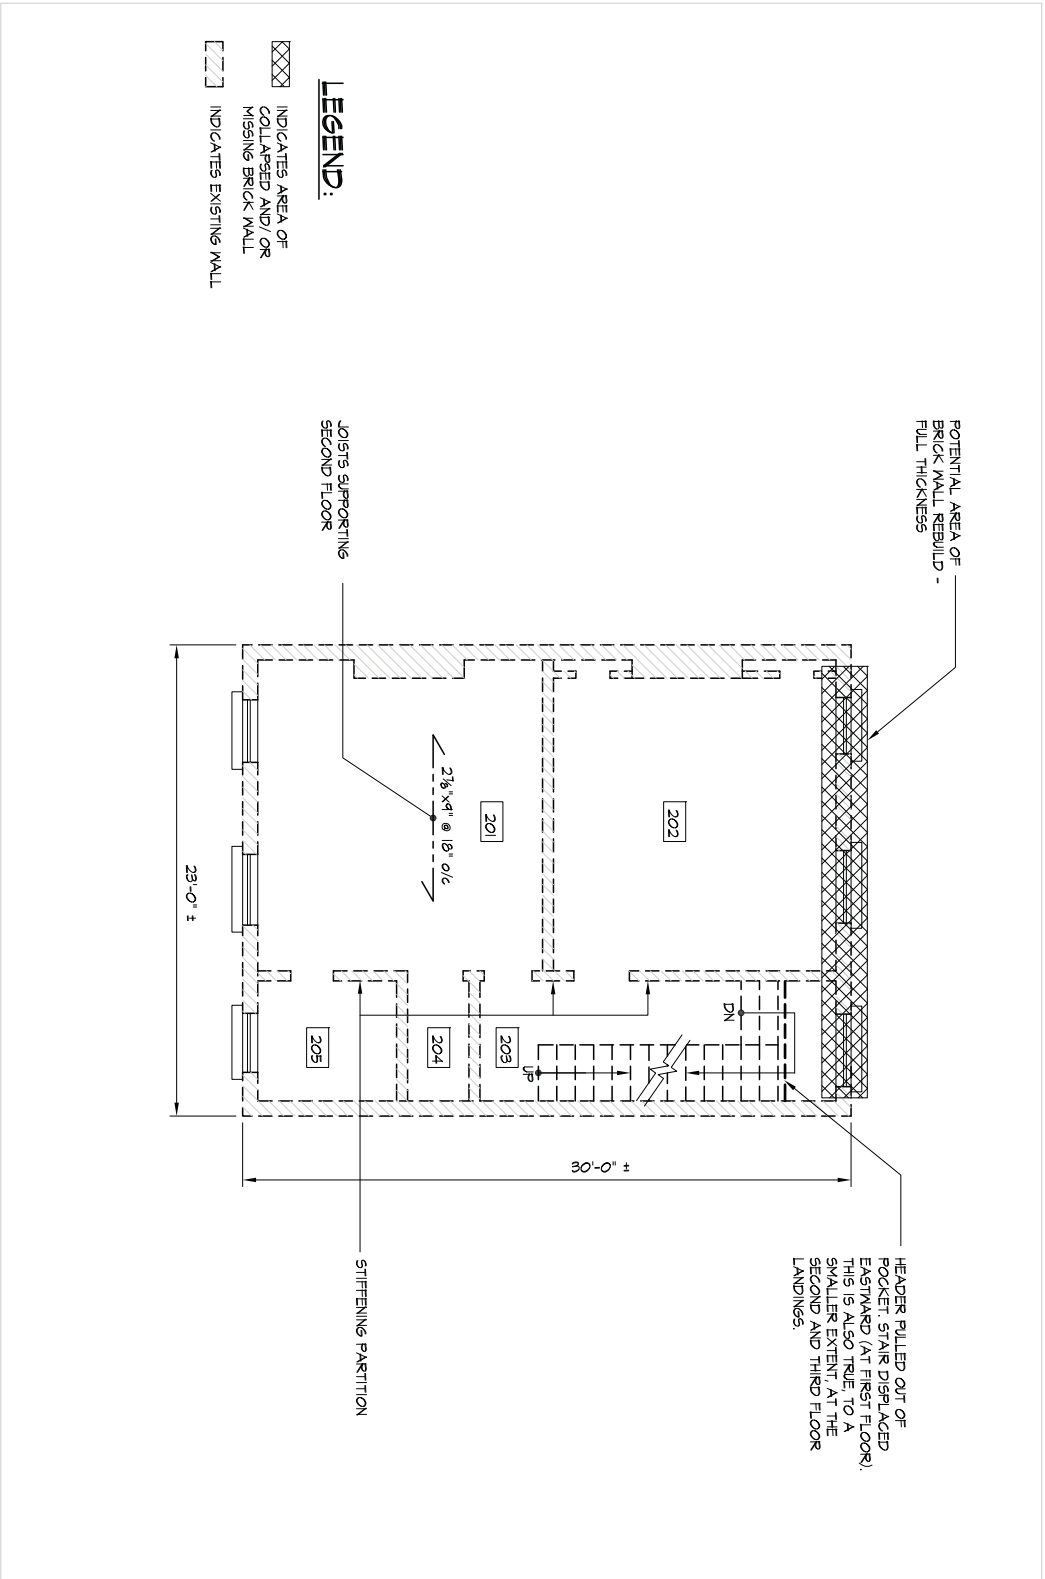
LEGEND:
 [Cross-hatched box] INDICATES AREA OF COLLAPSED AND/OR MISSING BRICK WALL
 [Dashed box] INDICATES EXISTING WALL

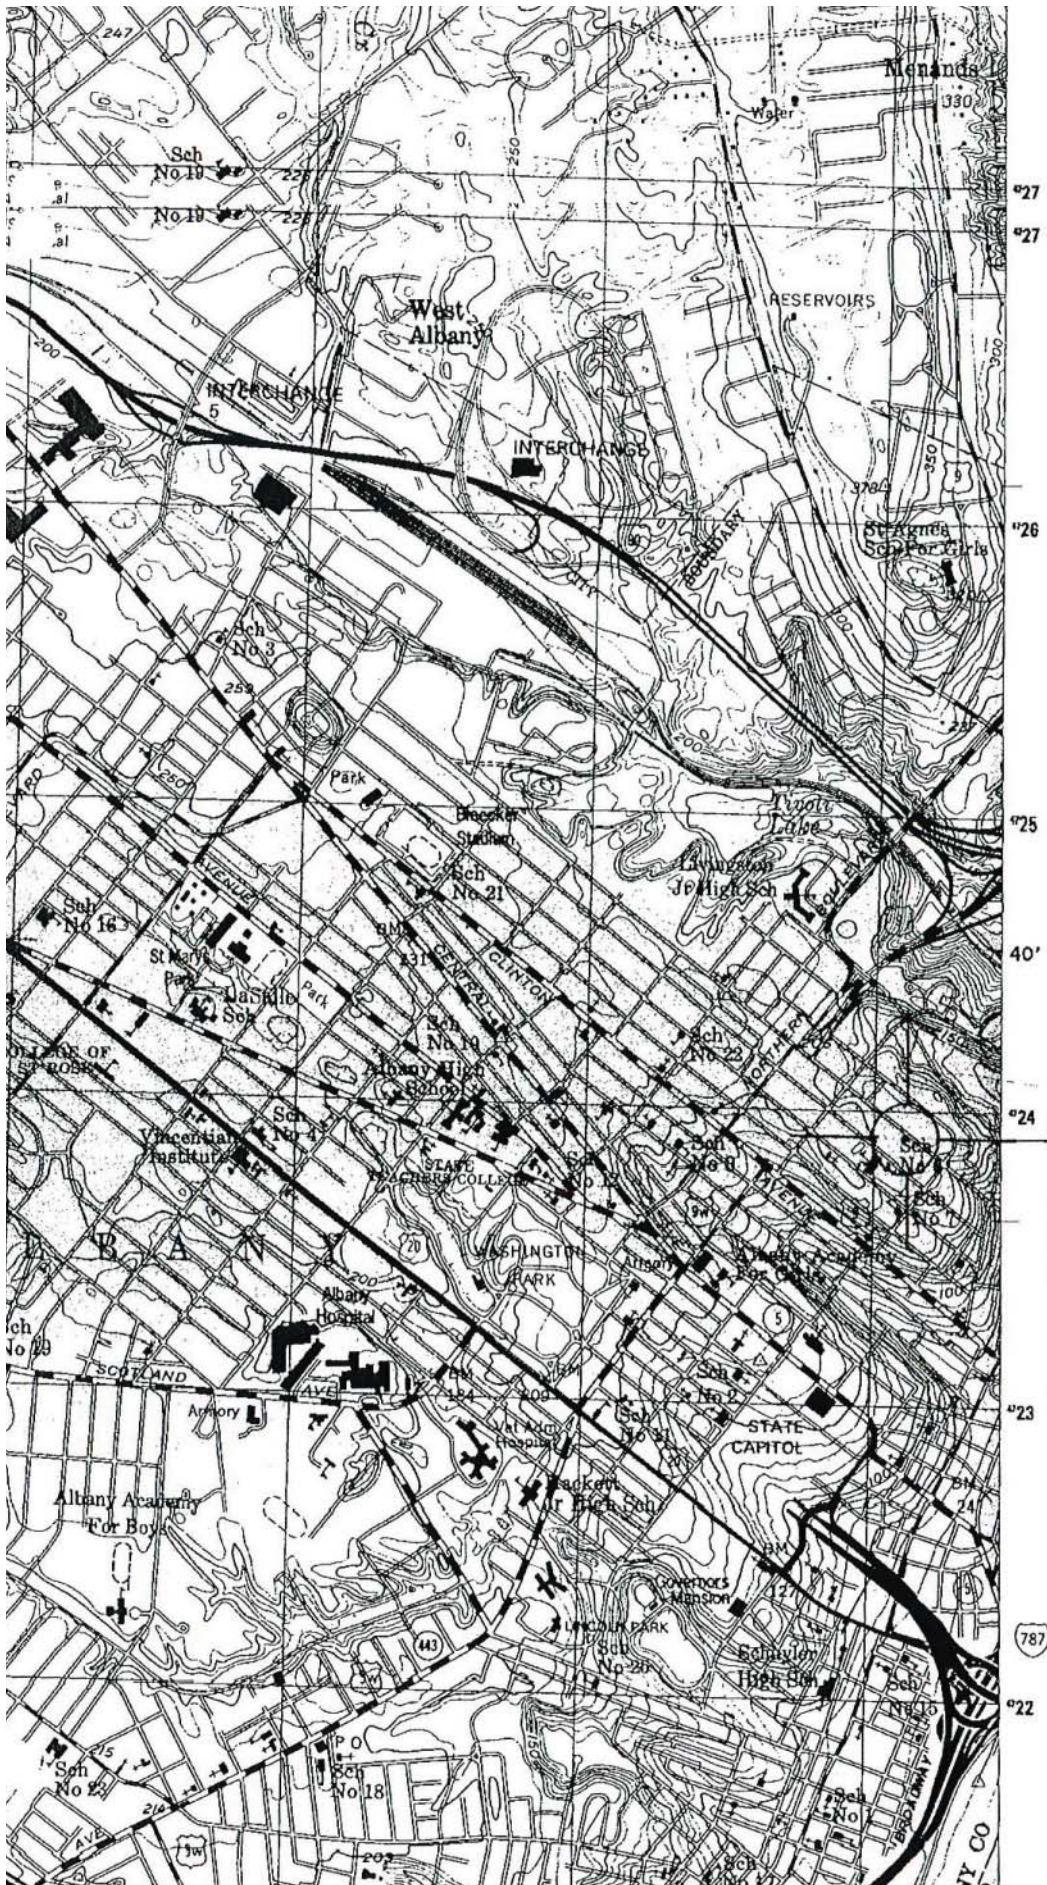
STEPHEN + HARRIET
 MYERS RESIDENCE
 194 LIVINGSTON AVE,
 ALBANY, ALBANY CO.,
 NEW YORK
 ALBANY QUAD
 ZONE 18

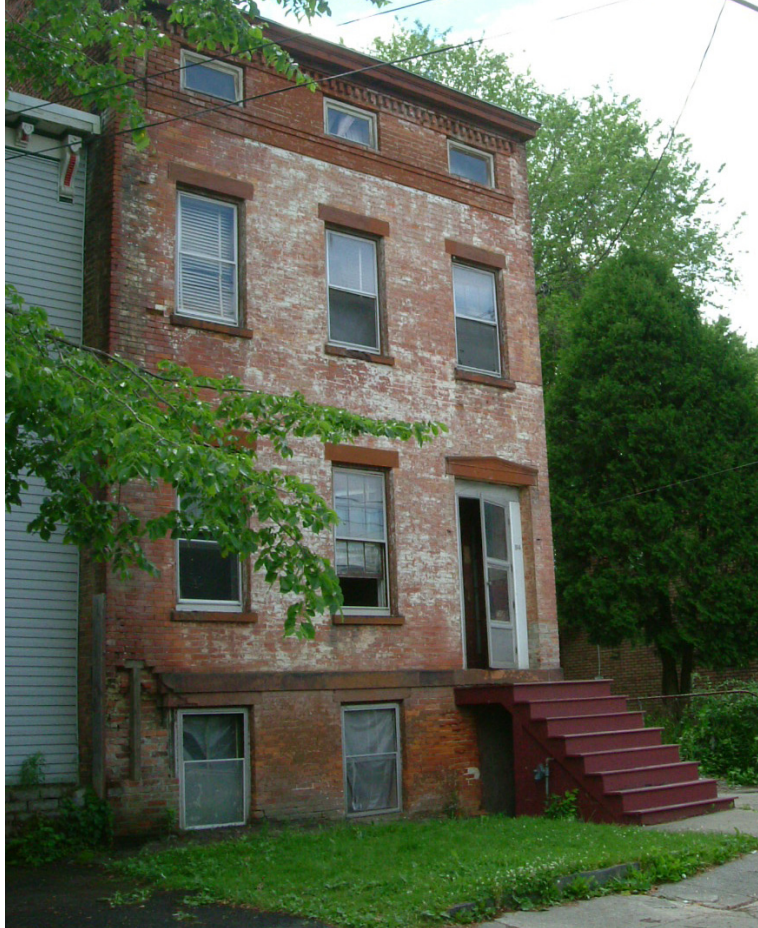
Existing Conditions Report

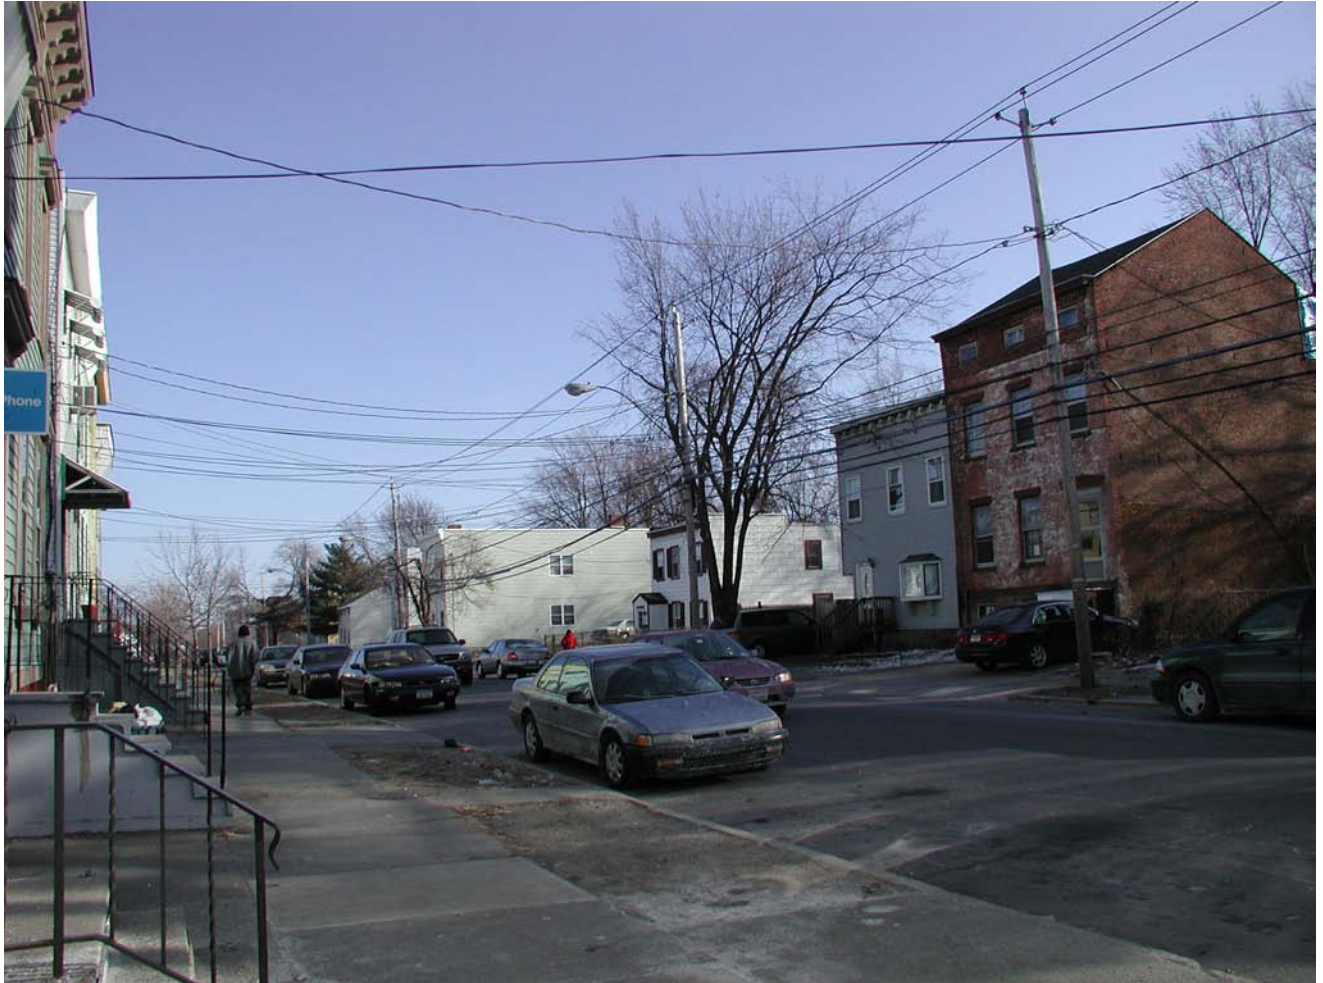
PURPOSE AND METHODOLOGY

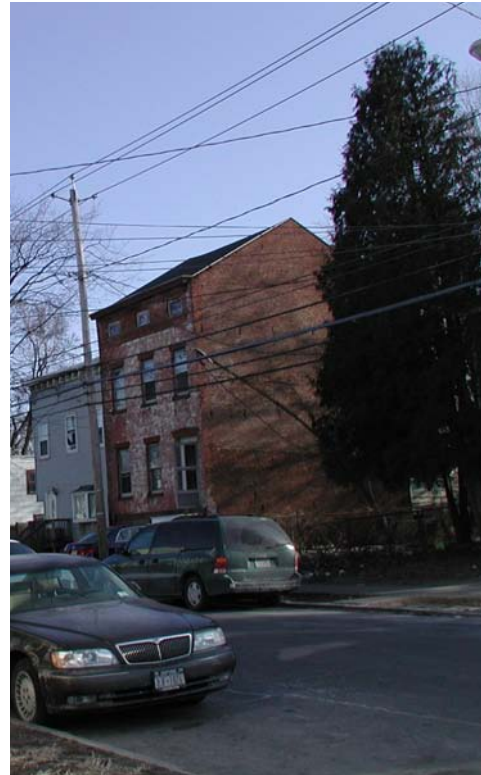
The front or north façade of the Myers House faces Livingston Street in the Arbor Hill neighborhood of Albany, New York.

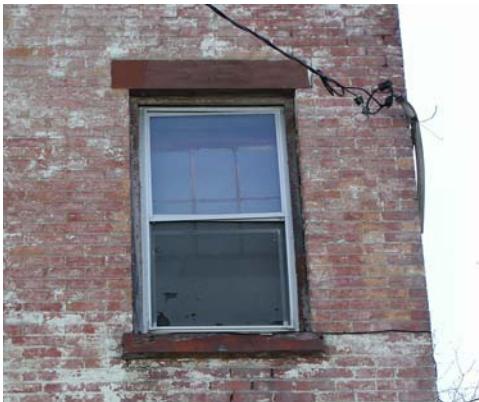
Door and window openings on the north façade are enriched with brownstone lintels and sills.

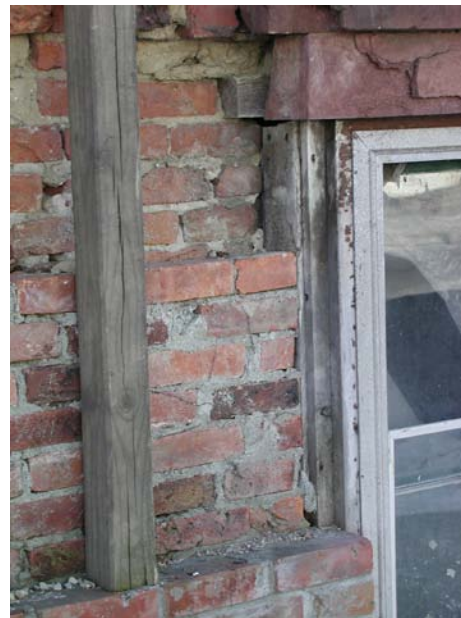
Brickwork at the east corner of the north façade has partially collapsed and requires immediate attention (note temporary support).

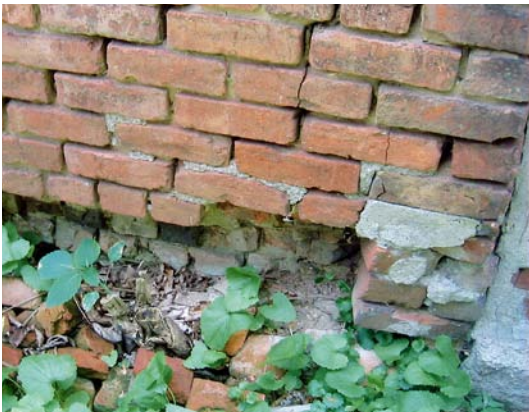
Weakened masonry at the south end of the west façade (note severely eroded mortar joints) has partially collapsed.

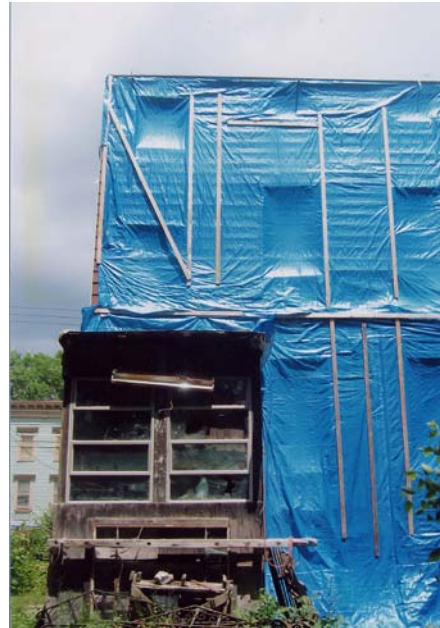
The south façade is presently covered in tarps to stop ongoing water infiltration. The rear porch, a later addition, is probably not salvageable.

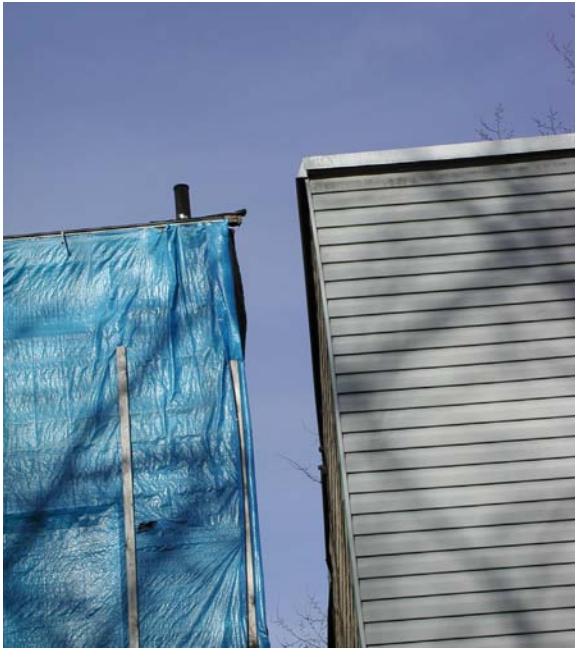
The masonry at the gable end on the east façade is visibly bulging.

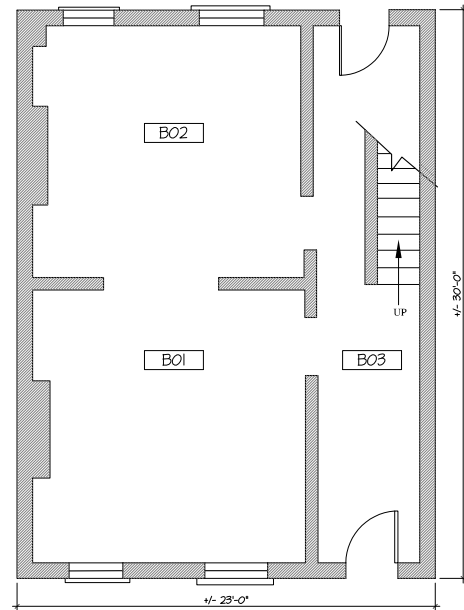
Schematic Cellar Floor Plan

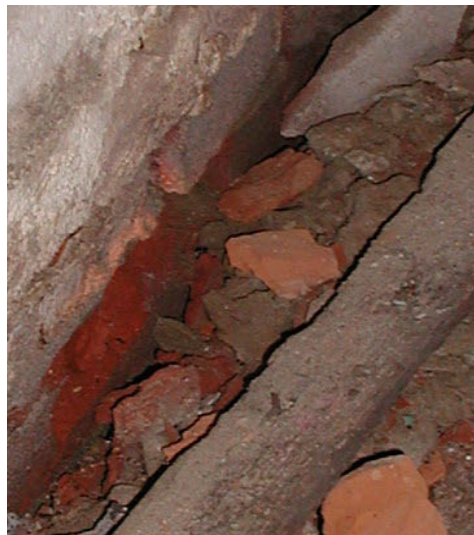
During a spring visit, damage was visible in the bricks in the east-west cellar partition, where the ice has melted.

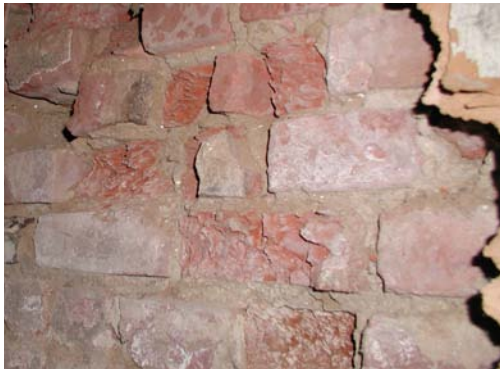
Repeat freeze and thaw cycles have left the bricks in the cellar walls brittle and friable.

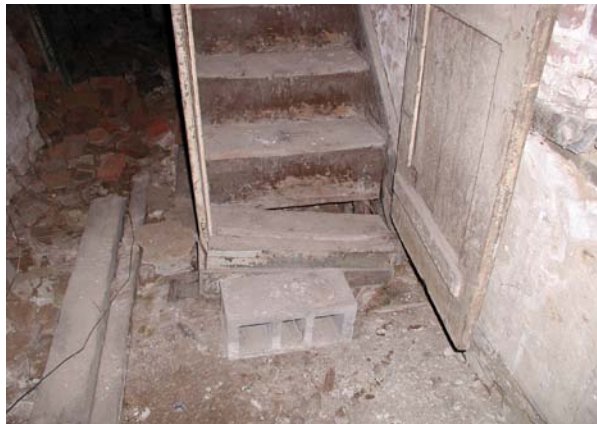
Removal of the historic floor and deterioration of the stringers have left the bottom of the stair to the cellar unsupported and precarious.

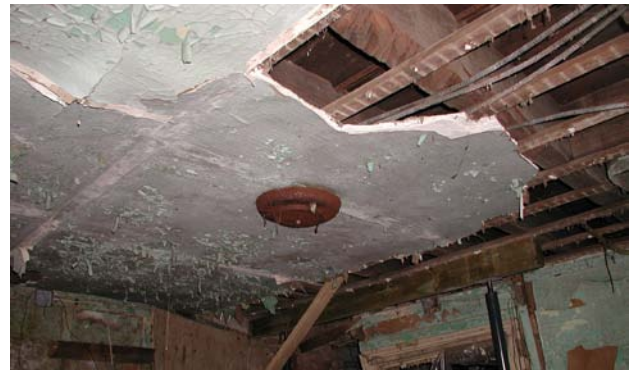
Both plaster and lath are missing from the ceiling in B02.

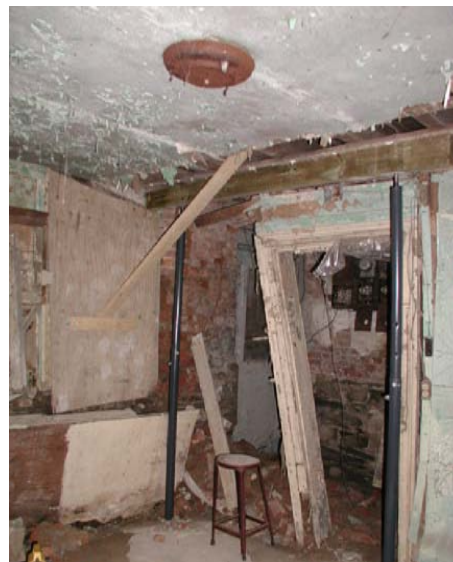
Ongoing water infiltration has destroyed many of the finishes in Room B02.

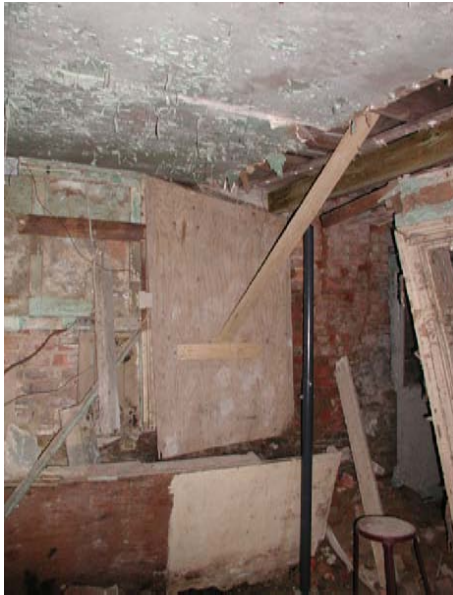
All of the brickwork at the south end of the stiffening partition between B02 and B03 has collapsed. Temporary posts and beam support the first floor.

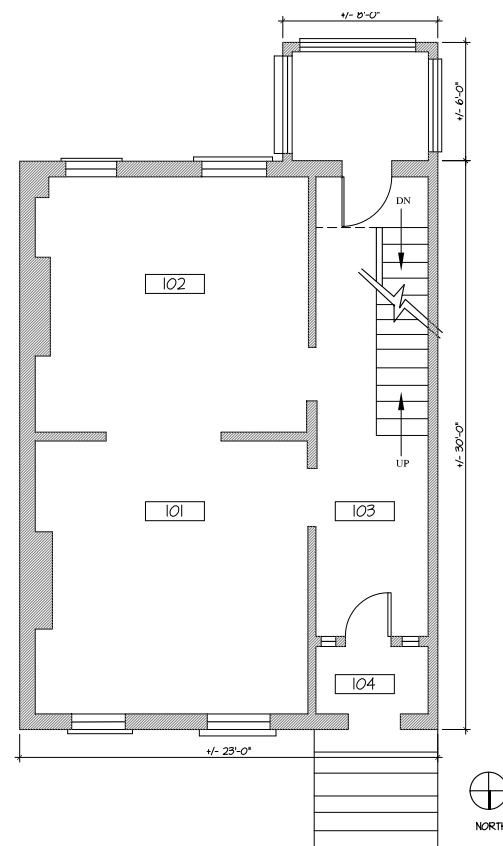
Schematic First Floor Plan

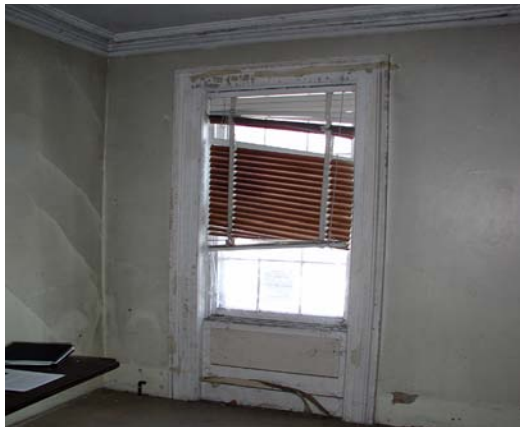
In Room 101, the front parlor has the most elaborate finishes in the house: a run plaster cornice and recessed wood panels below the windows. Diagonal cracks (at left in this photo) indicate settling.

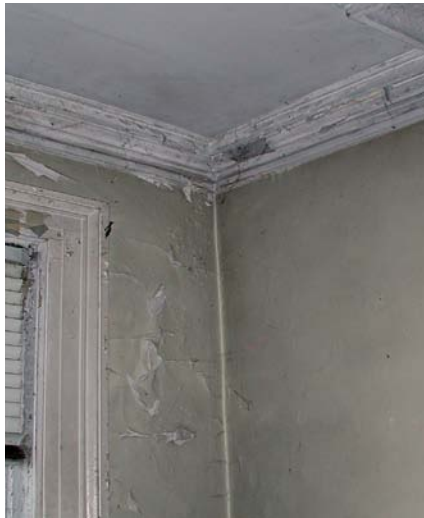
In the northeast corner of Room 101, peeling paint and soft plaster indicate moisture infiltration.

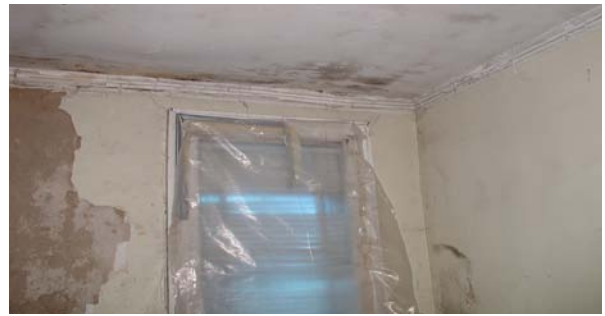
Water infiltration through the south wall damaged the plaster walls and cornice and left mildew stains on the ceiling of Room 102.

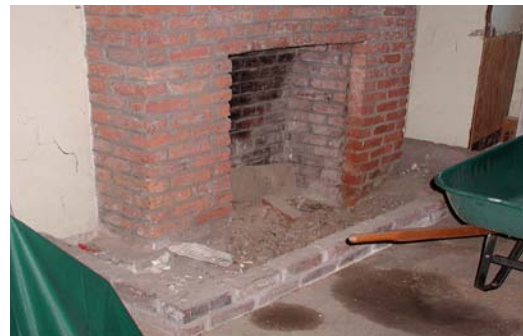
The curb of bricks in front of the fireplace in Room 102 is an interesting alteration.

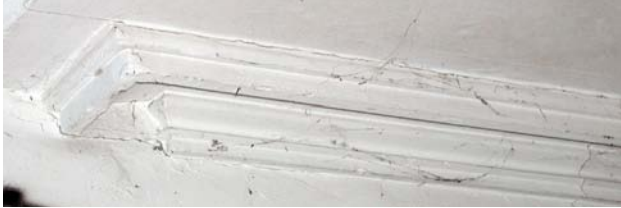
Room 103 retains an original plaster cornice. This cornice should be supported and protected from damage during the Stabilization work.

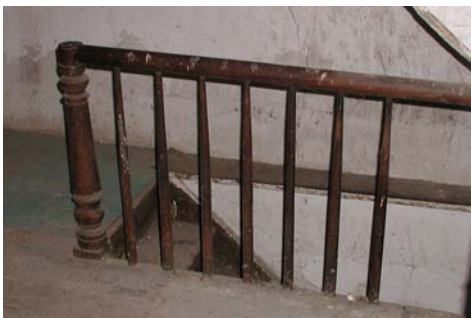
The stair to the Cellar retains most of its original ballustrade.

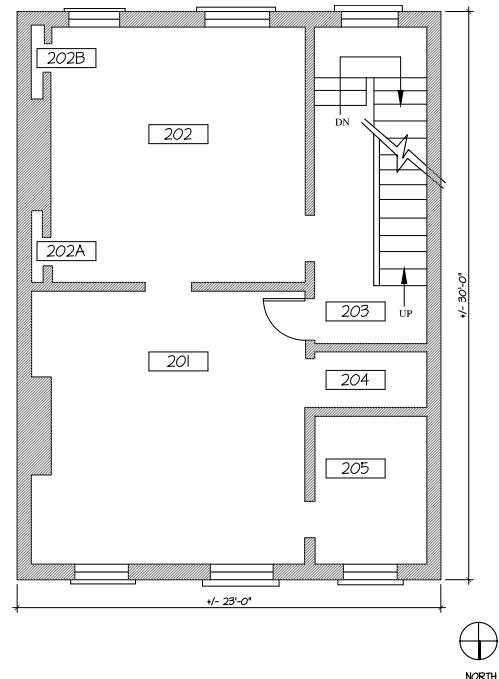
Schematic Second Floor Plan
