Stephen & Harriet Myers Residence
Albany, New York

Historic Structure Report

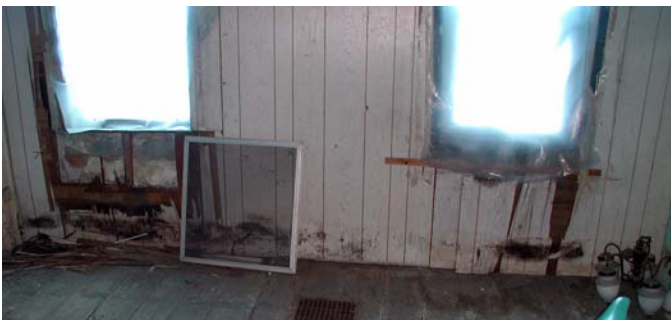
Ongoing water infiltration through the south wall of Room 202 has damaged both the original plaster wall finish and the faux wood paneling installed to hide the ruined plaster.

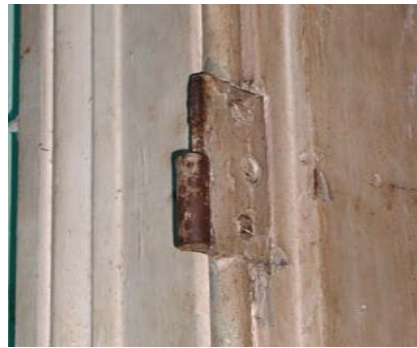
This lift-off hinge was found in Room 202. It was the only example of this type of hinge found in the building.

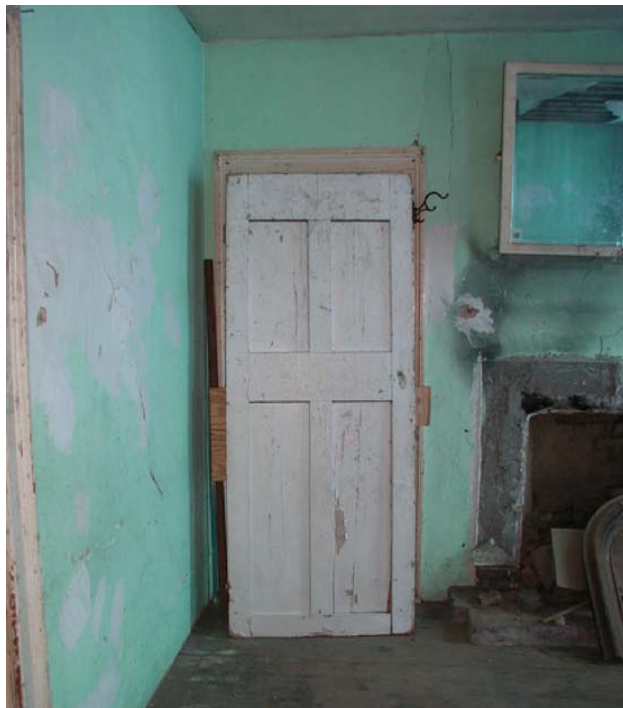
An original door with original hinges was found in Room 202.

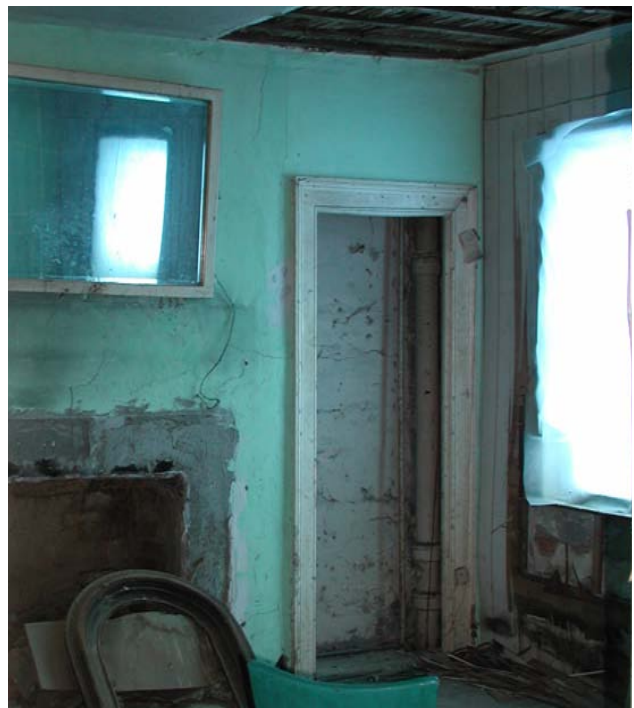
Room 202 has a shallow closet on either side of the fireplace opening. The mantelpiece was removed at an unknown date and the wall repaired with portland cement.

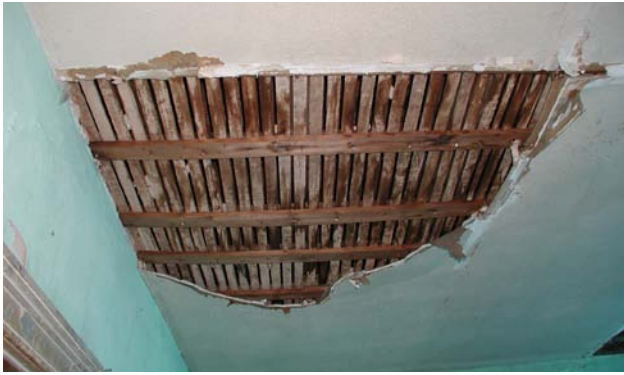
In Room 202 all of the original ceiling plaster was removed and a gypsum wallboard ceiling was installed on furring strips.

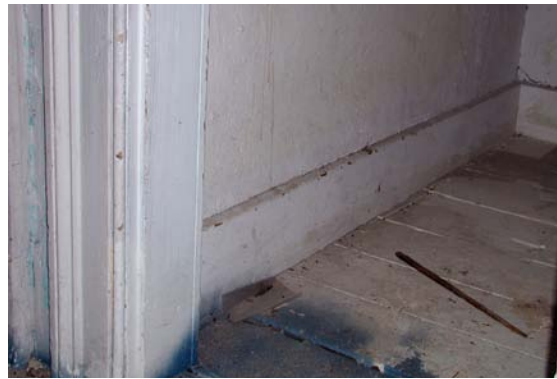
Room 204 is the only room in the entire house that retains original baseboards. The baseboard is a plain board with a beveled top edge.

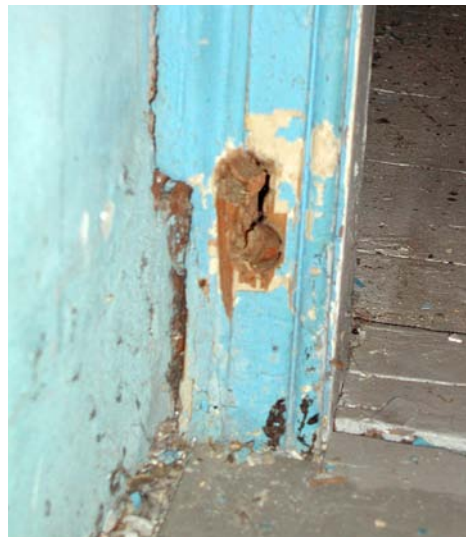
This cut in the door casing indicates that Room 205 once had baseboards similar to those found in Room 204.

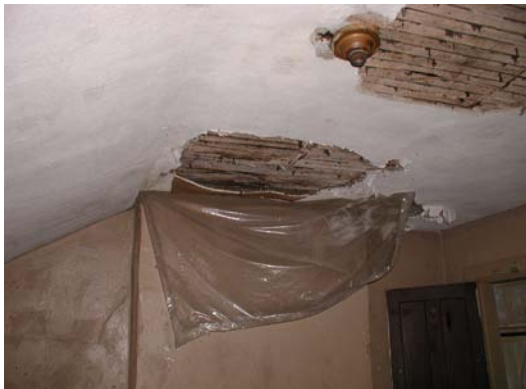
Damage to the plaster ceiling along the east wall in room 301 was likely caused by water entering through failed chimney flashings.

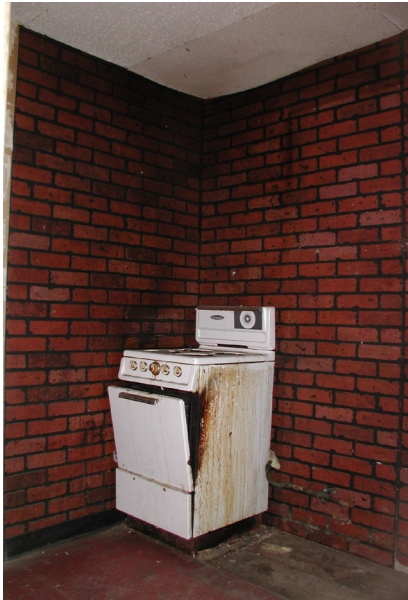
A modern stove in Room 303 indicates that this room was used as a kitchen in the late 20th century.

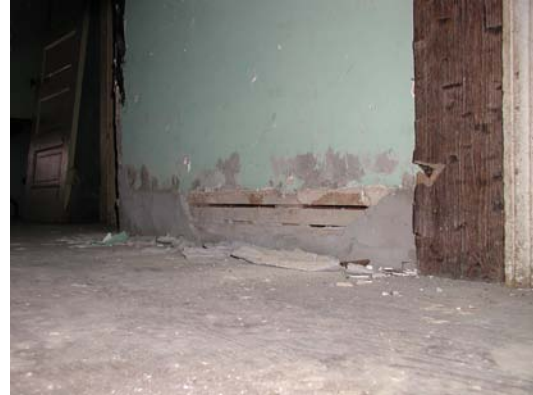
In Room 304, the baseboards were removed and the exposed space patched with cement.

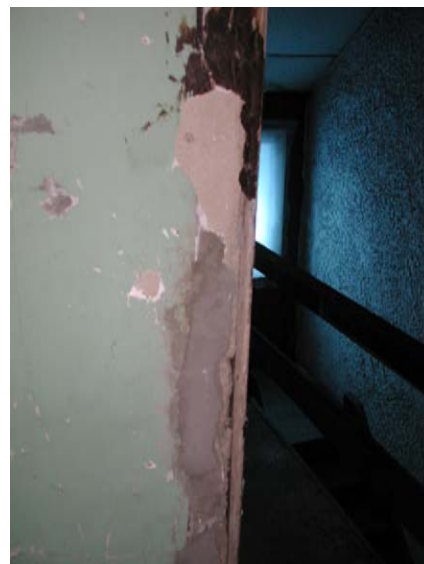
Damage to the outside corner in Room 304 exposed an original wood corner bead.

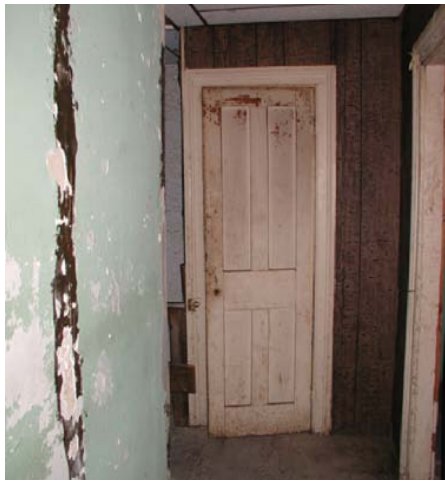
An original door frame with a four-panel, rail and stile door remains in place in the west wall of Room 304.

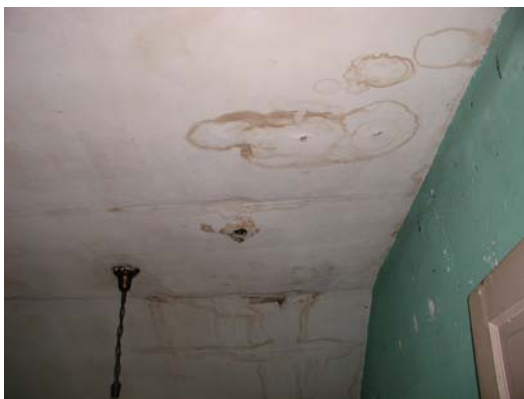
Water damage is clearly visible on the ceiling of Room 306.

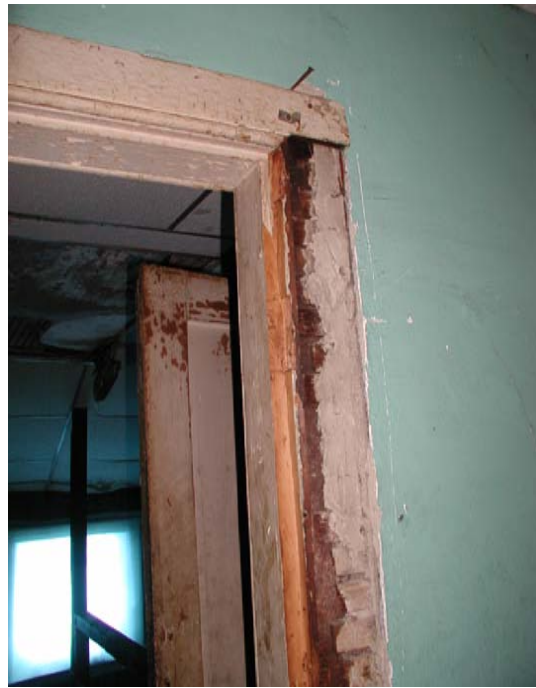
A missing door casing in Room 306 reveals that the lath and plaster base coat continued behind the trim. The final coat of plaster was installed after the casing was in place.

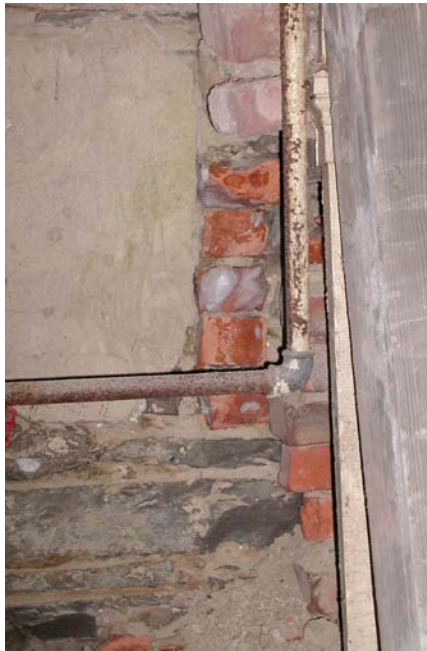
This iron pipe in Room B01 was most likely a gas pipe.

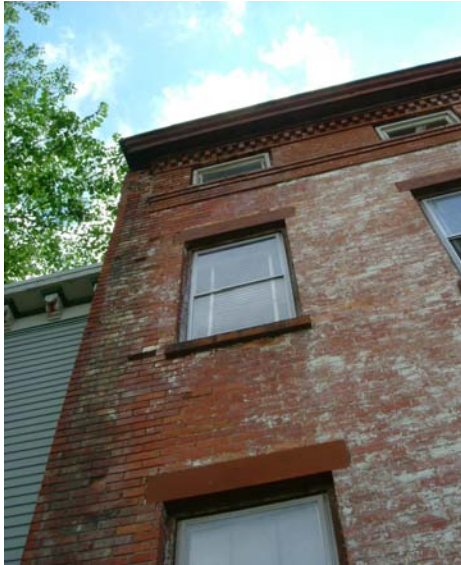
Stabilization of the exterior façades and structure must be completed before the Restoration work is begun.

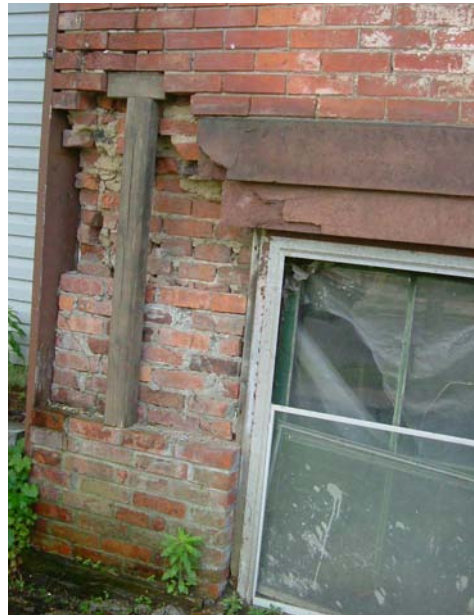
Missing bricks have left the northeast wall very thin and action should be taken immediately to reconstruct the wall.

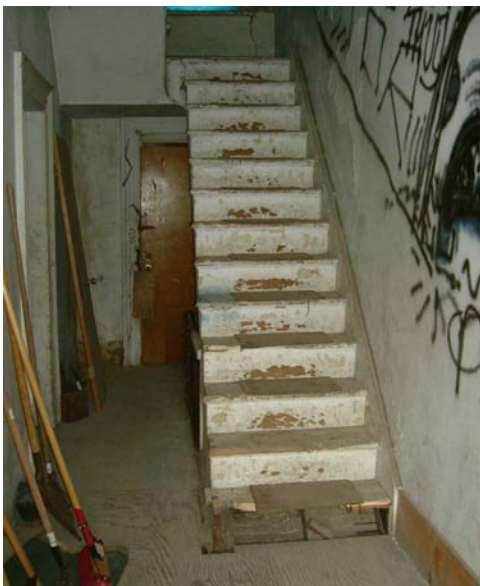
Stairs at first floor require a railing and should not be used by public.

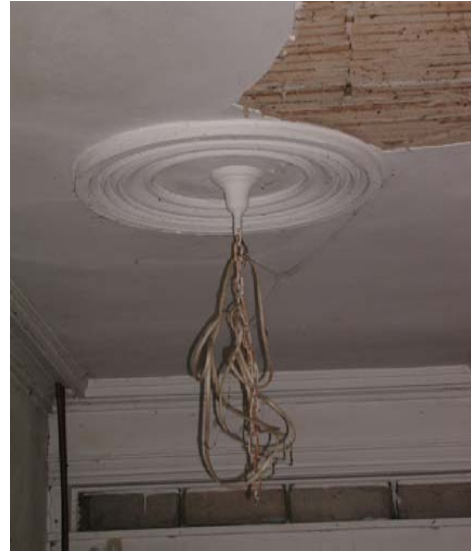
Once the Stabilization work is complete, attention can be paid to interior details such as moldings and light fixtures.

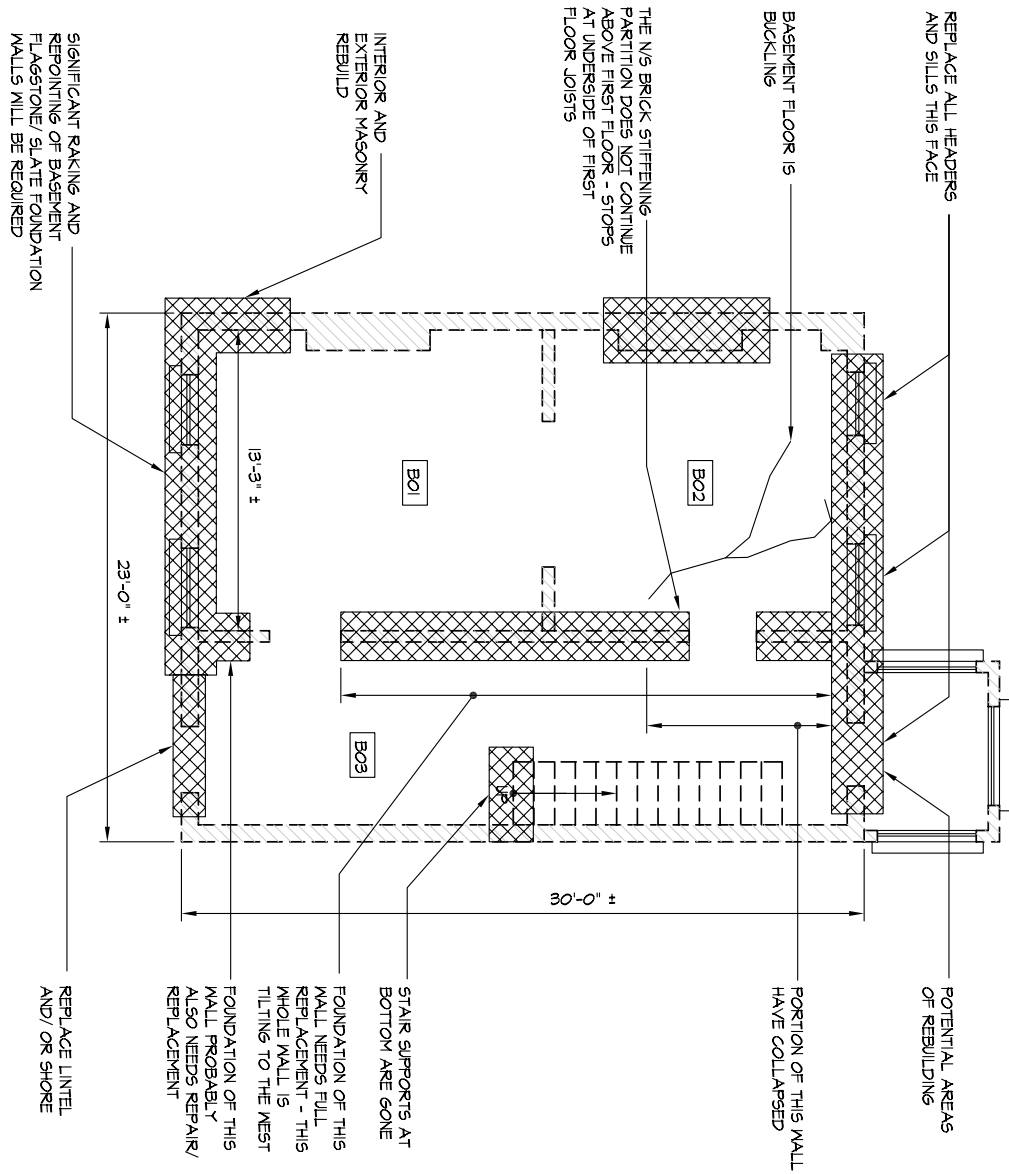
[Z] INDICATES EXISTING WALL

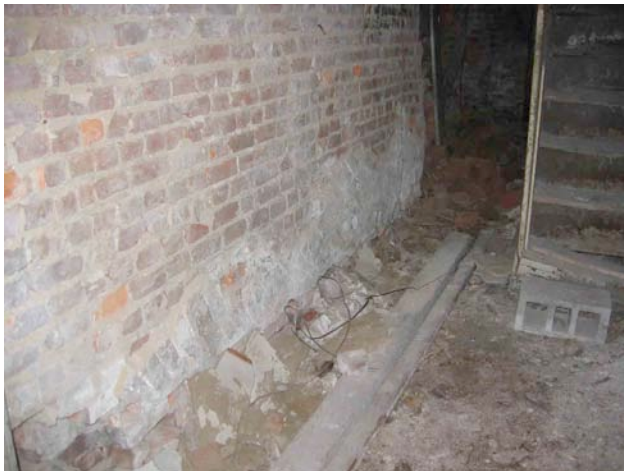
Photograph No. 3. View of west elevation of the north/south bearing wall in the basement. Note the severe deterioration/loss of masonry at the bottom of this wall.

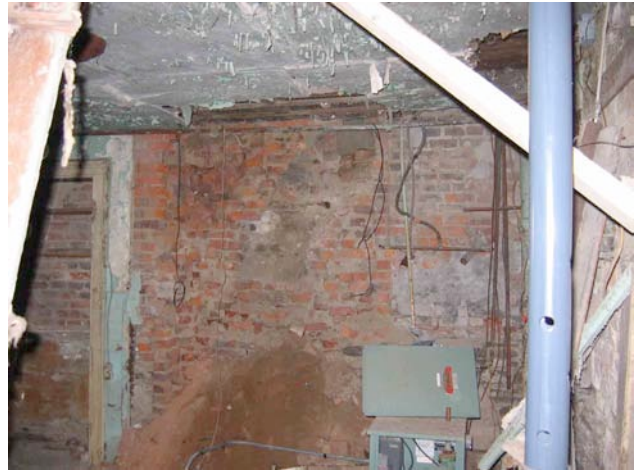
Photograph No. 6. View of brick wall failure at the SE corner of the basement; note pile of brick, mortar, and other debris from the collapsed portions of this brick wall.

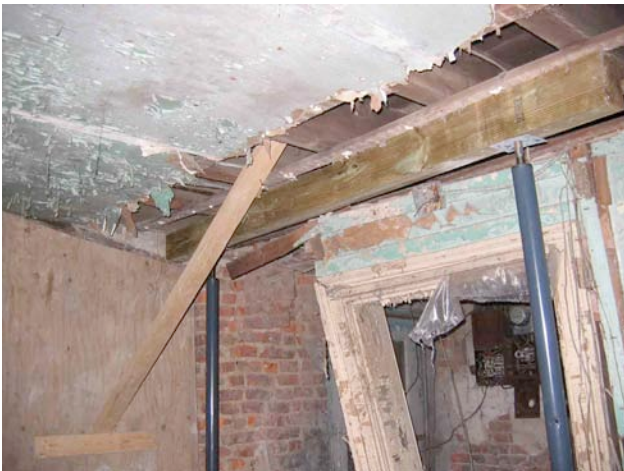
Photograph No. 7. View of eastern side of the north end of the north/south bearing wall in the basement. Note that even the temporary screw jacks appear to have displaced horizontally.

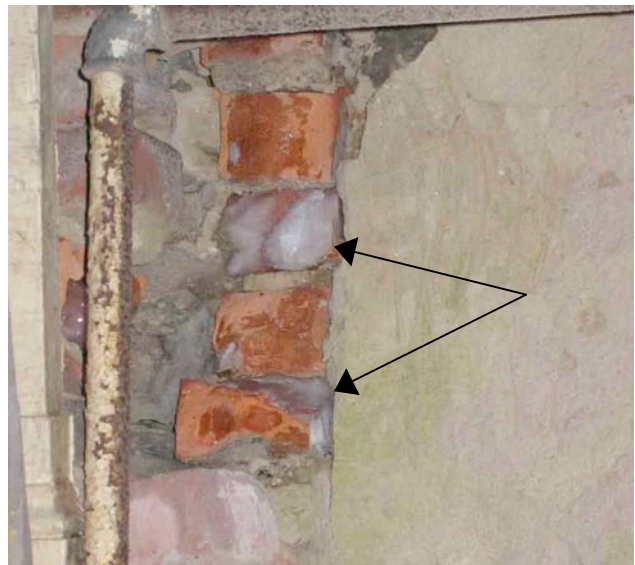
Photograph No. 8. View of severe moisture in the brick walls of the basement. This photograph was taken at the east wall of the building (i.e., the party or common wall with the adjacent row house). Arrows point to ice deposition on the brick surfaces.

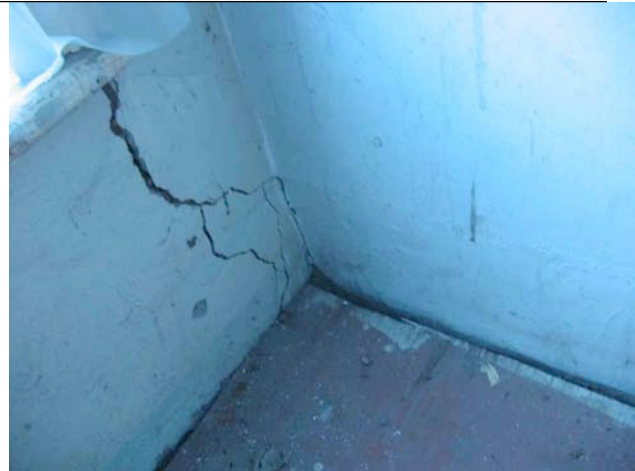
Photograph No. 14. View of crack in the interior plaster near the SW corner of the building.

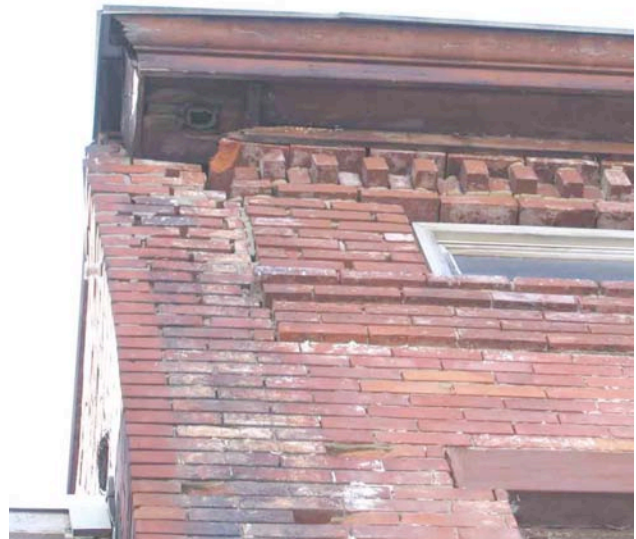
Photograph No. 18. View of missing mortar, missing bricks, and loose masonry at the cornice level (at the NE corner of the building).

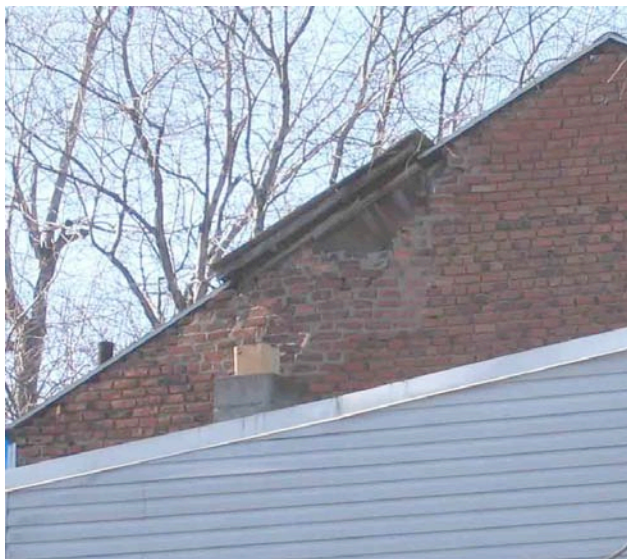
Photograph No. 19. View of missing masonry and poorly reconstructed masonry on the exterior of the East elevation.

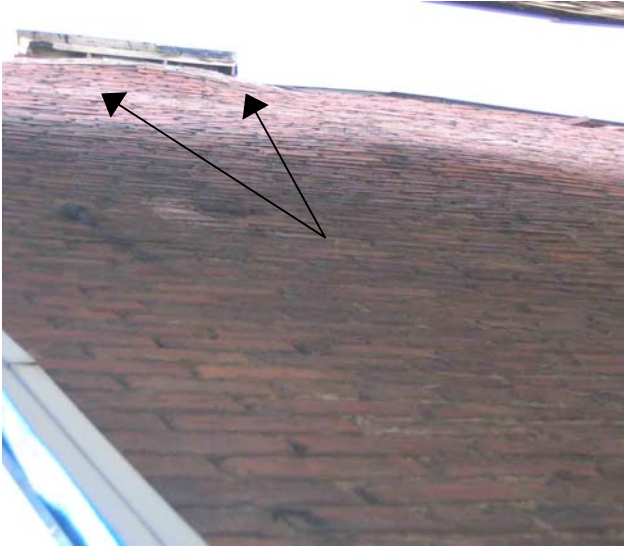
Photograph No. 21. View of one of the bulges in the exterior brick masonry. This view is at the SE corner looking up. The arrows point to the most severe bulging.

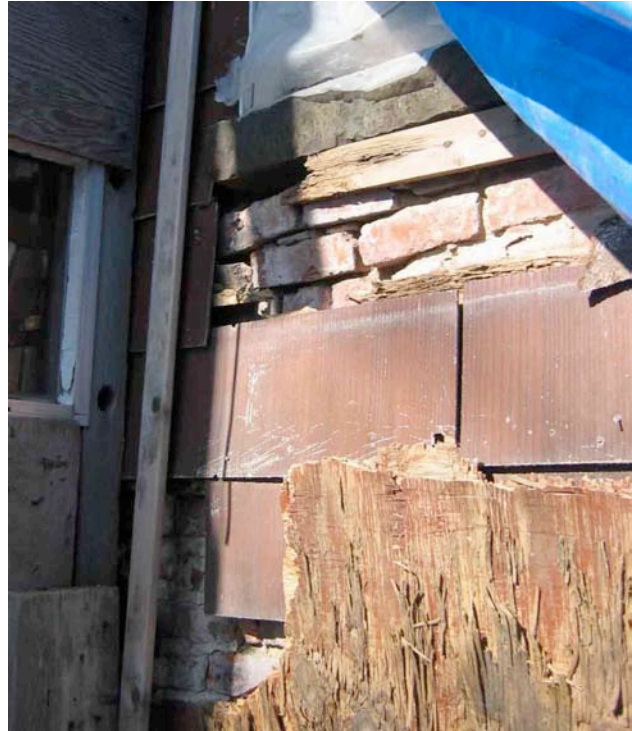
Photograph No. 22. View of the severely deteriorated masonry at the first floor window of the south elevation. Note almost complete absence of mortar between the bricks below the sill and behind the missing exterior siding.
