Stephen & Harriet Myers Residence
Albany, New York

Historic Structure Report

February 5, 2009

Prepared by:
STEPHEN TILLY, ARCHITECT
22 Elm Street
Dobbs Ferry, New York 10522
(914) 693-8898

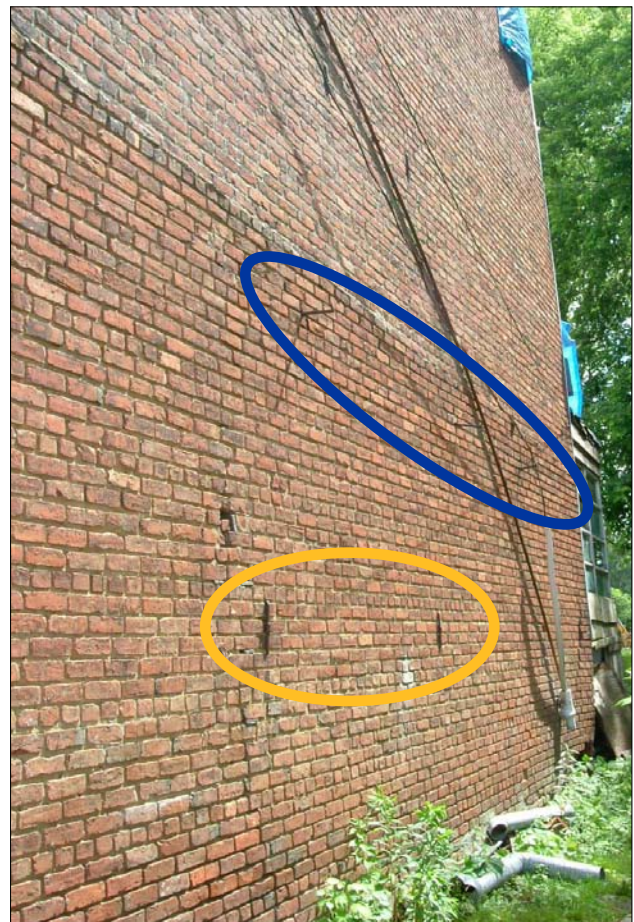
Figure 36: Both wrought iron ties (circled in orange) and joist hangers (circled in blue) are visible on the west façade.

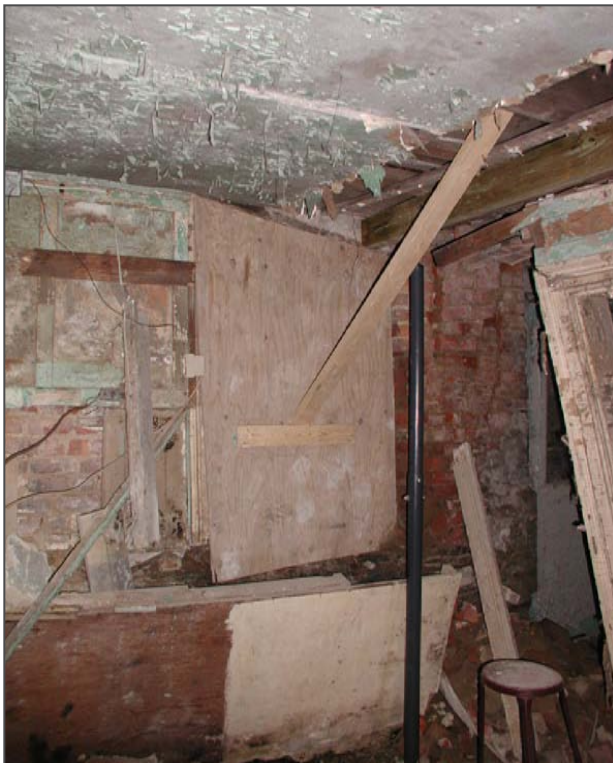
Figure 52: All of the brickwork at the south end of the stiffening partition between B02 and B03 has collapsed. Temporary posts and beam support the first floor.

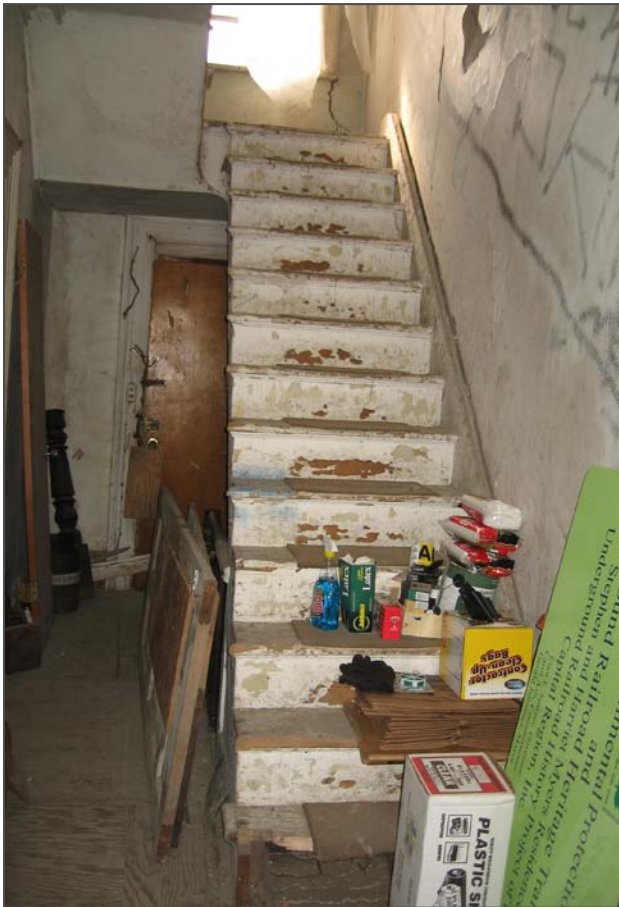
Figure 83: Staircase to the second floor with missing railing and balluster.

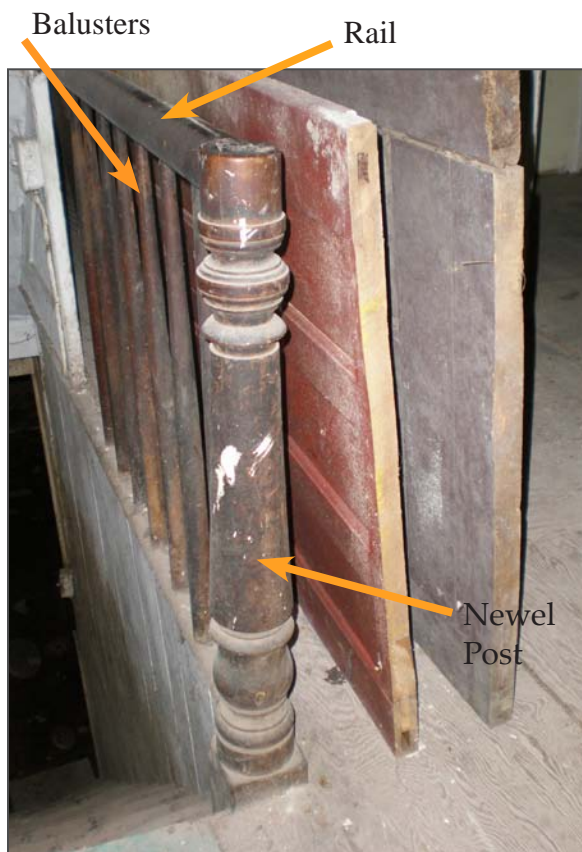
Figure 141: An intact railing section with rail, newel post and balusters from the staircase to the basement should be retained, repaired, and can be used as a pattern for replication.

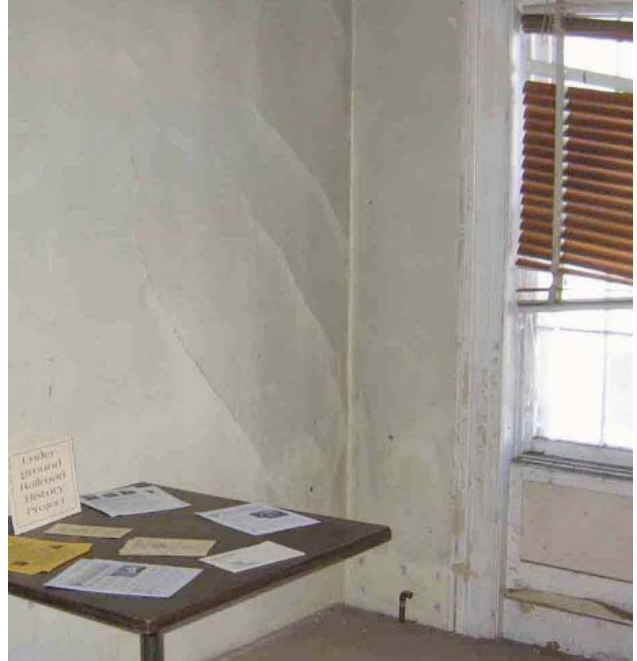
Photograph No. 10. View of typical diagonal cracking in the upper floors of the house. This occurs on the first floor (near the north wall of the house).

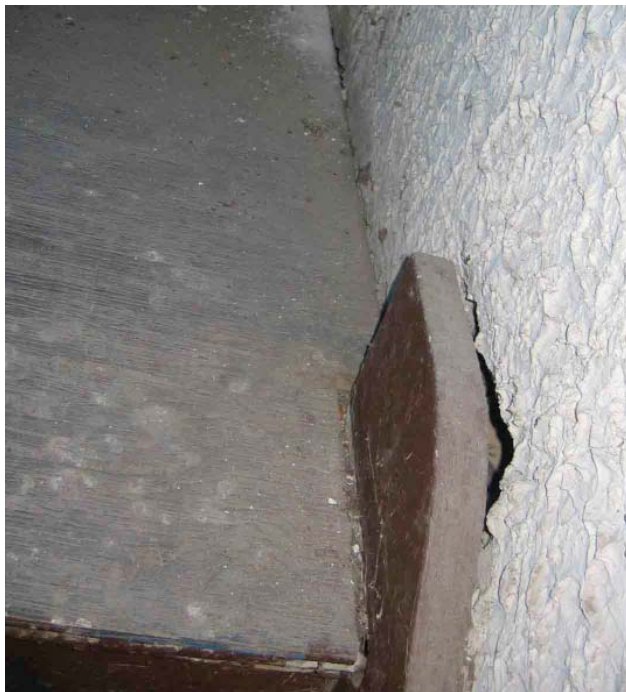
Photograph No. 11. View of stair landing at upper floor where the stair has pulled away from the interior surface of the exterior wall.

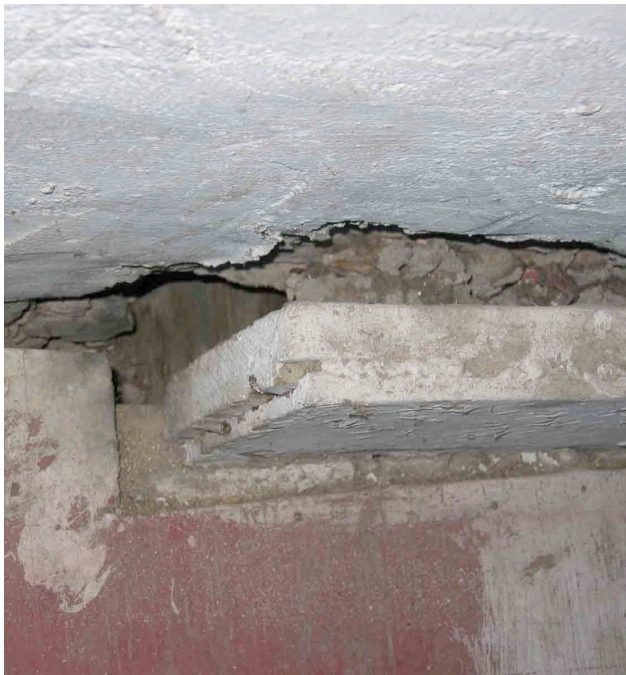
Photograph No. 15. View of another landing of the main staircase where the header and the stair have moved away from the interior face of the exterior wall.

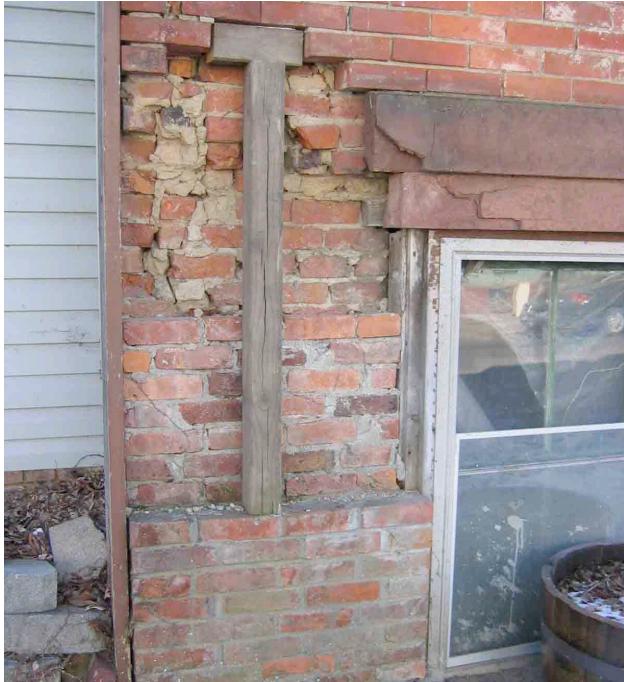
Photograph No. 17. View of localized failure of exterior wythes of brick masonry at the NE corner of the building.

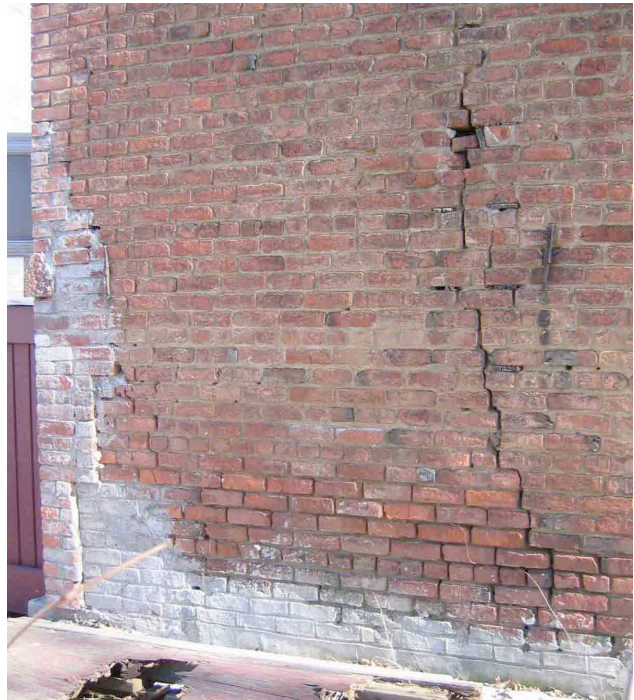
Photograph No. 20. View of one of the cracks in the masonry at the base of the West elevation wall (near NW corner of the building).

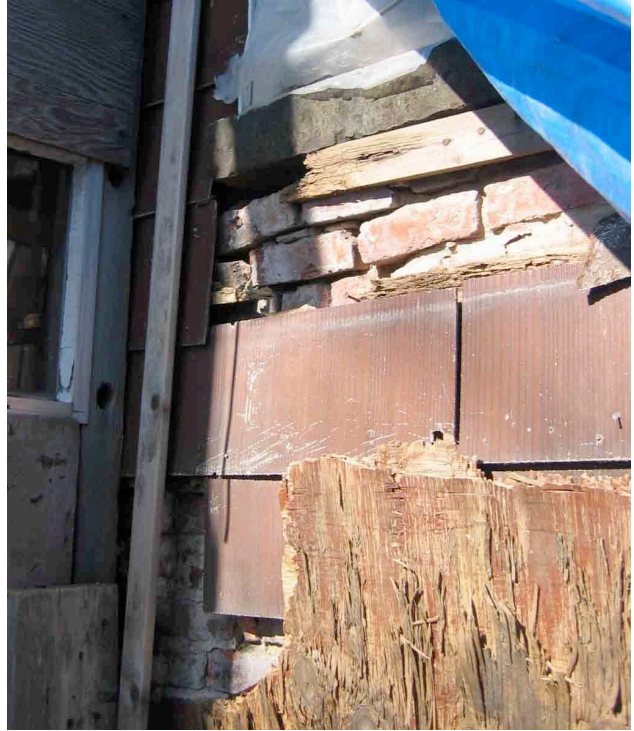
Photograph No. 22. View of the severely deteriorated masonry at the first floor window of the south elevation. Note almost complete absence of mortar between the bricks below the sill and behind the missing exterior siding.

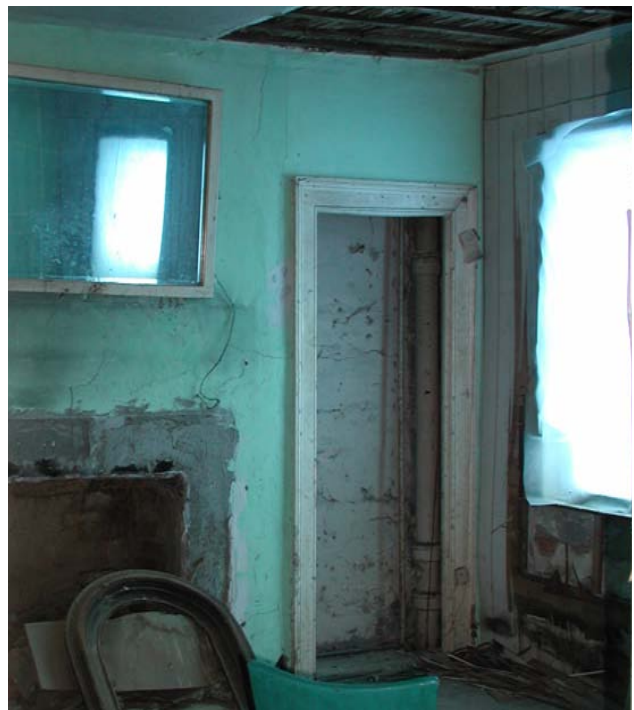
Room 202 has a shallow closet on either side of the fireplace opening. The mantelpiece was removed at an unknown date and the wall repaired with portland cement.

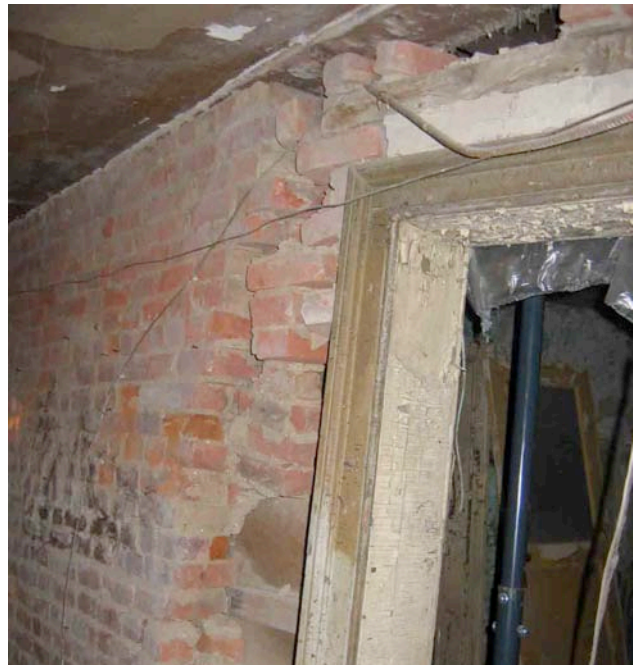
Photograph No. 4. View of the south end of the north/south bearing wall in the basement. Note the significant loss of bricks and disintegration of the wall.

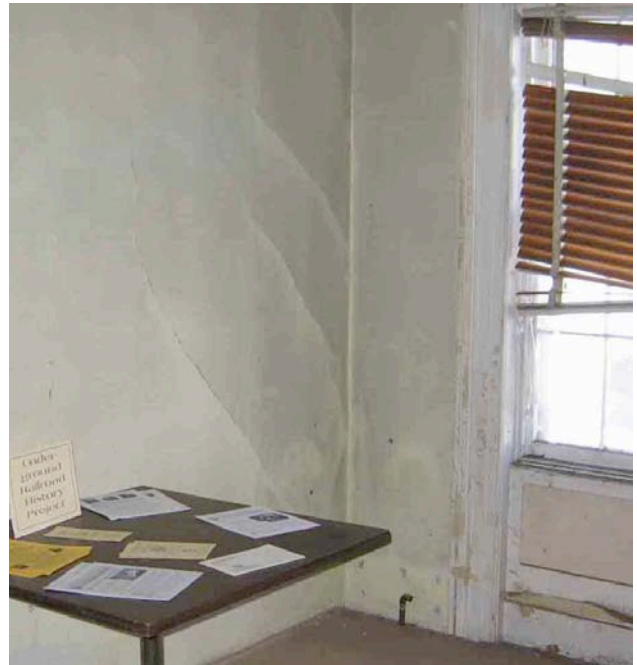
Photograph No. 10. View of typical diagonal cracking in the upper floors of the house. This occurs on the first floor (near the north wall of the house).

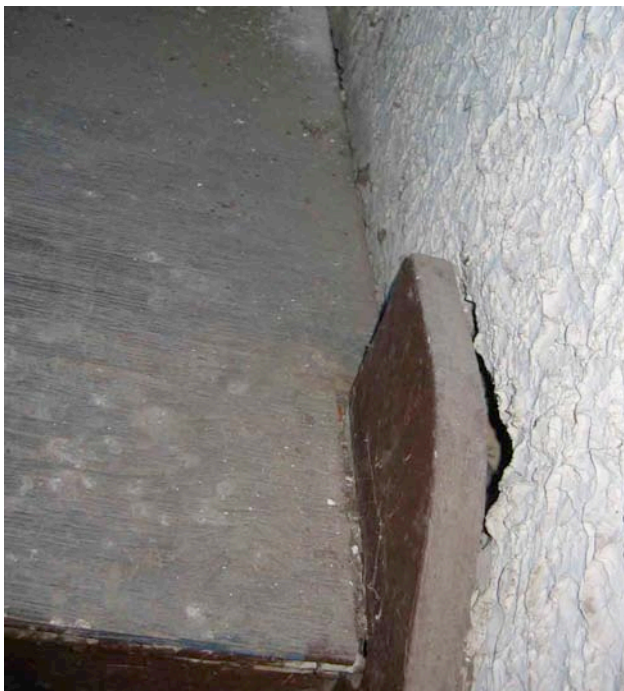
Photograph No. 11. View of stair landing at upper floor where the stair has pulled away from the interior surface of the exterior wall.

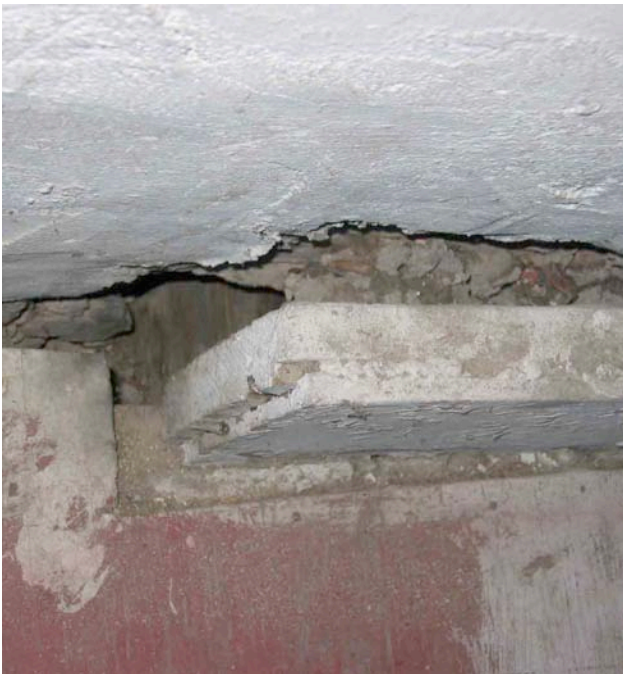
Photograph No. 15. View of another landing of the main staircase where the header and the stair have moved away from the interior face of the exterior wall.

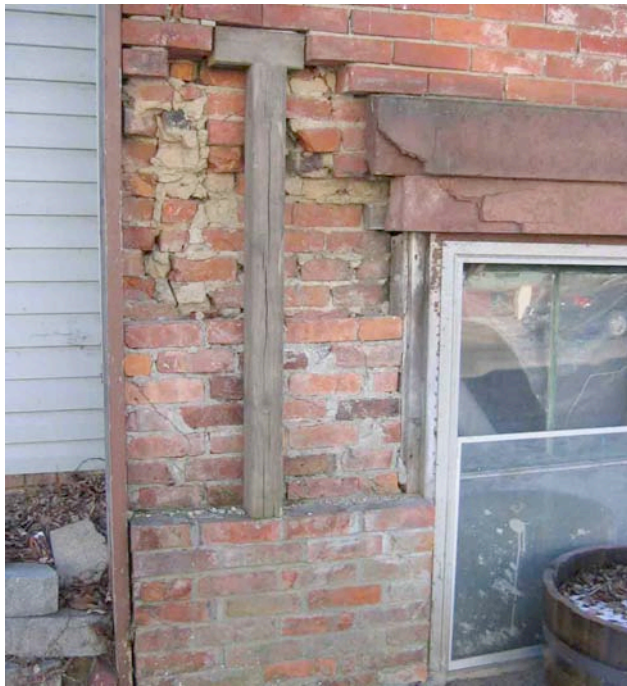
Photograph No. 17. View of localized failure of exterior wythes of brick masonry at the NE corner of the building.

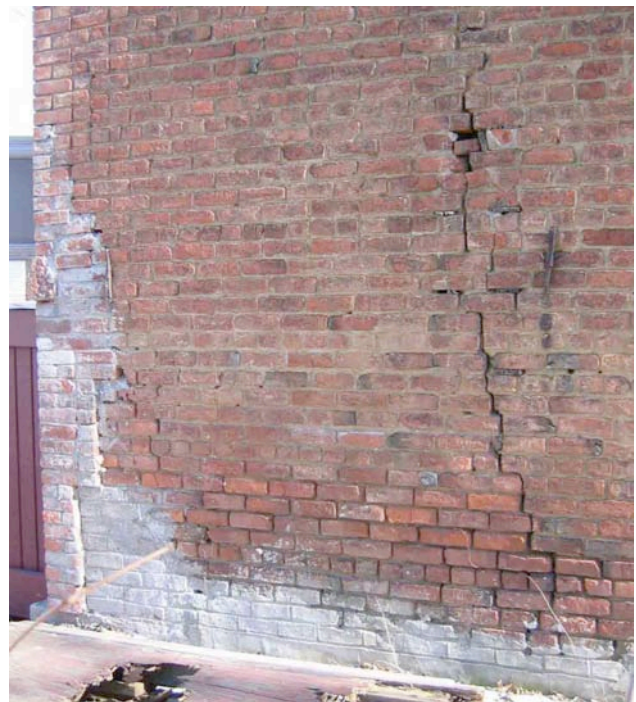
Photograph No. 20. View of one of the cracks in the masonry at the base of the West elevation wall (near NW corner of the building).

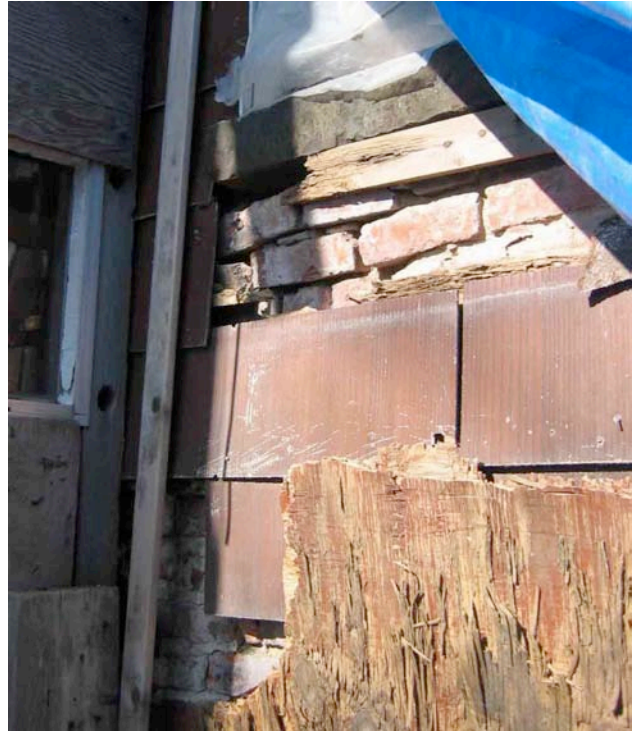
Photograph No. 22. View of the severely deteriorated masonry at the first floor window of the south elevation. Note almost complete absence of mortar between the bricks below the sill and behind the missing exterior siding.
