Stephen & Harriet Myers Residence
Albany, New York

Historic Structure Report

February 5, 2009

Prepared by:
STEPHEN TILLY, ARCHITECT
22 Elm Street
Dobbs Ferry, New York 10522
(914) 693-8898

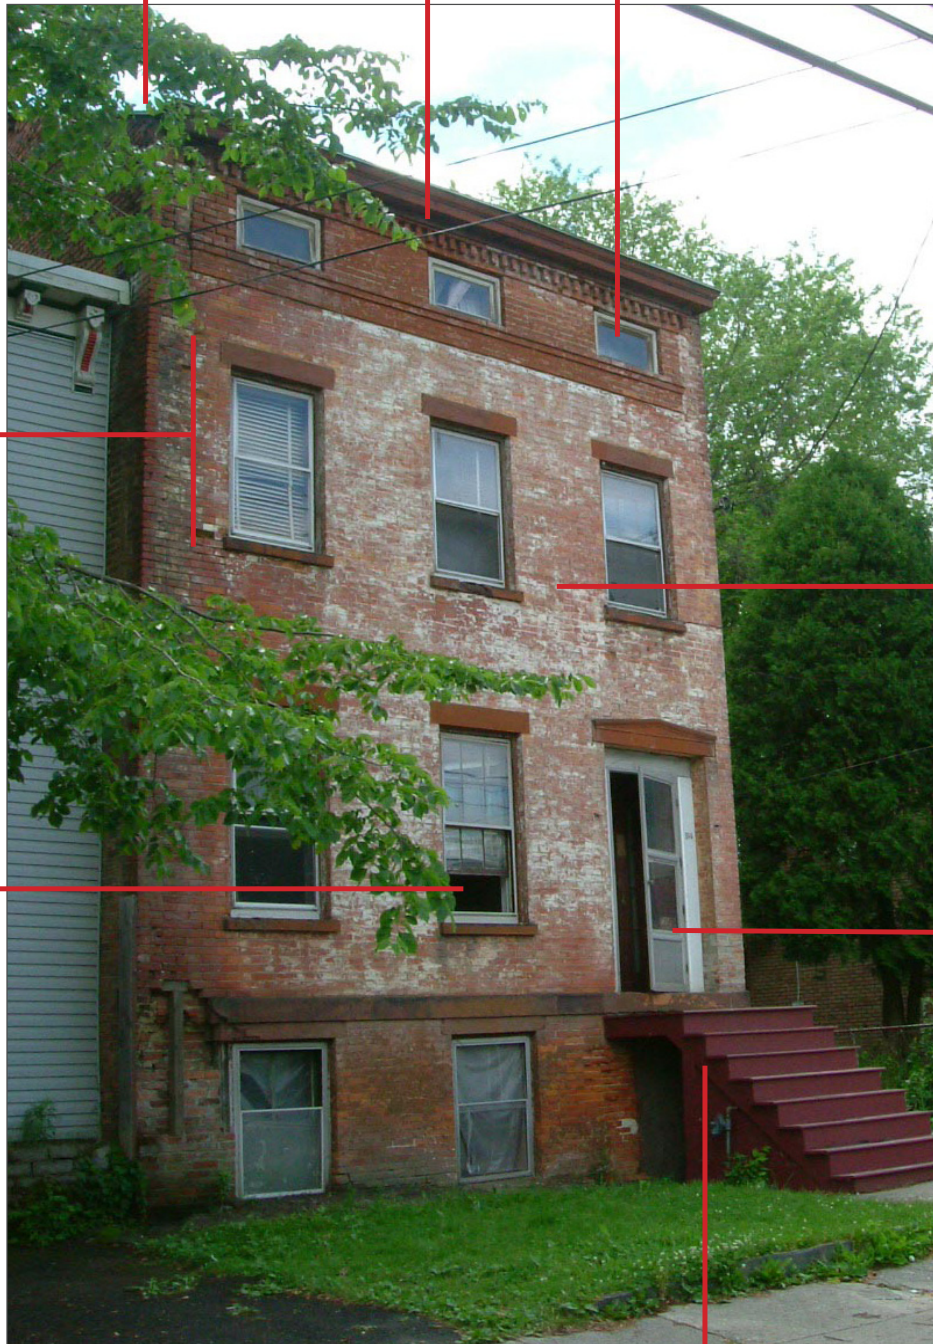
DETAIL 10: The original stoop has been removed. Although Greek Revival row houses in Albany have masonry or wood stoops, a more modest building of this period, like the Myers Residence, would most likely have had a wooden stoop. The lack of anchors on the building and masonry footing supports this conclusion.

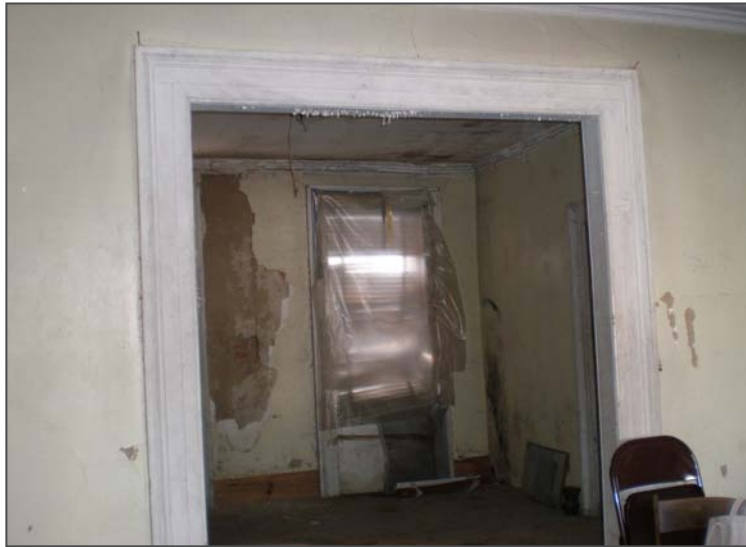
Figure 29: View from the Front Parlor into the Rear Parlor on the first floor. A set of double doors would have originally been installed in the opening. Although double doors that slide into the walls were a popular feature of Greek Revival buildings there is no evidence that this existed in the Myers Residence.

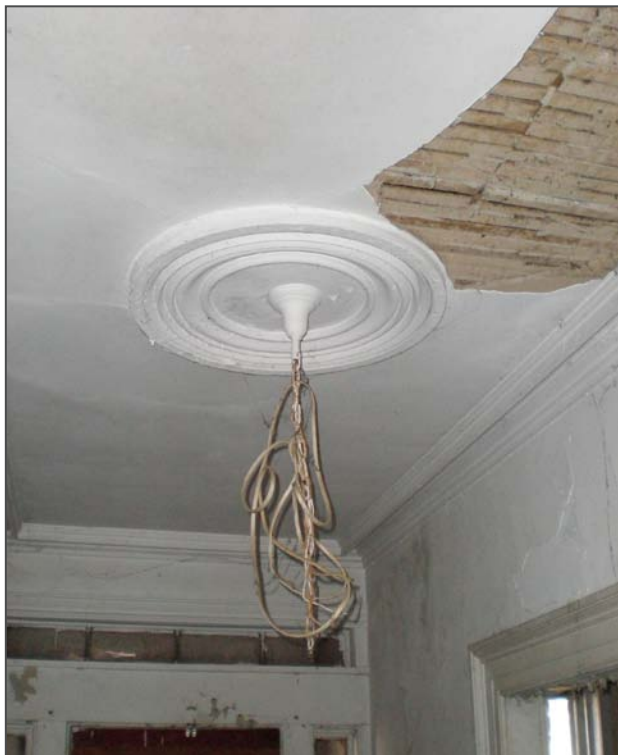
Figure 31: View of the ceiling medallion in the first floor side hallway. There is no indication that decorative centerpieces were installed in the Front or Rear Parlors but one is present in the side hall. The simple, circular molding design reflects standard detailing of the Greek Revival Style and appears to be original to the building.

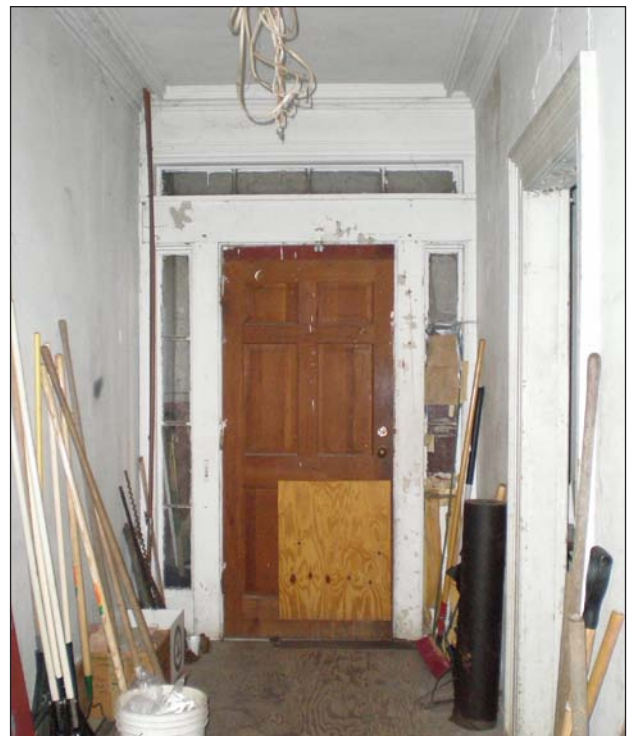
Figure 32: Viewed from the interior first floor hallway, the details of the front entryway are clear. The Myers Residence has a classic Greek Revival entryway with rectangular transom and sidelights. The door is not original. In Albany, Greek Revival buildings similar to this would have had single or double paneled doors.

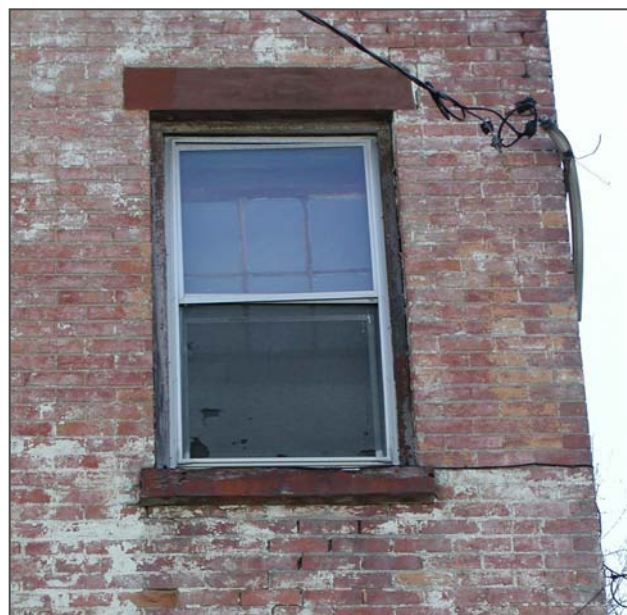
Figure 35: Door and window openings on the north façade are accented with reddish-brown sandstone lintels and sills.

The sandstone water table, sills and lintels are all deteriorated (spalling). At the east end, above the collapsed area of brick, an entire section of the water table (approximately 3' long) is missing. The damage is worst at the east end, where the leader was removed.

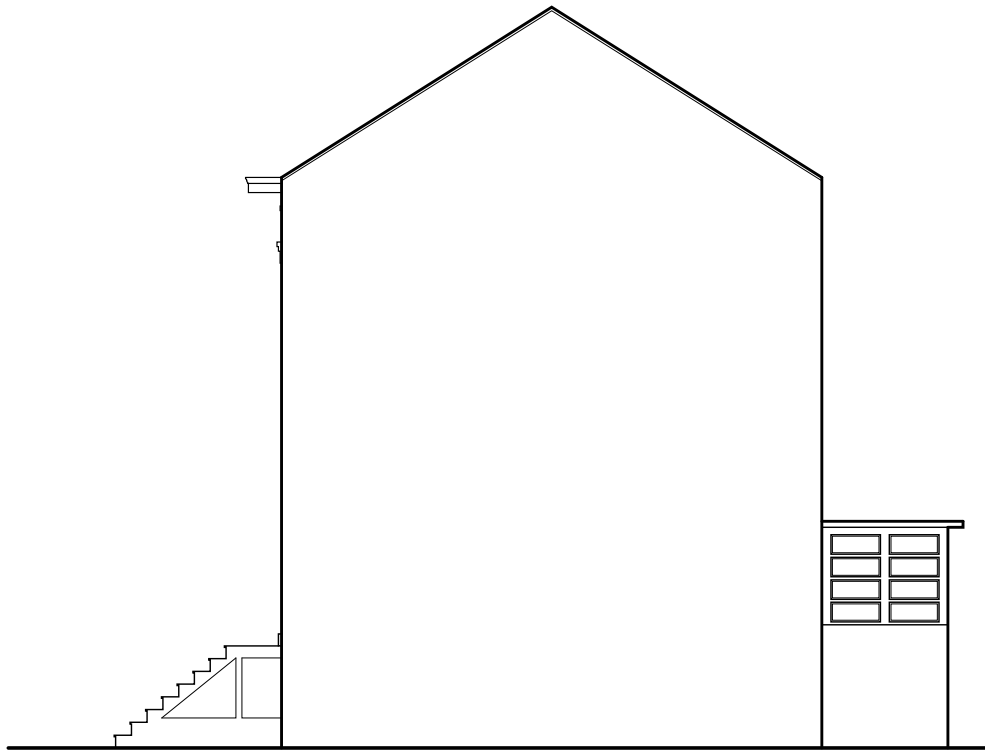
Figure 43: West Elevation

The west façade is the gable wall and has no windows or other openings. The bricks used on the west facade are of lesser quality than those on the north facade (front of the building). Molded bricks measuring 7 -3/4" x 2-1/2" x 3-3/4" are laid in common bond with five courses of stretchers between courses of headers. At the south end, the lowest courses of bricks have suffered partial collapse (*Figure 42*). This weakened area likely resulted from the same roof runoff and foundation issues that affected the south façade. Much of the mortar appears to be original and will require repointing.

From the interior of the building it is evident that the wall has pulled away from the interior stair. A large crack visible on the exterior is

also apparent on the interior plaster in the same location. It is not clear whether the separation was a result of the stair moving or the exterior wall moving/settling; however, this question should be further investigated during the first phase of work .

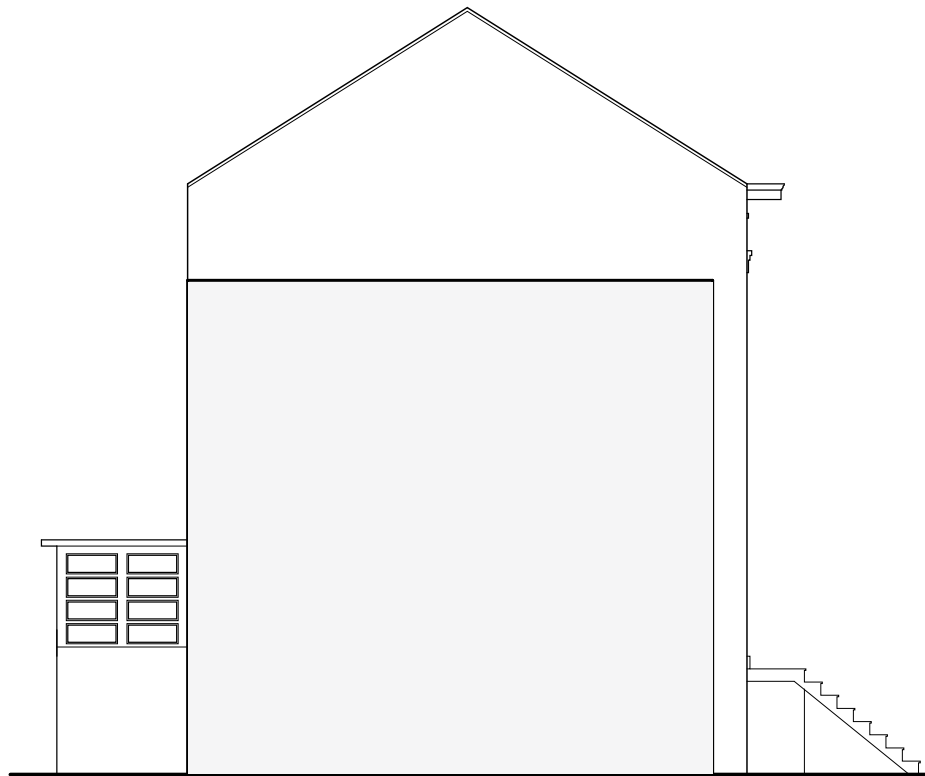
Figure 48: East Façade Elevation with shaded area indicating the portion of façade concealed by neighboring structure.

The east façade is partially concealed by an adjacent residential structure. As a result, only the exposed portions could be surveyed. The most obvious issue on the east façade is a bulge in the brick masonry where the roof meets the wall. The likely source of this deformation is water infiltration through failed chimney flashings (the chimneys have since been removed). Bricks in this area are clearly shifted out of plumb and mortar is substantially deteriorated.

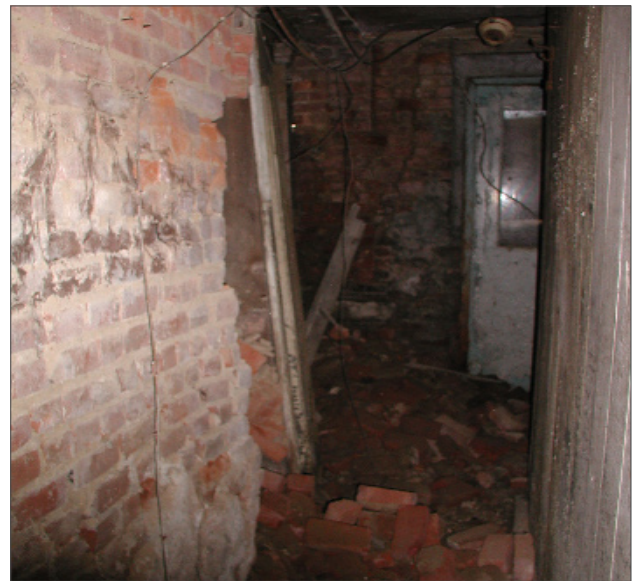
The north-south “stiffening” wall has suffered partial collapse at the north end and has shifted out of plumb at the south end. The partial collapse is likely a weakened masonry assembly due to failed mortar. As a result of failed gutters and roof runoff (the gable runs east to west, thus approximately half of the roof runoff is deposited on the south façade and foundation), the water entered through the porous exterior wall and saturated the south end of the contiguous stiffening partition. The water dissolved the lime in the mortar, causing it to lose cohesion. In recent years, the basement has not been heated and the wet mortar has been undergoing freeze/thaw cycles in the winter, further accelerating its breakdown.

Figure 53: The south end of the brick stiffening wall between the basement hall (B03) and the former kitchen (B02) has suffered partial collapse.

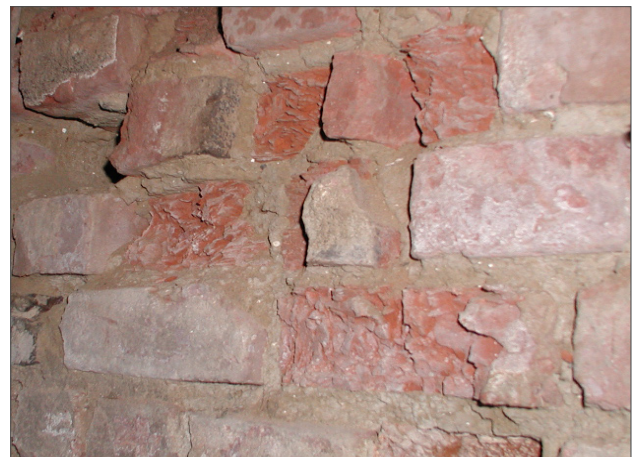
The brick masonry in the east-west partition wall has also suffered severe deterioration caused by moisture (*Figure 54*). During a site visit in March of 2006, frost and ice were clearly visible in the bricks of the east-west partition. The source of the frozen moisture is not readily evident, but most likely it comes from dampness rising from the underlying soil. Most of this moisture is sealed in by the relatively non-porous concrete floor; the trapped moisture looks for the easiest means of travel –

in this case, the relatively porous old brick and soft mortar wall – to escape. A large diagonal crack in the brickwork near the door indicates settling of this partition as well.

Figure 54: Repeat freeze and thaw cycles have left the bricks in the basement walls brittle and friable.

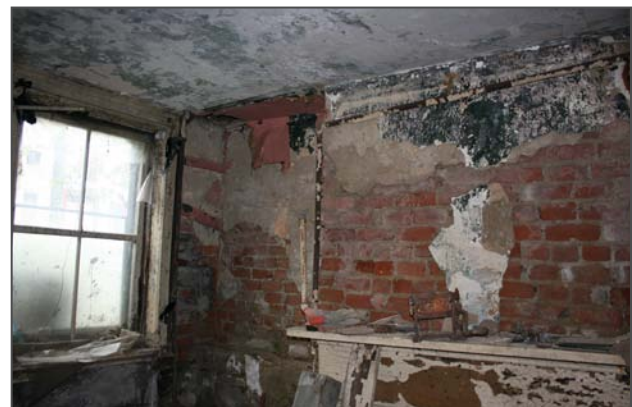
Figure 55: Most of the finishes in the basement are deteriorated from water infiltration. Plaster from the walls and chimney breast in the northeast corner of Room B01 have delaminated from the brick walls.

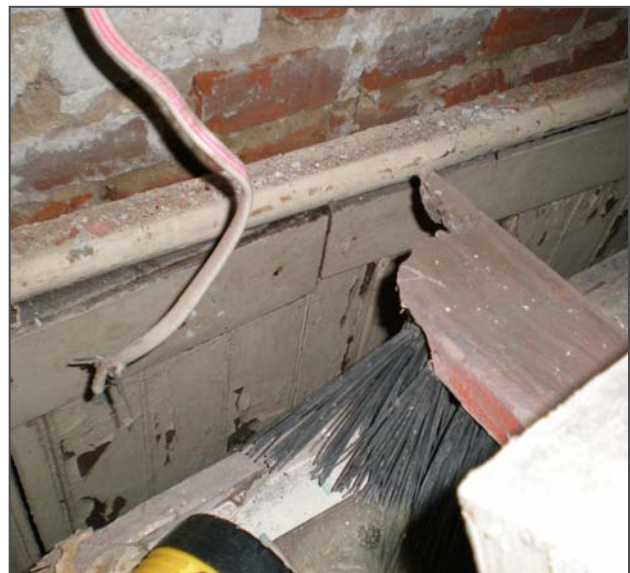
Remnants of a beaded board wainscot remain on the south, west, and east walls. Whitewash on the plaster below the chair rail suggests the wainscot was installed after the initial construction of the building. Portions of chair rail were also found on these walls and may have been installed with the wainscot.

Figure 61: Intact wainscoting and chair rail on the south wall in Room B01.

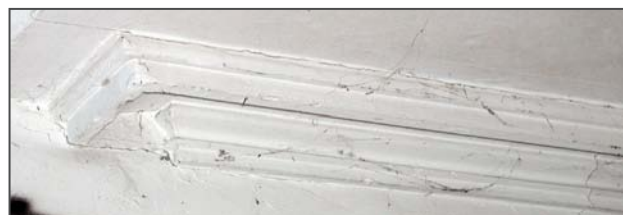
Figure 82: Room 103 retains an original plaster cornice.

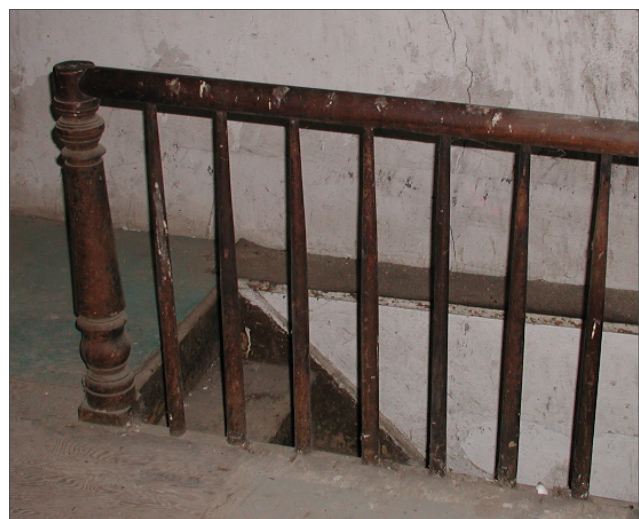
Figure 85: The stair to the cellar retains most of its original ballustrade. The cap on the newel post is missing.

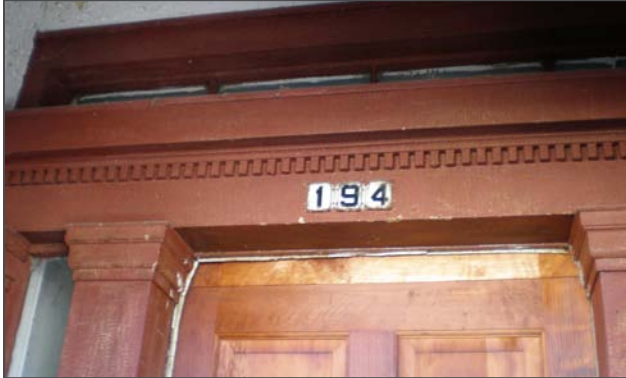
Figure 88: Detail of wooden frontispiece with dentil cornice.

There is no evidence of an architrave on the north door and it is less elaborate than the door on the south wall. The wooden frontispiece on the south wall contains an exterior cornice with dentils, two square pilasters with Italianate molded caps flanking the door opening, a four-light transom overhead and two side lights, with four lights each. Overall, the frontispiece is in good condition.

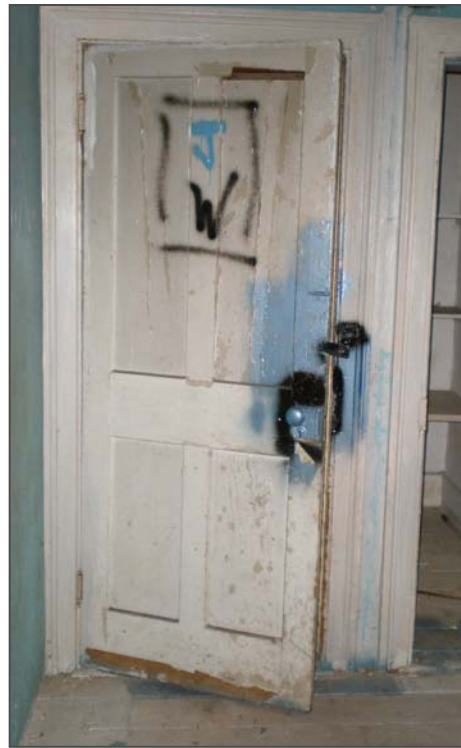
Figure 96: A four-paneled door hanging in 201 with possible original hardware, one of the few that remain.

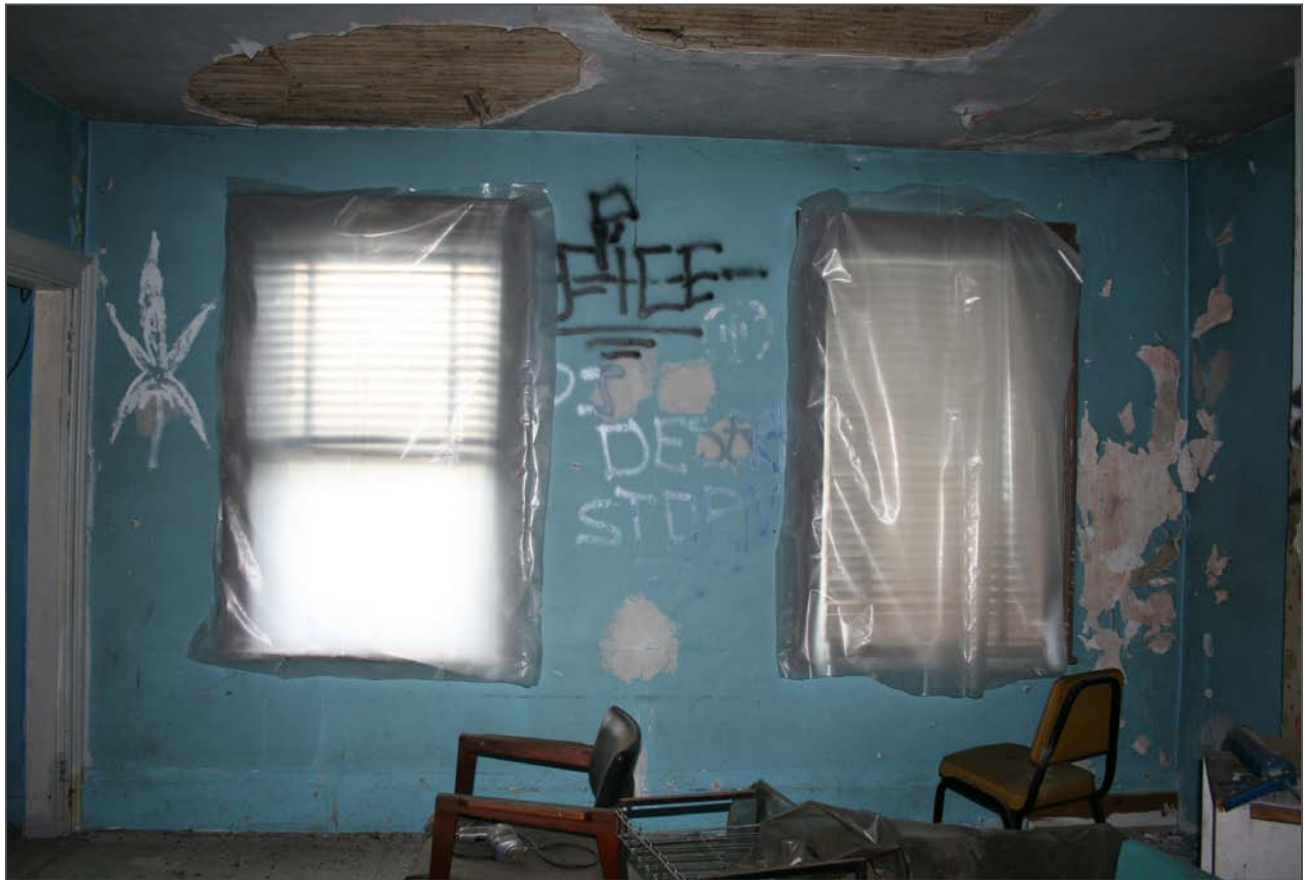
Figure 97: Two windows on the north facade illuminate this room.

wooden trim is painted and in good condition. Both windows retain the frame from exterior storm windows, and the west window also has a screen.

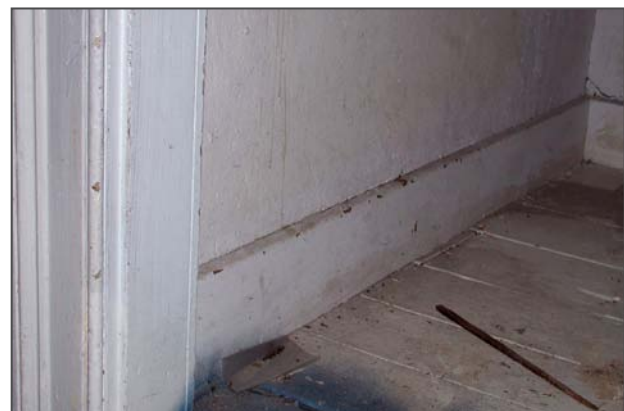
Figure 109: Room 204 is the only room in the entire house that retains original baseboards. The baseboard is a plain board with a beveled top edge.

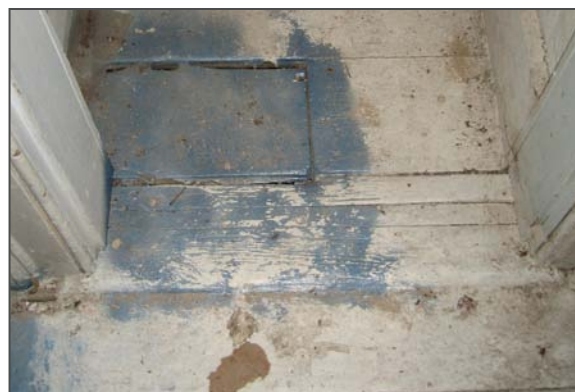
Figure 110: The east end of the floor has been cut, likely to facilitate access to the gas pipes serving the chandelier in Room 103 below.

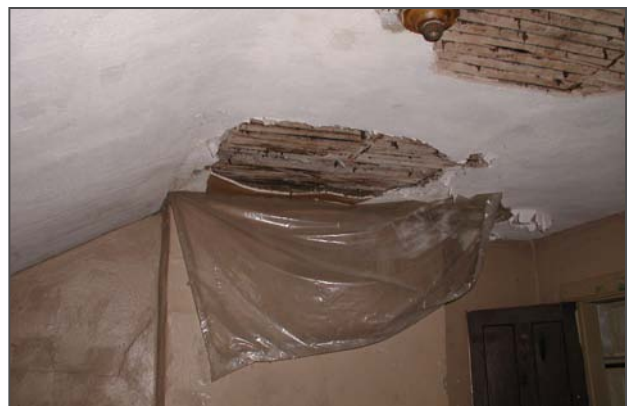
Figure 118: Damage to the plaster ceiling along the east wall in Room 301 was likely caused by water entering through failed chimney flashings.

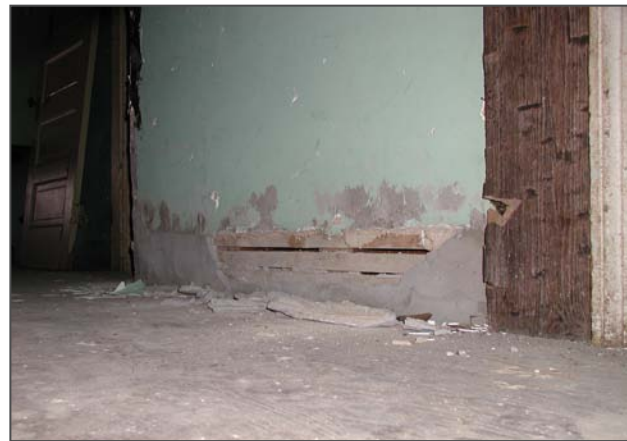
Figure 124: In Room 304, the baseboards were removed and the exposed space parged with cement.

condition and can be retained and repaired. The baseboard has been removed and the exposed wall parged over in portland cement. The south wall of the stair hall is plaster on brick, and covered in faux wood panelling. This wall has been exposed to water infiltration for some time, and it is unlikely this plaster is in salvageable condition.

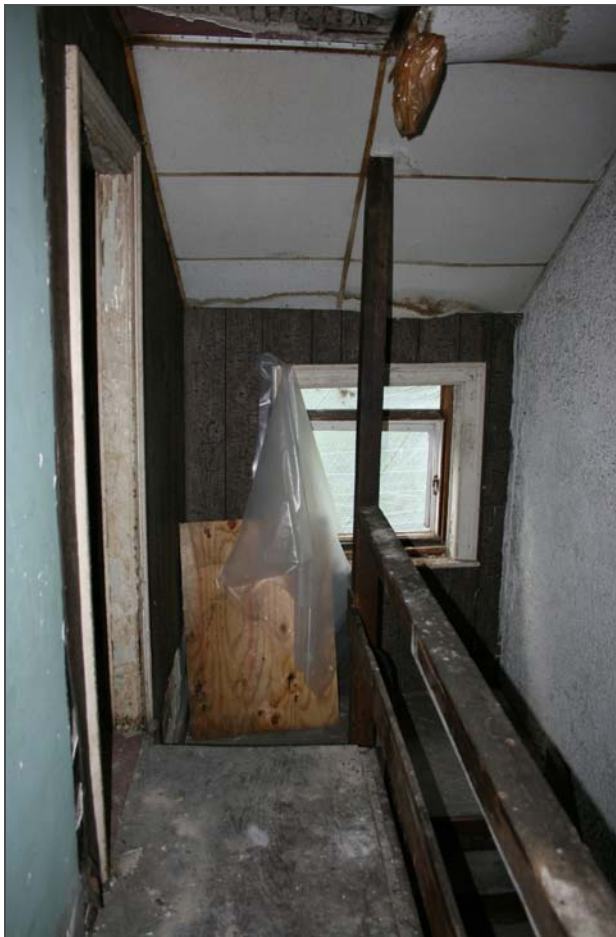
Ceiling: The ceiling is covered with two-foot by four-foot acoustic panels with a metal grid. Where tiles are missing, the exposed plaster ceiling above is visible and in very poor condition. The plaster is missing and only the lath remains. Water stains are visible on the acoustic tiles, indicating ongoing moisture

Figure 125: View looking south into the north-south corridor of Room 304.

infiltration in the ceiling and suggesting that any surviving plaster is likely in very poor condition and will require complete replacement in-kind.

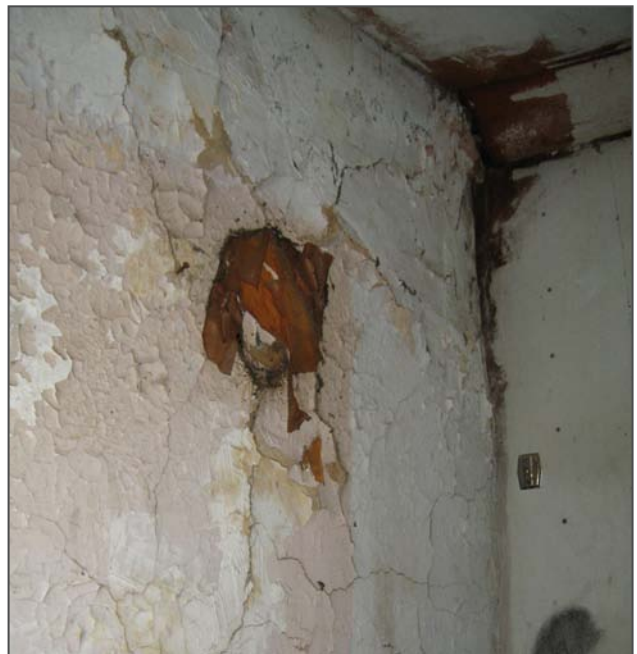
Figure 135: Former location of a stove hole in the chimney breast on the east wall of Room 302 is evidence of an original or early use of a stove to heat this space.

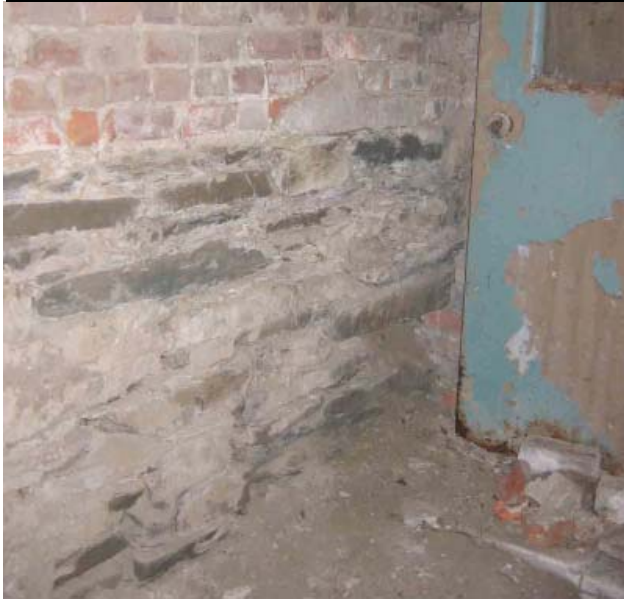
The other types of deterioration in the basement include the loss of significant amounts of brick and stone masonry from the interior surfaces of the exterior masonry walls. See Photograph No. 1 for a view of the deterioration on the interior face of the west elevation exterior wall. These elements must be repaired by either selective or complete rebuilding (depending upon the extent of deterioration).

Photograph No. 1. View of interior face of exterior wall at NW Corner of Basement.

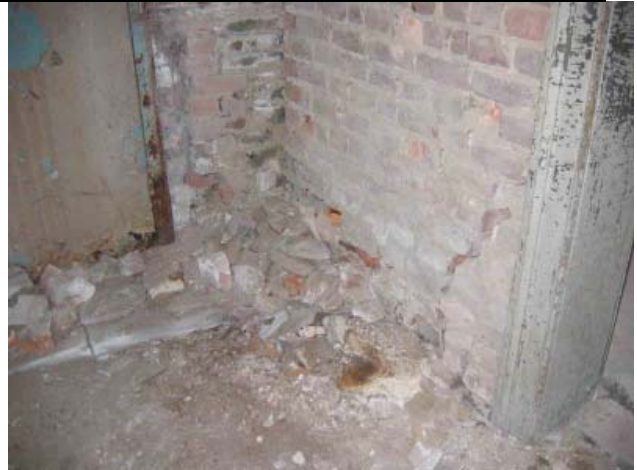
The deterioration of the north/ south bearing wall in the interior of the basement extends to the north side of the house. See Photograph No. 2 for a view of this deterioration. This section of the north/ south wall will also require reconstruction for their long-term stability.

Photograph No. 2. View of interior wall in basement (north end of the north/south bearing wall); opposite side of hallway from Photograph No. 1.

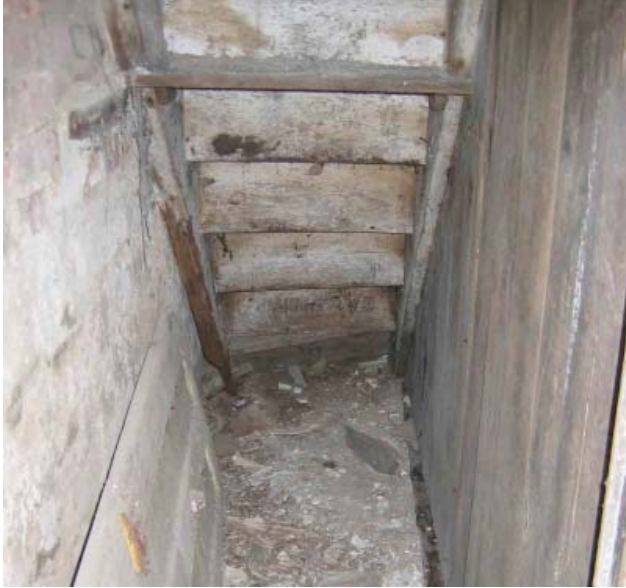
In addition to the masonry deterioration in the basement, there is also noticeable rot, insect damage, and loss of materials at the wood staircase (from the first floor to the basement). The repair of this stair will likely require complete removal and replacement with new sound materials. See Photograph No. 5 and No. 9 for views of this staircase.

Photograph No. 5. View of underside of wood stairs in the basement.

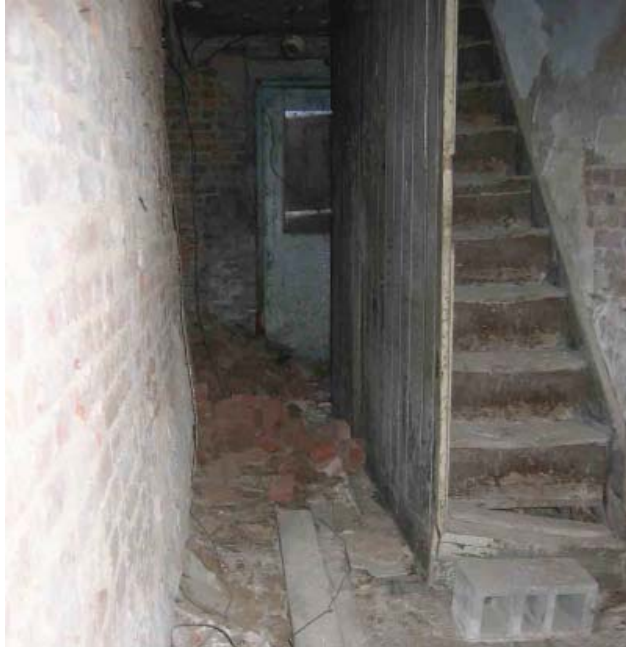
The northern and central sections of this same north/ south load bearing interior brick wall are also in very poor condition. See Photographs No. 3 and No. 9 for illustrations of this wall. Because of the extent of its deterioration and the expense associated with retaining the masonry this section of wall will likely need to be rebuilt. As with the southern section of this wall, their reconstruction will require the construction of new foundations for the brick wall. One of the reasons for the failure of this wall appears to be the placement of very poor original foundations underneath the wall. There are several alternative structural design options available to the Owner for the reconstruction of this wall—including complete removal and rebuilding with concrete masonry units and/ or steel beams and columns. If a more historically authentic look is desired, it is possible that the wall can be rebuilt almost entirely of brick. The suitability of each of these options should be evaluated prior to undertaking any extensive design effort.

Photograph No. 9. View of basement hallway looking south. The north/ south bearing wall is on the left side of this image; note that the wall is no longer plumb and has moved sideways.

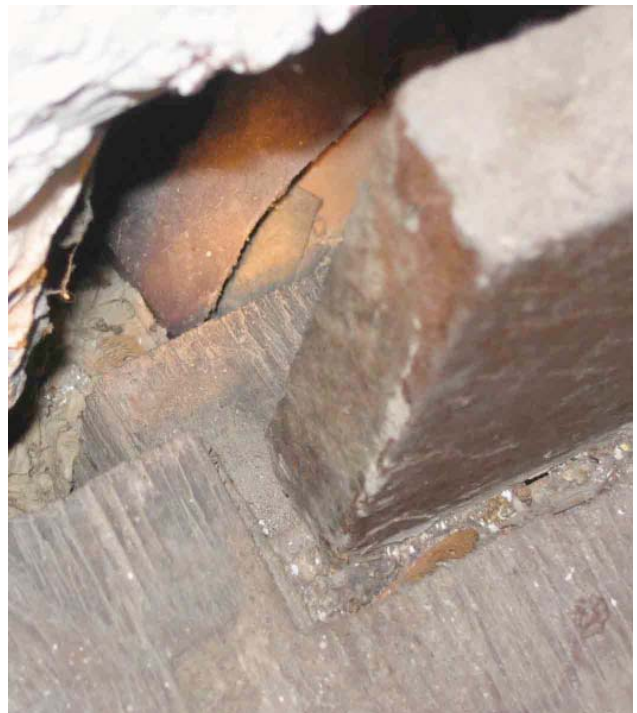
At the intermediate floor landings of the staircase there was some noticeable separation between the staircase and the west exterior wall of the house. See Photographs No. 11, No. 12, and No. 15 for views of this type of separation. We recommend that a probe be completed in this area to expose the condition of the staircase elements and the masonry wall. Once the conditions are visible then a structural repair can be designed. It appears likely that the connection between the wood header and the brick wall will need to be reinforced. Photograph No. 14 shows some additional cracking of plaster.

Photograph No. 12. View of header and side of stair landing at upper floor where the stair has pulled away from the interior surface of the exterior wall. This is a close-up of

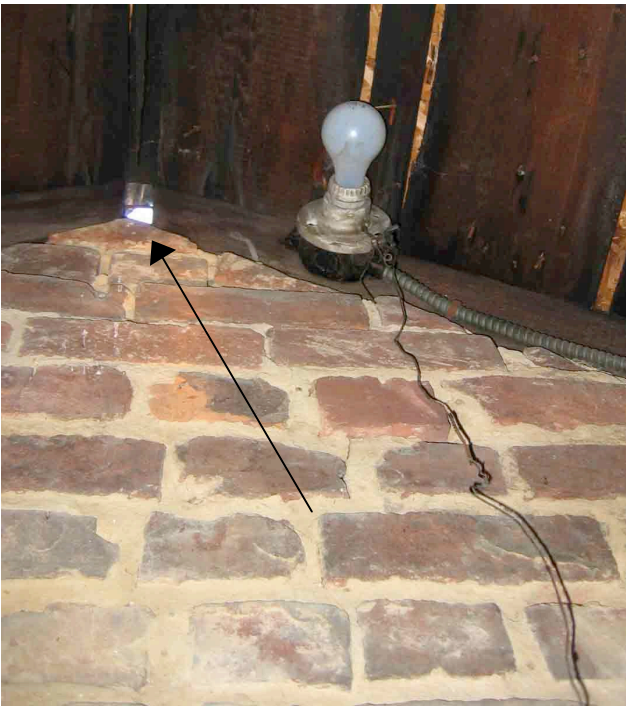
While we did not observe close-up the condition of the brickwork near the top of each of the walls, the loss of mortar on the interior and exterior surfaces of the masonry walls is likely to extend all of the way to the top of the house. Indeed, see Photograph No. 16 for a view of the loss of mortar at the top of the east gable; this view of the interior surface of the brickwork also shows the hole at the top of the gable that undoubtedly lets water into the building.

Photograph No. 16. View of interior surface of the west gable as viewed from the attic. The arrow points to where light (and water) enters the attic.

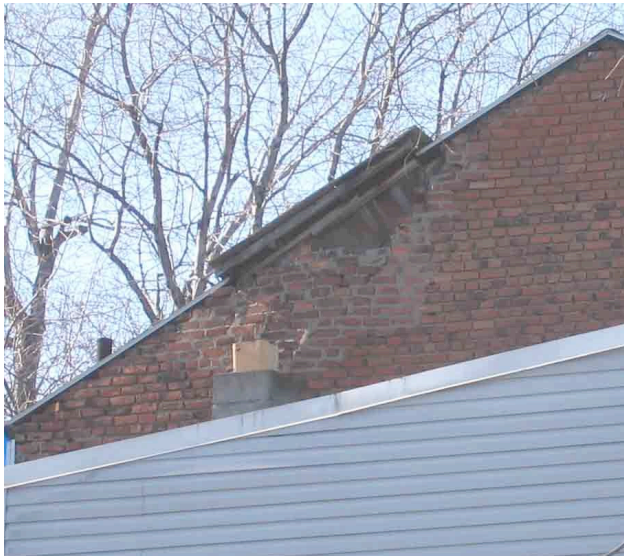
At the third floor level we noted already discussed exterior masonry deterioration and the slight horizontal separation of the west exterior wall of the house from the interior wood-framed staircase. The deterioration of the exterior masonry includes some significant areas of lost and/ or poorly rebuilt exterior masonry and the horizontal bulging of the brick near the east gable. See Photograph No. 19 for an exterior view of the east elevation (from a distance) and Photograph No. 21 for an exterior view of the east elevation (from the ground level looking steeply up to the top of the gable).

Photograph No. 19. View of missing masonry and poorly reconstructed masonry on the exterior of the East elevation.

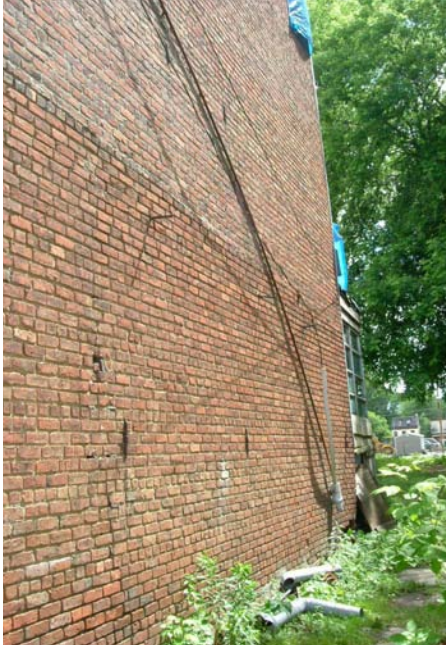
Wrought iron ties visible on the west façade strengthen the connection between the joists and the masonry.

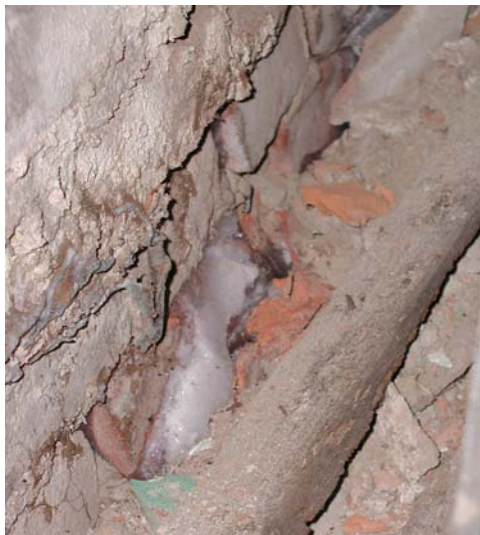
During a winter visit, ice was visible in the bricks in the east-west cellar partition.

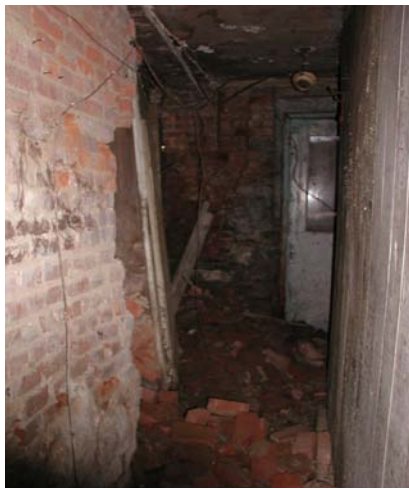
The south end of the brick stiffening wall between the cellar hall (B03) and the former kitchen (B02) has suffered partial collapse.

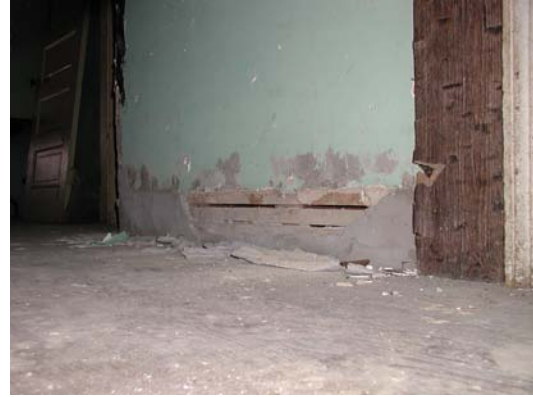
In Room 304, the baseboards were removed and the exposed space patched with cement.

The south wall of the hall is plaster on lath and was once covered in some sort of paneling; long smears of mastic indicate the location of the seams. The plaster is in good condition and can be retained and repaired. The baseboard has been removed and the exposed wall patched over in portland cement. The south wall of the stair hall portion is plaster on brick, and covered in faux wood paneling. This wall has been exposed to water infiltration for some time and it is unlikely this plaster is in salvageable condition.

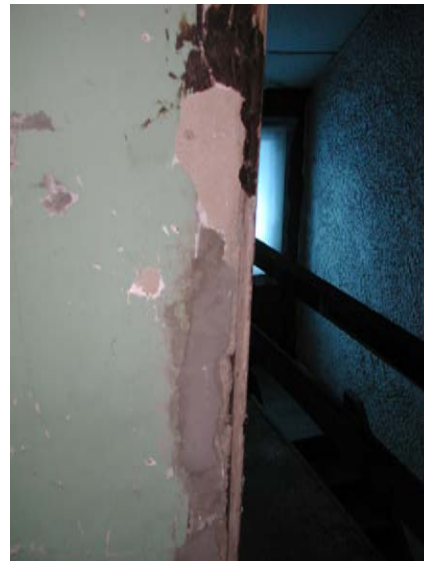
The plaster on the outside corner of the stair hall is damaged and has been repaired with portland cement. The portland cement is of course inappropriate and should be removed and the area properly repaired with matching plaster. However, the damage exposes an interesting detail: an original wood corner bead is visible here.

Damage to the outside corner in Room 304 exposed an original wood corner bead.

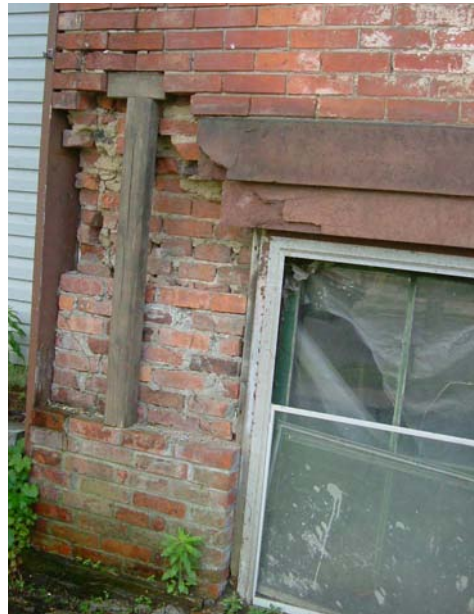
- The missing bricks have left this wall precariously thin. Mortar analysis should be completed and the missing section reconstructed.

Missing bricks have left the northeast wall very thin and action should be taken immediately to reconstruct the wall.

Reconstruct missing brickwork at east end of north façade.

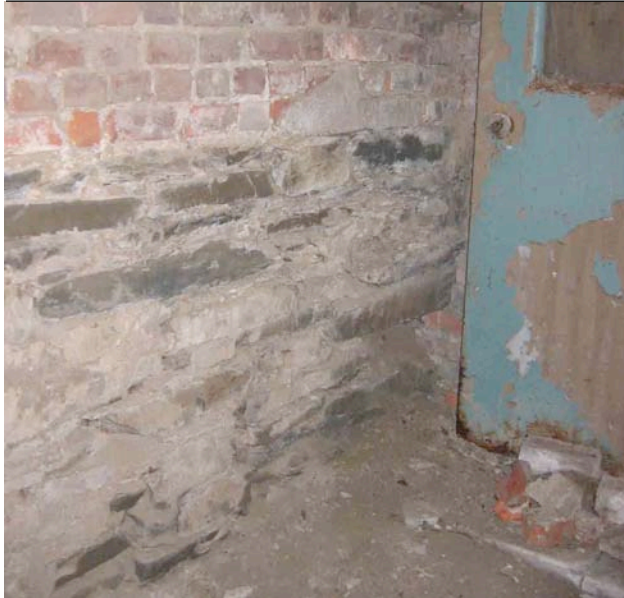
Photograph No. 1. View of interior face of exterior wall at NW Corner of Basement.

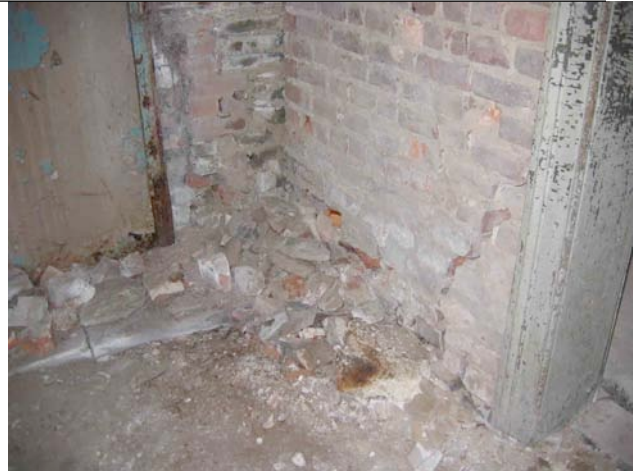
Photograph No. 2. View of interior wall in basement (north end of the north/south bearing wall); opposite side of hallway from Photograph No. 1.

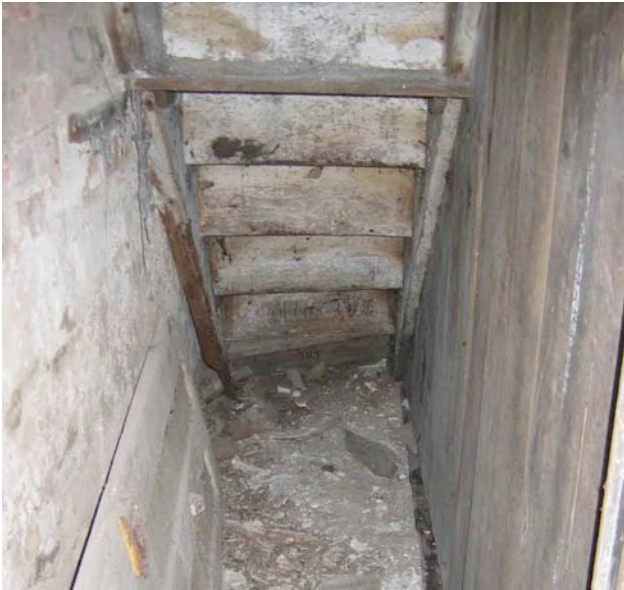
Photograph No. 5. View of underside of wood stairs in the basement.

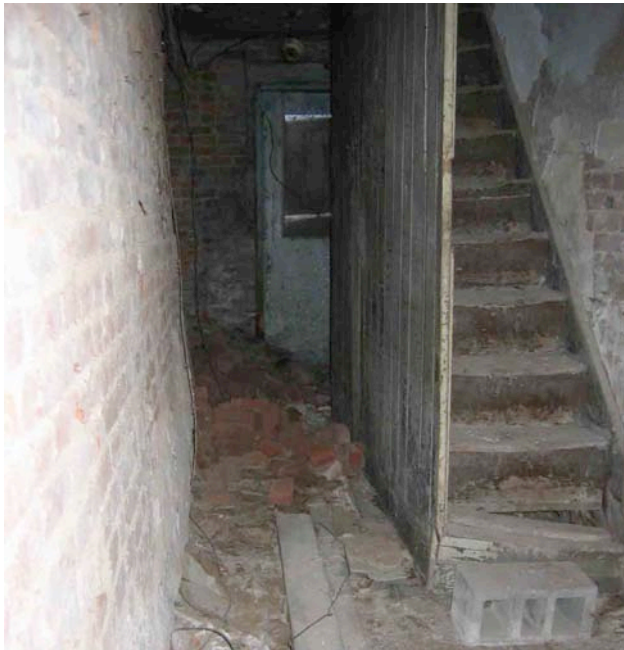
Photograph No. 9. View of basement hallway looking south. The north/ south bearing wall is on the left side of this image; note that the wall is no longer plumb and has moved sideways.

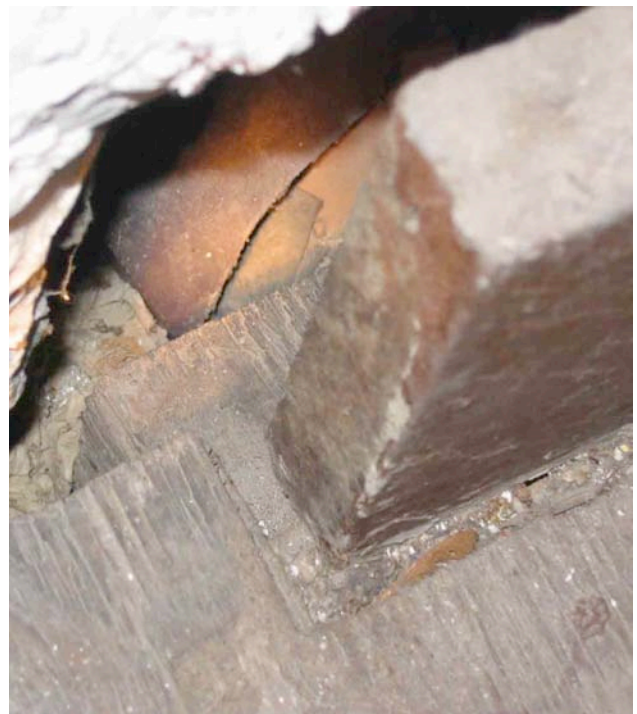
Photograph No. 12. View of header and side of stair landing at upper floor where the stair has pulled away from the interior surface of the exterior wall. This is a close-up of Photograph No. 11.

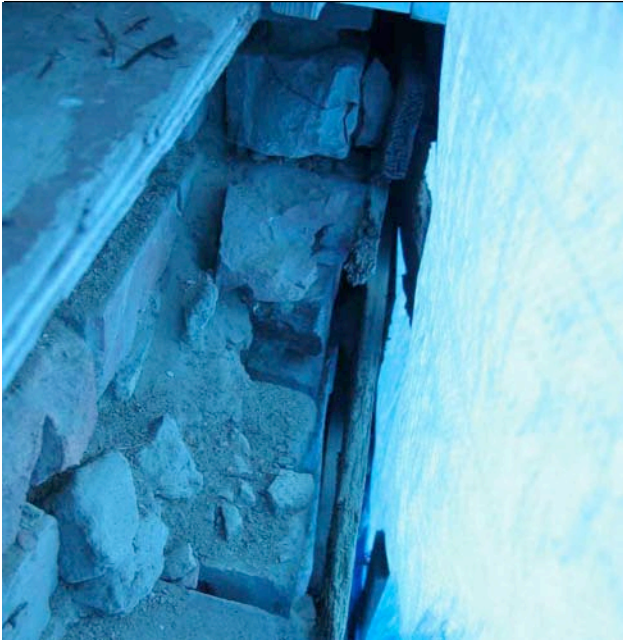
See Photograph No. 17 for a view of the ground level portion of the northeast corner at the exterior wall and see Photograph No. 18 for a view of the cornice deterioration at the northeast corner. See Photograph No. 13 for a partial view of the masonry that is immediately below a second floor windowsill on the south elevation. Note that the mortar is almost completely missing from the bricks in this area. Photograph No. 22 shows another portion of the south elevation; in this case the view is located just a few feet below the first floor.

Photograph No. 13. View of the exterior brick below a second floor window sill (on the south elevation).

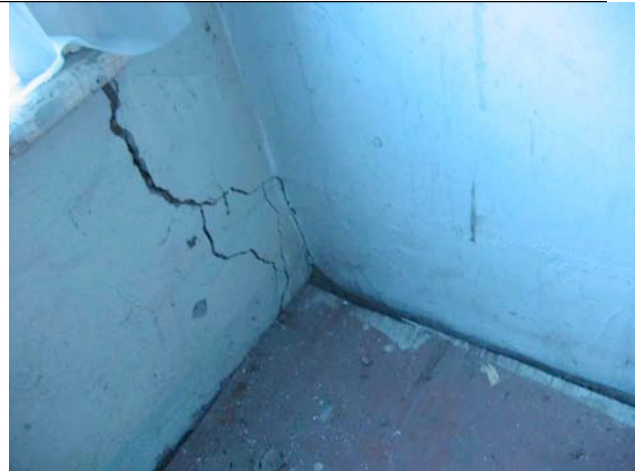
Photograph No. 14. View of crack in the interior plaster near the SW corner of the building.

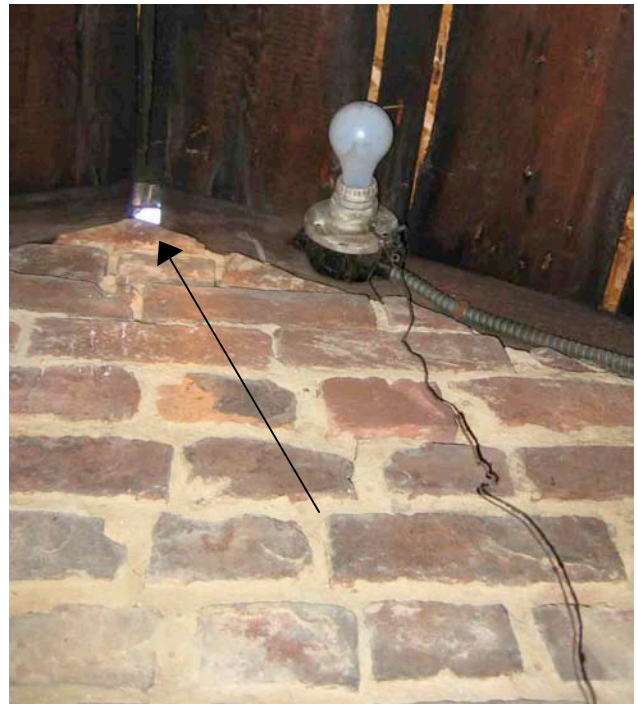
Photograph No. 16. View of interior surface of the west gable as viewed from the attic. The arrow points to where light (and water) enters the attic.
